**FEMA Levee Certification
Ventura County, California**

**Calleguas Creek Levee (CC-3)
Pleasant Valley Road to Highway 101**

**Evaluation Report
February 27, 2009**

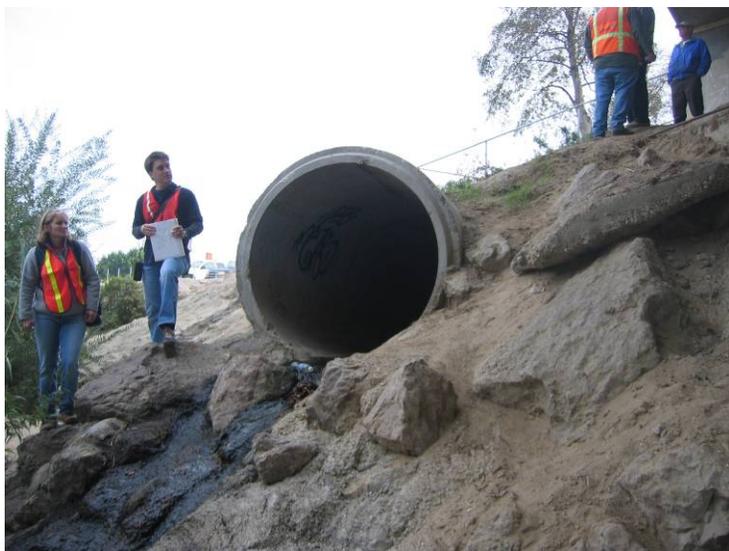
1. Seven (7) storm drain outlets with various opening sizes from 18 inch to 60 inch in diameter were observed on the levee side slope. These culvert openings do not have any closure devices (flap gates) in place. Closure devices are necessary to avoid flooding behind the levee caused by the backup of the channel flow.

Calleguas Creek Levee (CC-3) (Photo No. P1) – 60” RCP SD w/o a closure device. An active trickle of water was observed.

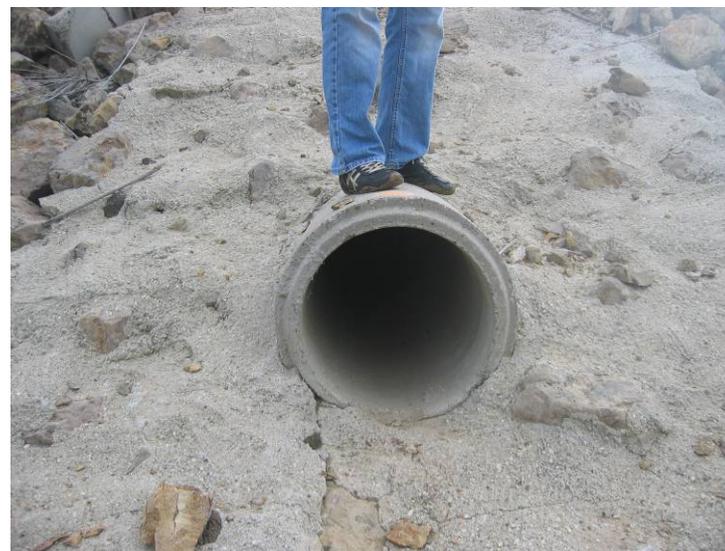
Calleguas Creek Levee (CC-3) (Photo No. P3) – 18” RCP SD w/o a closure device.

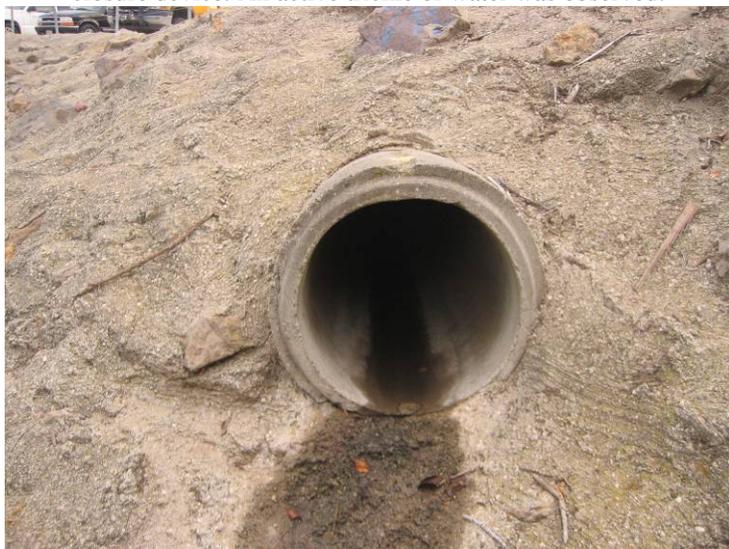
Calleguas Creek Levee (CC-3) (Photo No. P2) – 18” RCP SD w/o a closure device.

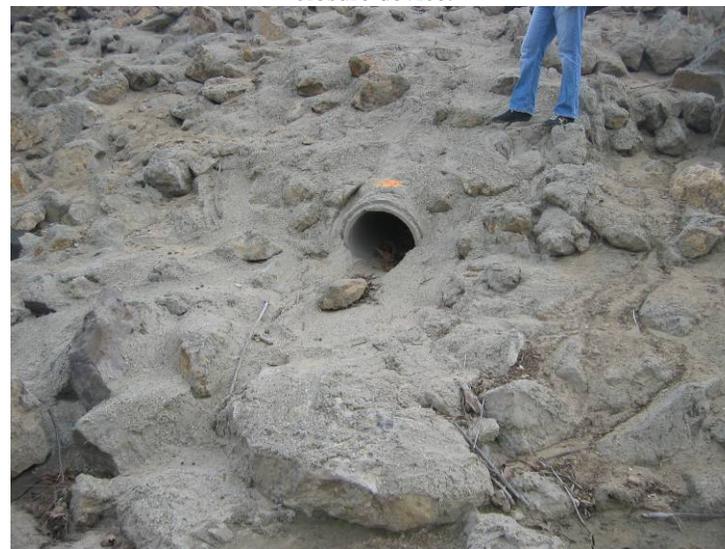
Calleguas Creek Levee (CC-3) (Photo No. P4) – 18” RCP w/o a closure device. A drop inlet for the RCP was located on the dry-side of the levee.

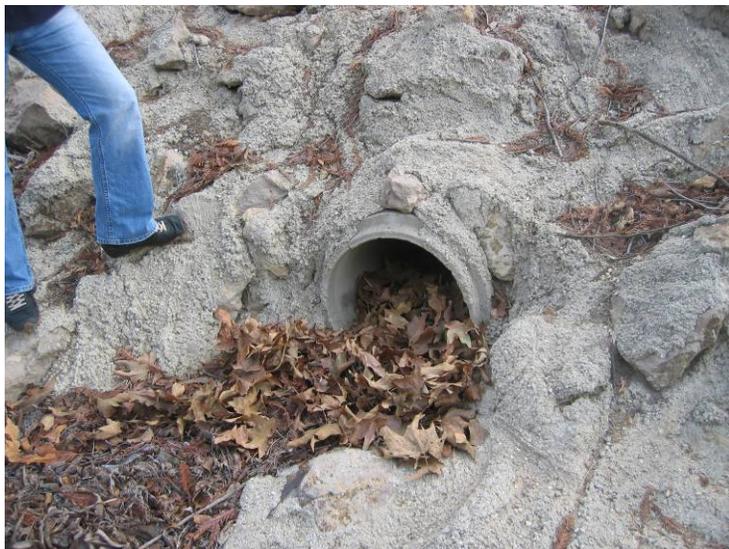
Calleguas Creek Levee (CC-3) (Photo No. P5) – 18” RCP w/o a closure device. A drop inlet for the RCP was located on the dry-side of the levee.

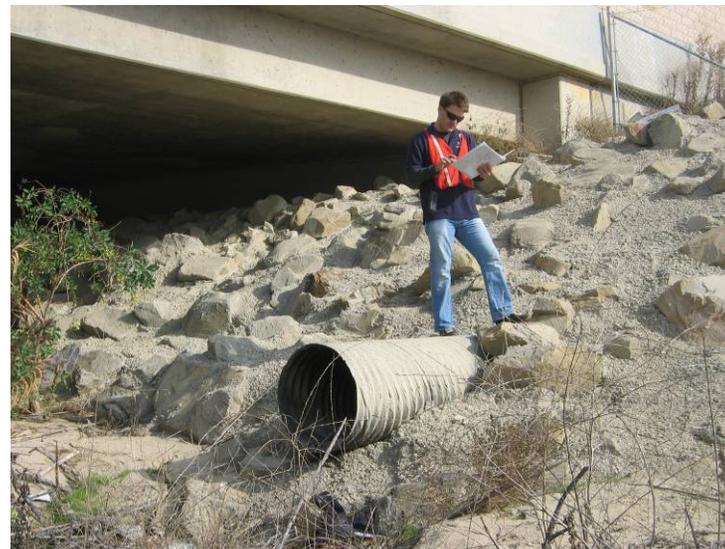
Calleguas Creek Levee (CC-3) (Photo No. P7) – 24” CMP w/o a closure device immediately downstream of HWY 101. No as-built plan available.

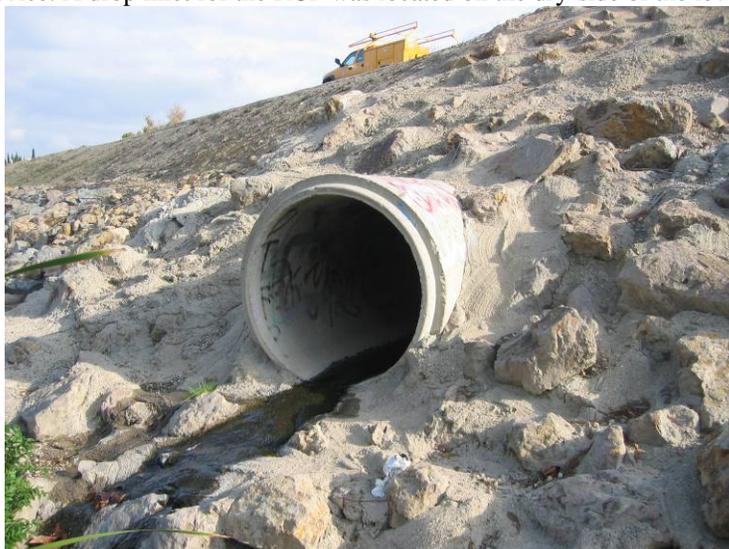
Calleguas Creek Levee (CC-3) (Photo No. P6) – 42” RCP w/o a closure device. An active trickle of water was observed.

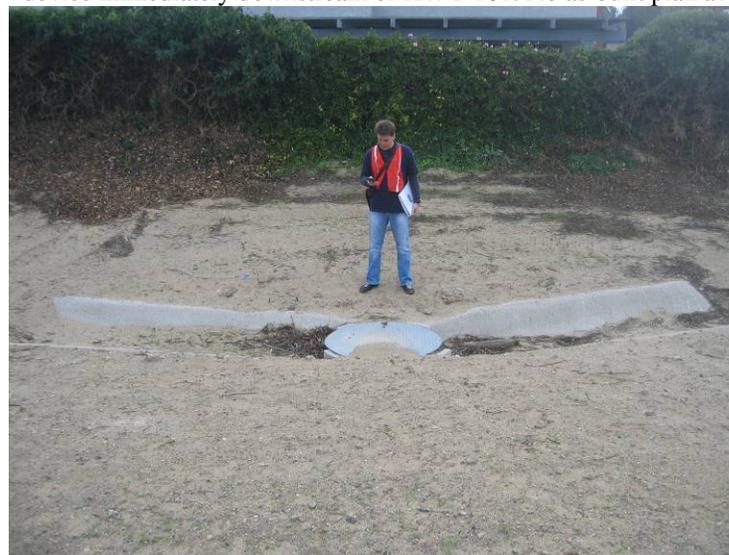
Calleguas Creek Levee (CC-3) (Photo No. F1) – Looking at a typical drop inlet structure collecting water along toe of landward side of the levee.

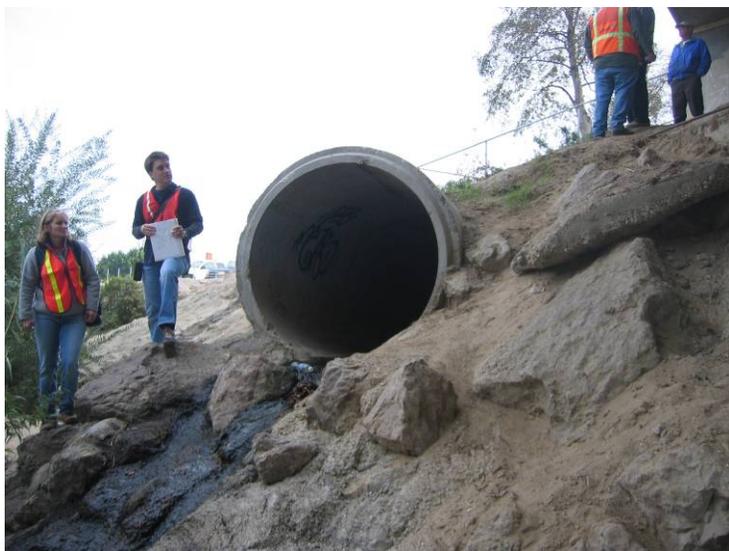
Calleguas Creek Levee (CC-3) (Photo No. M1) – 60” RCP SD w/o a closure device (Sta.478+95.)

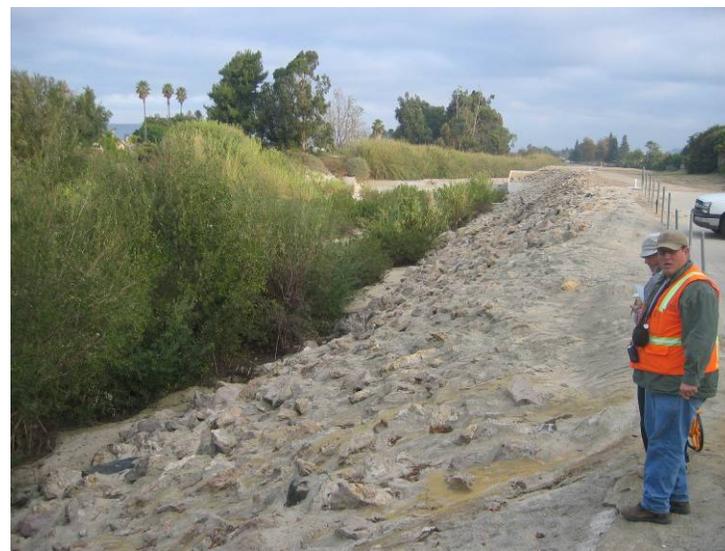
Calleguas Creek Levee (CC-3) (Photo No. M3) – Vegetation within 15’ of Toe (Riverward side).

<p>2. Please describe methods for vegetation and rootball removal.</p>	<p>4" DIAMETER TRUNK OR GREATER: Cut the woody vegetation approximately two (2) feet above ground level leaving a prominent stump for use in the rootball extraction process. Remove the stump and rootball by pulling or extracting with a backhoe or similar equipment. Clean the rootball cavity of all loose soil and remaining root system (roots greater than 1/2" diameter). Prepare the cavity by excavating per FIGURE 2. Backfill with excavated soil or imported soil with equivalent or lower permeability. Place material in horizontal lifts no greater than twelve (12) inches. Moisture conditioned to at least optimum moisture content and compacted to at least ninety (90) percent of the maximum dry density of the fill soil per ASTM D1557. Compaction typically requires the use of manually operated compaction equipment or compaction attachment to a backhoe. Compaction testing should be performed per ASTM D1556 or D2922. A minimum of one (1) test per three (3) cubic yards of backfill.</p> <p>2"-4" DIAMETER TRUNK: Cut the woody vegetation stump flush with the ground. Treat the stump with a protective coating similar to polyurethane to prolong the decay process.</p>

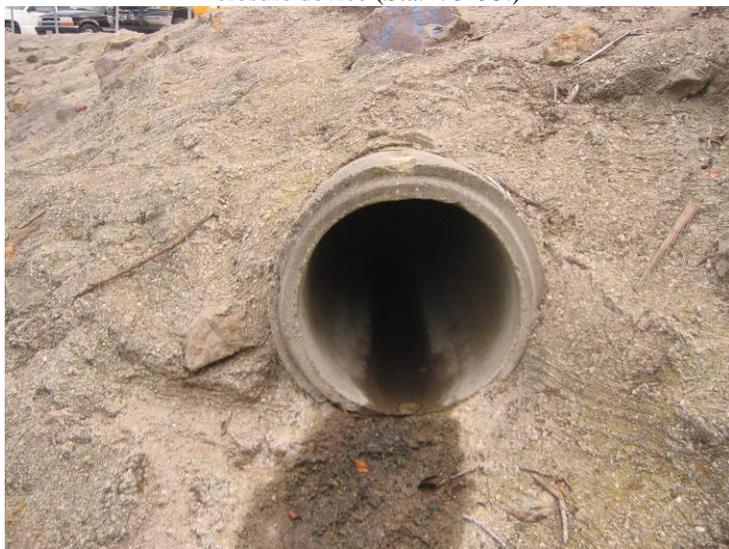
Calleguas Creek Levee (CC-3) (Photo No. M2) – 18” RCP SD w/o a closure device (Sta.479+45).

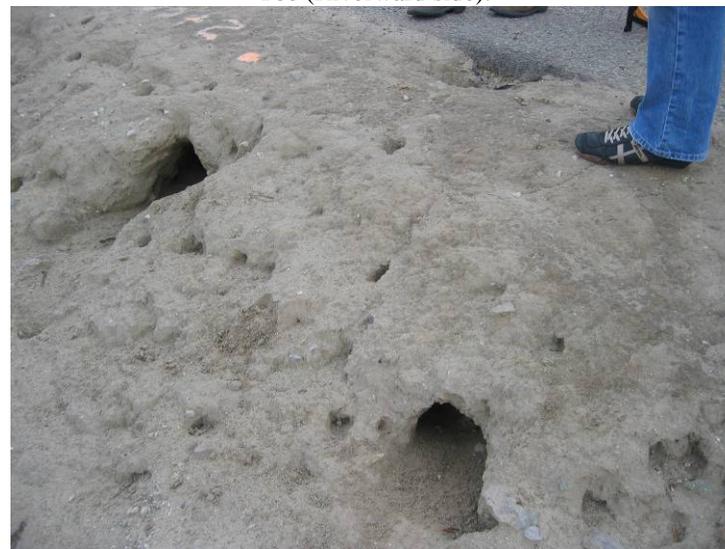
2. Multiple animal burrows were observed in the field. They are located near the top of the slope and along the interface between the revetment and dirt embankment. A few burrow holes were located on the asphalt-paved top of the levee. They do not affect the structural integrity of the levee but need to be repaired during maintenance.

7. Animal Burrows					A No animal burrows present on the levees.	- A number of animal burrows were observed throughout the entire length of the levee at the top of slope. A few burrows
					M Several animal burrows present which may lead to seepage or slope stability problems, and they require immediate attention.	
			X		U Significant maintenance is required to fill existing burrows, and the

Calleguas Creek Levee (CC-3) (Photo No. M4) – Multiple animal burrows on top of slope for an entire length of CC-3 (Riverward side).

VCWPD O&M QUESTION	TETRA TECH/AMEC RESPONSE
<p>1. Animal burrow/hole repair procedures. Please confirm acceptable methods. Also confirm acceptable documentation method.</p>	<p>For small isolated burrows, infilling of the burrow with grout is sufficient. The grout should be relatively free flowing to permeate the burrows. A typical grout specification would be similar to CalTrans Specifications Section 41-1. A copy of this section is attached but should be modified to suit the conditions.</p> <p>For areas where a large number of interconnected burrows exist or the amount of burrows present has caused surficial instability, removal and replacement/re-compaction of the impacted material is needed. The attached Figure 1 presents a typical detail and backfilling requirements.</p> <p>Documentation for the singular burrows shall consist of a documentation of the location, size, volume of grout placed, and other pertinent details. Documentation of the removal and replacement/re-compaction of the impacted material shall be conducted by a certified testing and materials lab that the District is familiar with. The documentation shall include a report provided by the testing and materials lab. AMEC will periodically observe these locations and will require a copy of the report for documentation and review.</p>

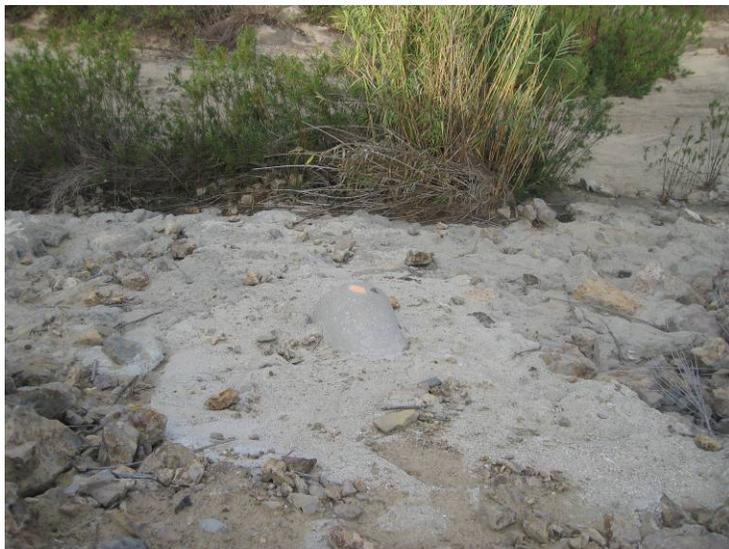
Calleguas Creek Levee (CC-3) (Photo No. M5) – 18" RCP SD w/o a closure device (Sta.482+00).

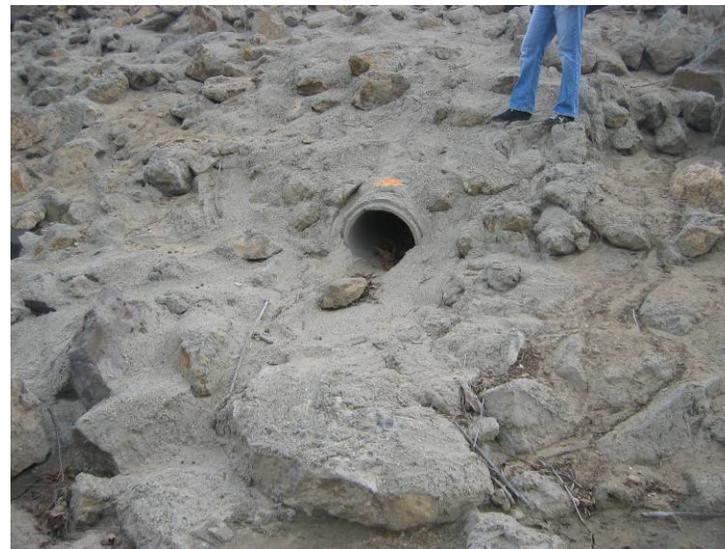
Calleguas Creek Levee (CC-3) (Photo No. M7) – 18" RCP w/o a closure device (Sta.488+00).

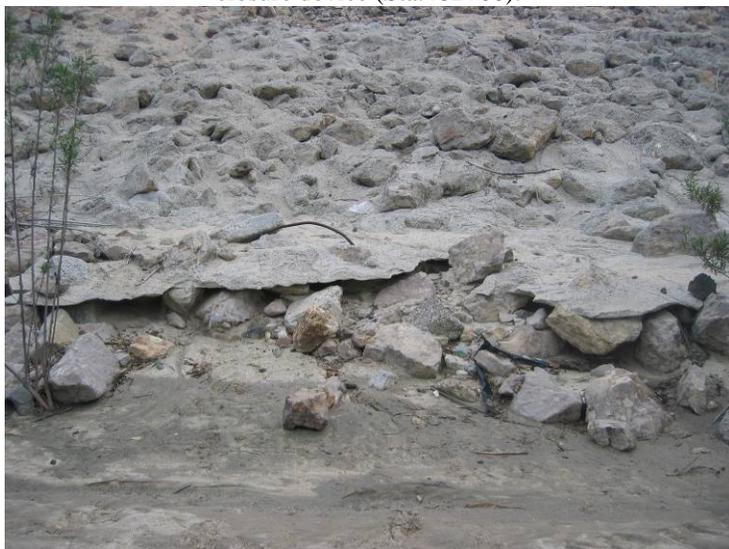
Calleguas Creek Levee (CC-3) (Photo No. M6) – Undercut at bottom of grouted revetment caused by toe erosion.

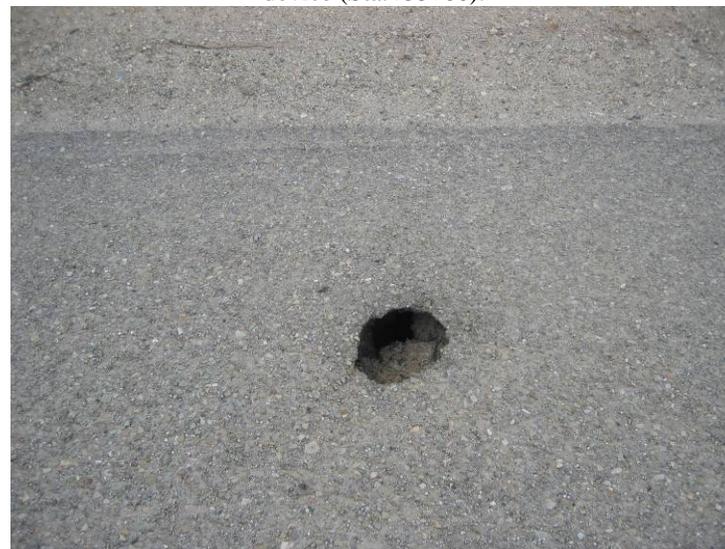
Calleguas Creek Levee (CC-3) (Photo No. M8) – Animal burrow through paved top of levee (Riverward side).

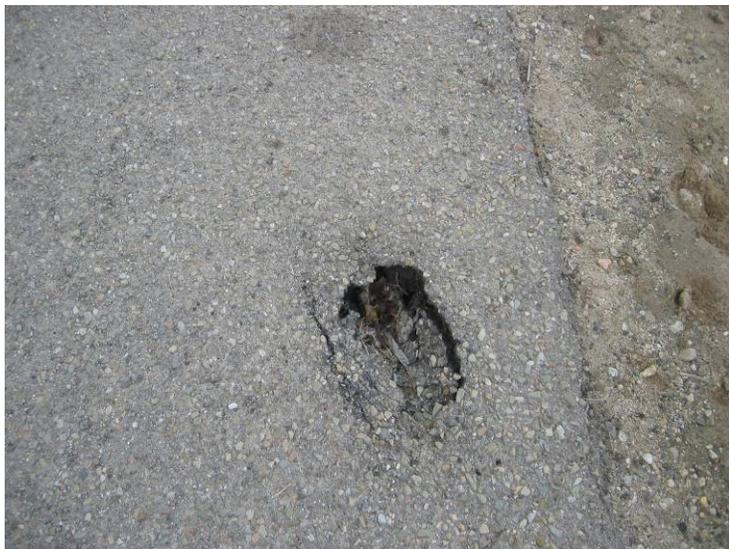
Calleguas Creek Levee (CC-3) (Photo No. M9) – Animal burrow through paved top of levee (Riverward side).

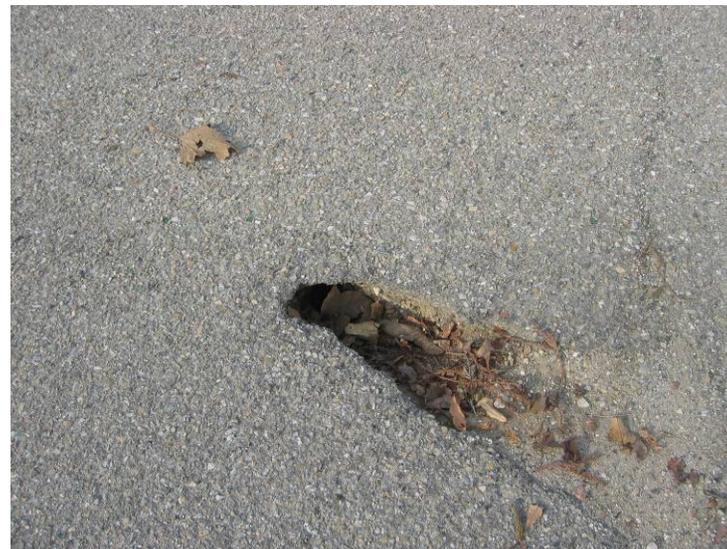
Calleguas Creek Levee (CC-3) (Photo No. M11) – Animal burrow through paved top of levee (Riverward side).

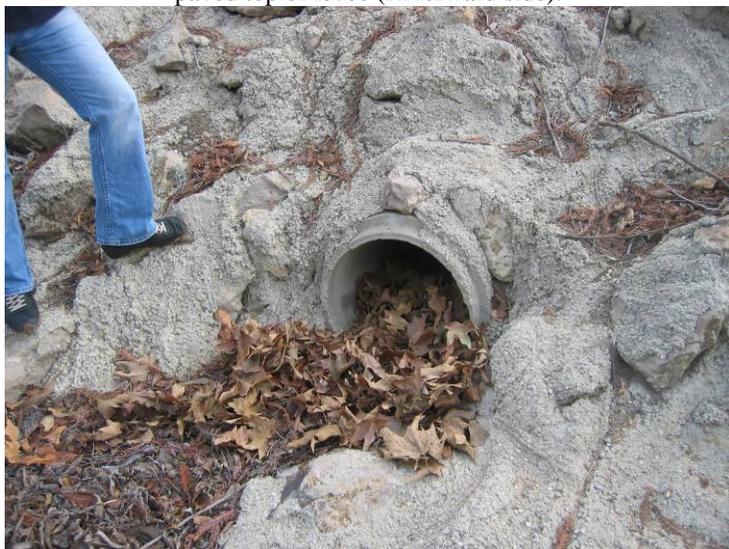
Calleguas Creek Levee (CC-3) (Photo No. M10) – 18” RCP w/o a closure device (Sta.495+00).

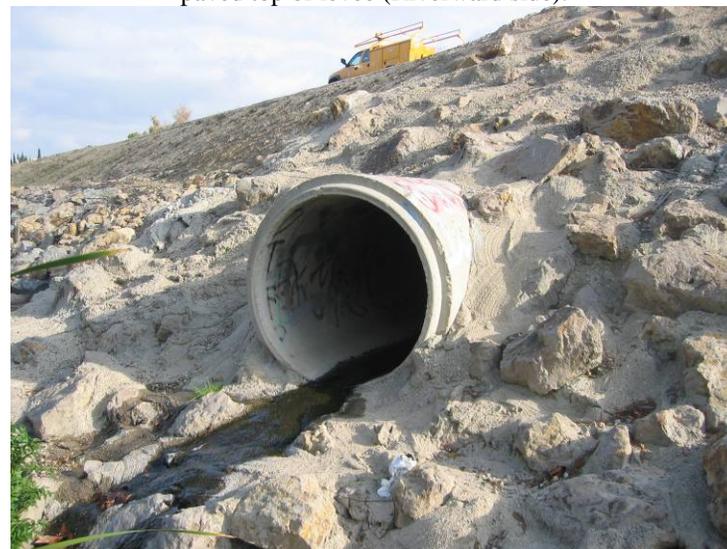
Calleguas Creek Levee (CC-3) (Photo No. M12) – 42” RCP w/o a closure device (Sta.499+12).

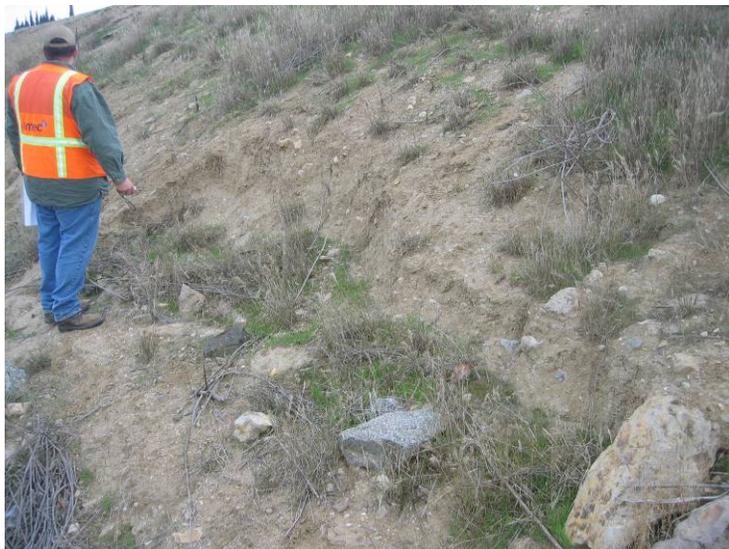
4. Several areas with bank erosion were observed on the side slope of soil embankment above the rock bench near HWY 101 Bridge.

Calleguas Creek Levee (CC-3) (Photo No. M13) – Erosion on earthen embankment above rock bench placed at toe (Riverward side).

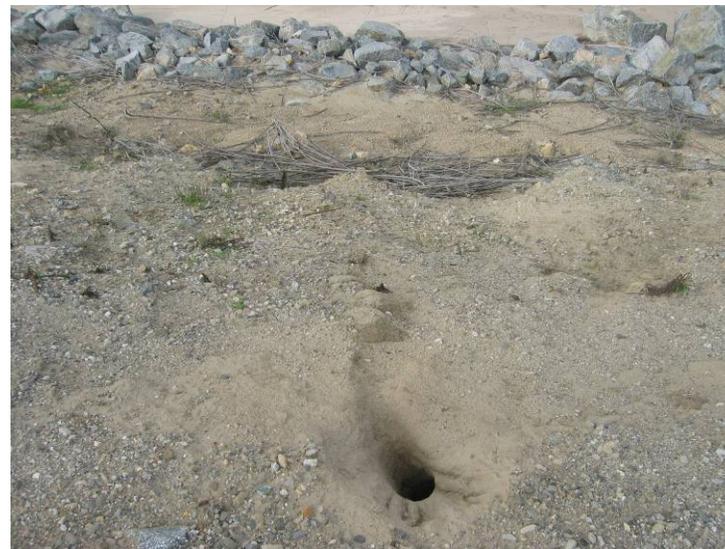
Calleguas Creek Levee (CC-3) (Photo No. M15) –Erosion on earthen embankment above rock bench placed at toe for 10-ft (Riverward side).

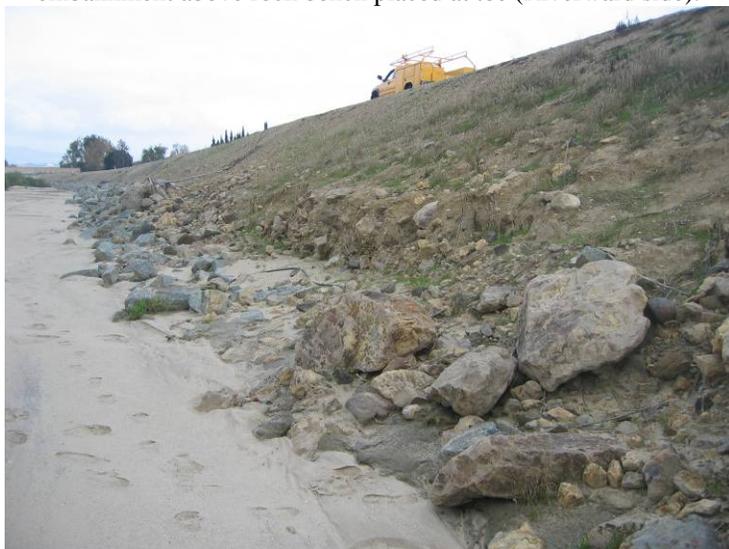
3. A 5- to 6-ft high rock bench was constructed by the County along the toe of the ungrouted riprap section of the levee after the 1998 El Nino flood up to the observed high water mark. However, currently a 55-ft section of the rock bench has possibly washed away exposing the ungrouted toe of the levee and needs to be repaired to achieve the continuity of the bench and avoid a weak spot. The County personnel confirmed that as-built plans were available for the rock bench and should be provided for review.

GPS		*Photo No.	Description	Action Required
Lat	Long			
N34.21174	W119.01483	M14	Erosion at toe of levee. A 55-ft long section of rock bench is washed away. An earthen embankment behind the bench is also eroded.	Restore earthen embankment and rock bench at toe to design condition. Additional engineering analysis recommended.
N34.21227	W119.01475	M15	Bank erosion on earthen embankment for approximately 10 ft long above rock bench placed at toe (Riverward side)	Fill voids with impervious material and firmly compact and restore design slope.
N34.21250	W119.01472	M16	Bank erosion on earthen embankment for approximately 10 ft long above rock bench placed at toe (Riverward side)	Fill voids with impervious material and firmly compact and restore design slope.
N34.21402 to N34.21490	W119.01471 to W119.01482	M17	Vegetation within 15' of Toe & minor debris (Riverward Side)	Remove vegetation and root ball, fill voids with impervious material and firmly compact.

3. Erosion / Bank Caving					A No active erosion, undermining, or bank caving due to riverbed degradation or flow impingement, observed on the landward or on the riverward side of the levee.	- Approximately between stations 498+15 and 498+70, a rock bench placed along the toe of the levee (riverward side) was washed away, and the earthen embankment behind it was experiencing erosion along the toe.
					M There are areas where active erosion is occurring or has occurred on or near the levee embankment, but levee integrity is not threatened.	
			X		U Erosion, undermining, or caving is occurring or has occurred along the toes that threatens the stability and integrity of the levee. The erosion or caving has progressed into the levee section or into the extended footprint of the levee foundation and has compromised the levee foundation stability.

Calleguas Creek Levee (CC-3) (Photo No. M14) – Erosion at toe of levee. A 55-ft long section of rock bench is washed away.

M14	Erosion at toe of levee. A 55-ft long section of rock bench is washed away. An earthen embankment behind the bench is also eroded.	Restore earthen embankment and rock bench at toe to design condition. Additional engineering analysis recommended.	C3/C4	E2	Excavate and repair in kind			
M15	Bank erosion on earthen embankment for approximately 10 ft long above rock bench placed at toe (Riverward side)	Fill voids with impervious material and firmly compact and restore design slope.	C3/C4	E2	Excavate and repair in kind			
M16	Bank erosion on earthen embankment for approximately 10 ft long above rock bench placed at toe (Riverward side)	Fill voids with impervious material and firmly compact and restore design slope.	C3/C4	E2	Excavate and repair in kind

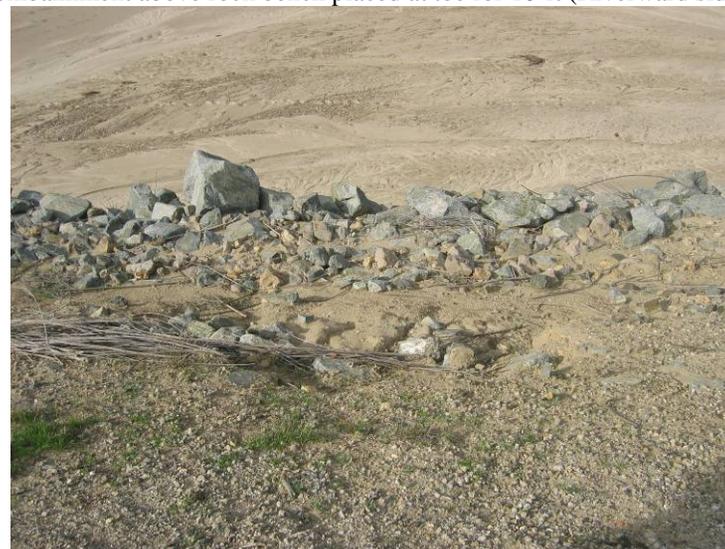
Calleguas Creek Levee (CC-3) (Photo No. M16) –Erosion on earthen embankment for 10 ft long above rock bench placed at toe (Riverward side).

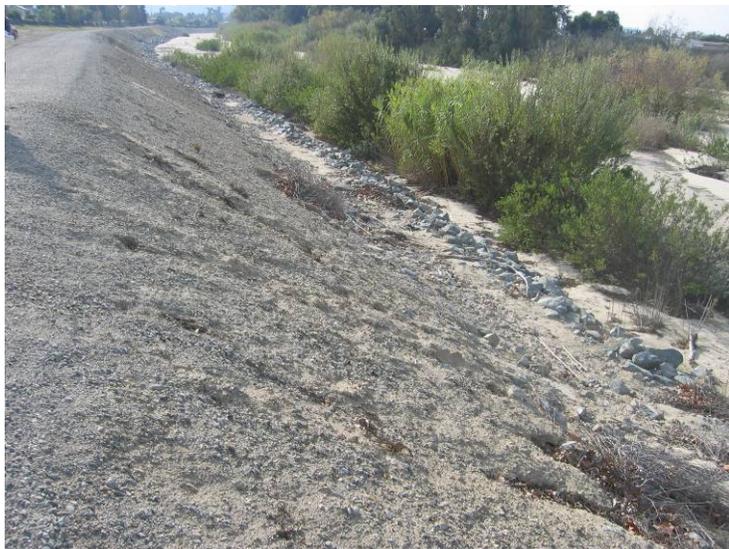
Calleguas Creek Levee (CC-3) (Photo No. M17) – Vegetation within 15' of Toe & minor debris (Riverward Side).

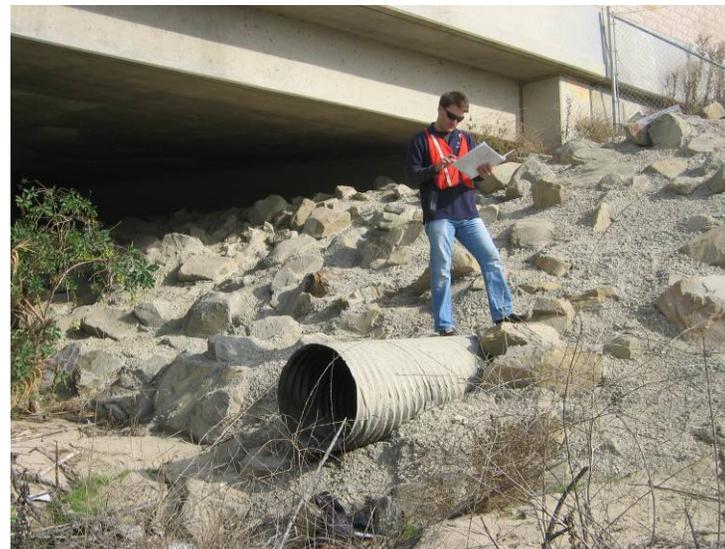
Calleguas Creek Levee (CC-3) (Photo No. M19) – 24" CMP w/o a closure device immediately downstream of HWY 101. No as-built plan available.

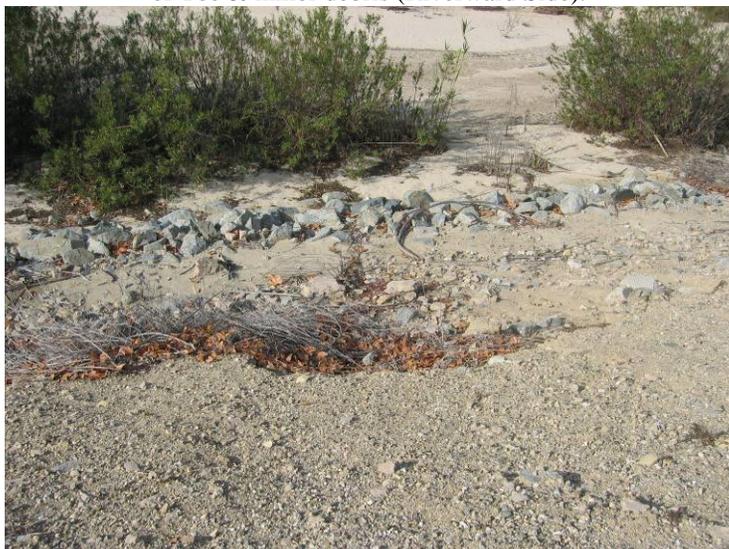
Calleguas Creek Levee (CC-3) (Photo No. M18) – Series of erosion areas on earthen embankment above rock bench placed at toe (Riverward side).
