**FEMA Levee Certification  
Ventura County, California**

**Calleguas Creek Levee and Somis Drain Floodwall (CC-2)  
Mission Oaks Boulevard to Adolfo Road**

**Evaluation Report**

February 13, 2009

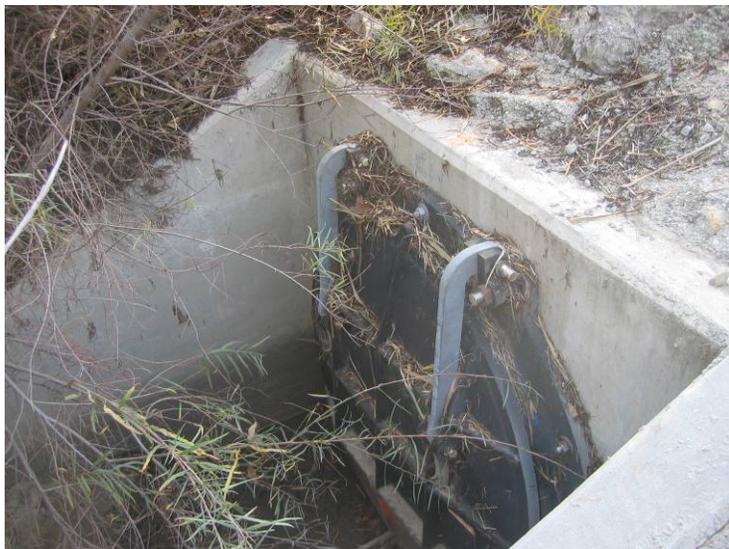
Calleguas Creek Levee (CC-2) (Photo No. P1) – 48” RCP with a flap gate

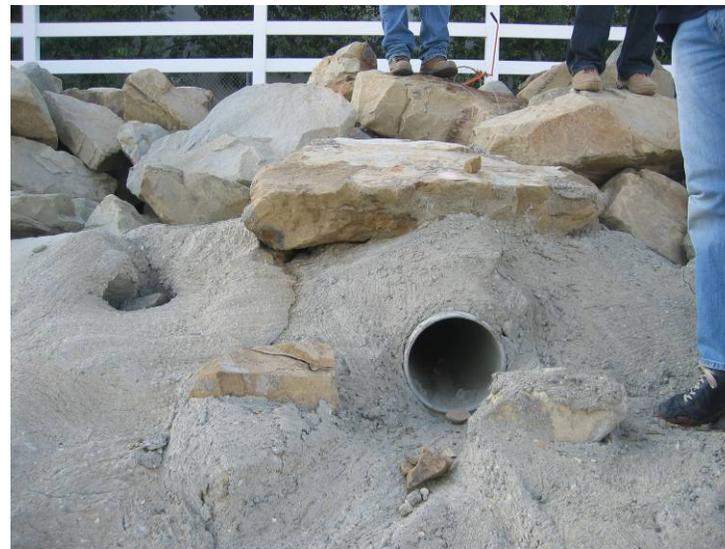
Calleguas Creek Levee (CC-2) (Photo No. P3) – 10” steel pipe w/o a closure device located upstream of Somis Drain

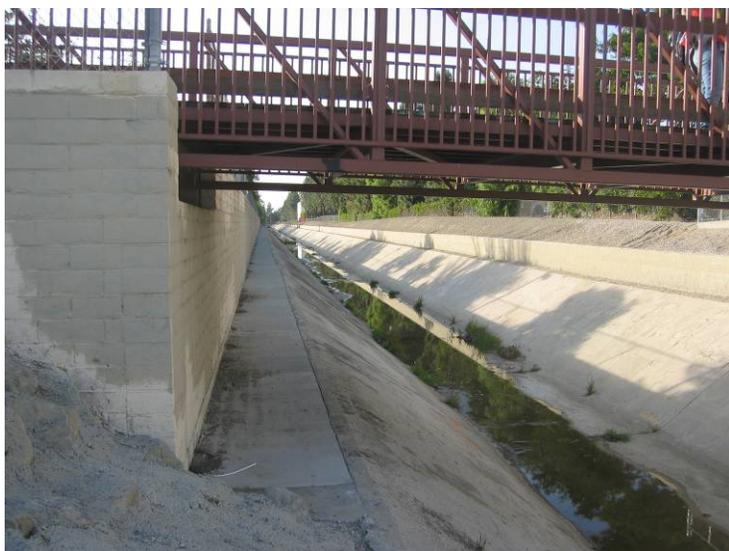
Calleguas Creek Levee (CC-2) (Photo No. P2) – Somis Drain confluence with Calleguas Creek

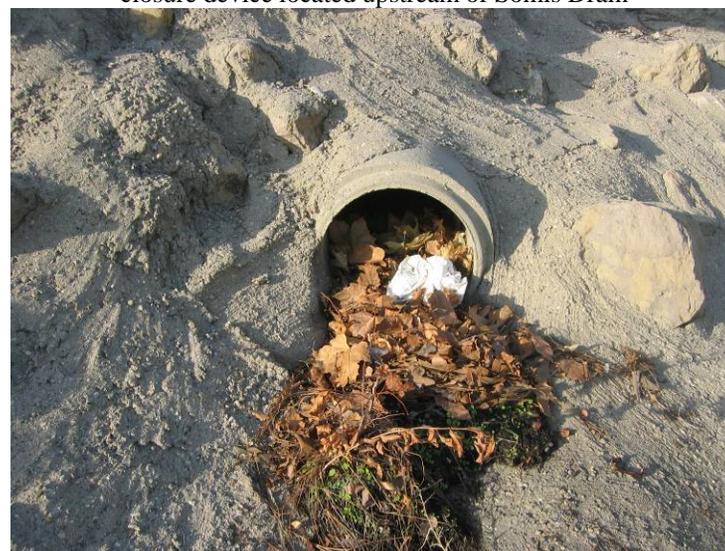
Calleguas Creek Levee (CC-2) (Photo No. P4) – 18” RCP w/o a closure device located upstream of Somis Drain. (No as-built plan available)

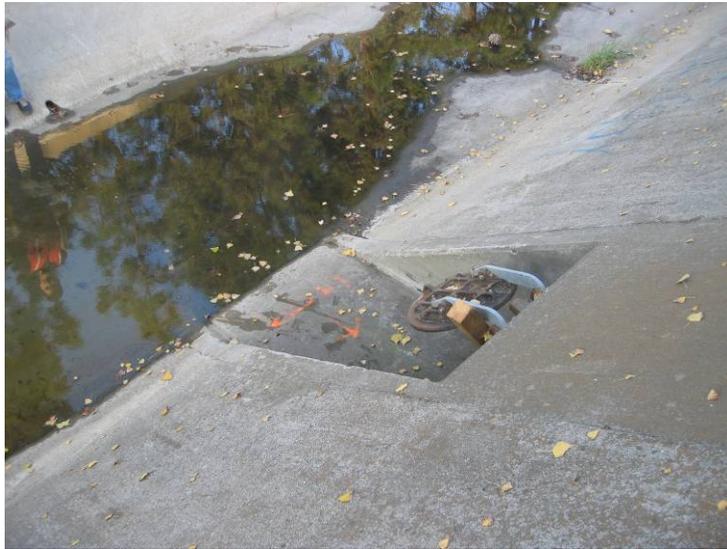
**Calleguas Creek Levee (CC-2) (Photo No. P5)** – 18” RCP with a flap gate near Flynn Street Bridge. As-Built unavailable

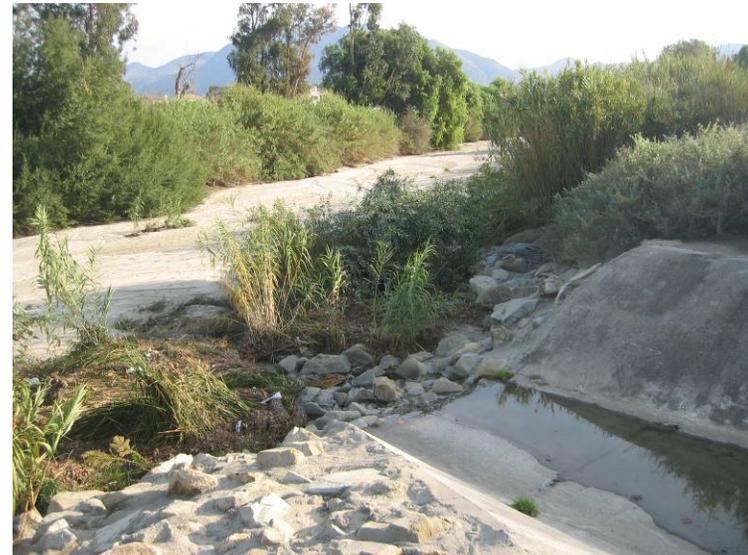
**Calleguas Creek Levee (CC-2) (Photo No. F2)** – Looking at the Somis Drain outlet into Calleguas Creek

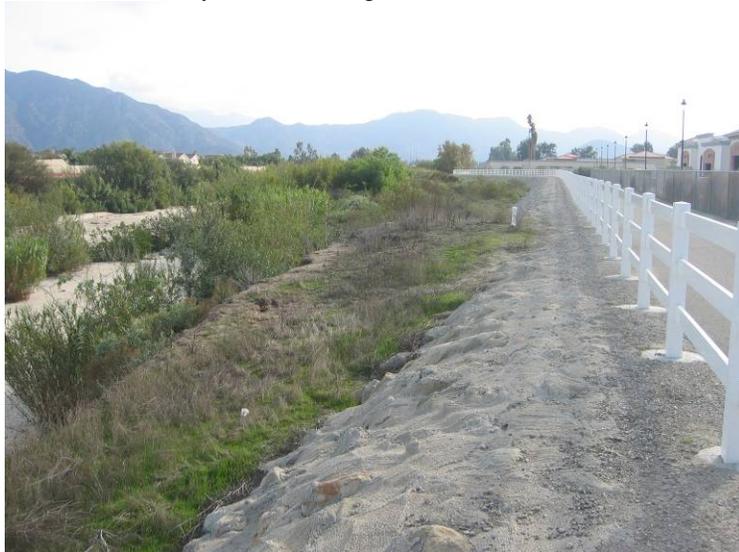
During field inspections, erosion of the access ramp into the channel was observed. Although the levee itself is not impacted, the stability of the access ramp is questionable. Numerous drainage pipes were observed during the site visit which outlet on the riverside of the levee. The purpose of these drains was not clear on the as-built drawings and if not functioning properly may impact the levee.

**Calleguas Creek Levee (CC-2) (Photo No. F1)** – Looking downstream at an earthen construction ramp down to the earthen terrace (Riverward side)

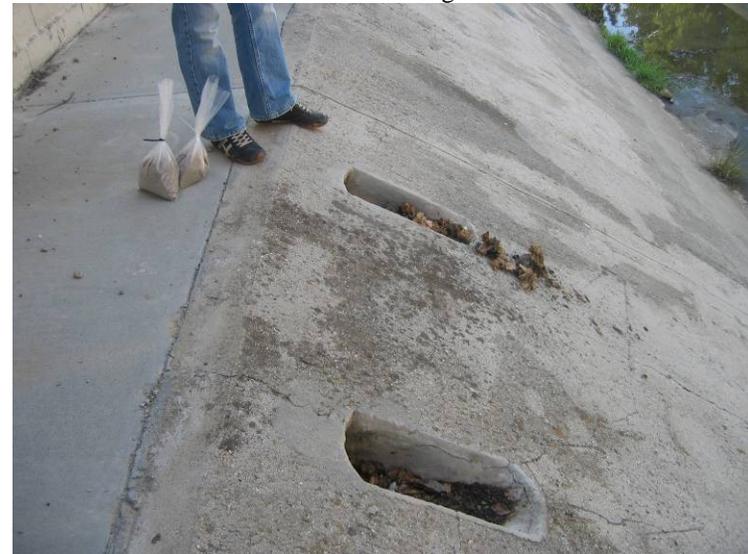
**Calleguas Creek Levee (CC-2) (Photo No. F3)** – A typical pair of weep holes along Somis Drain banks

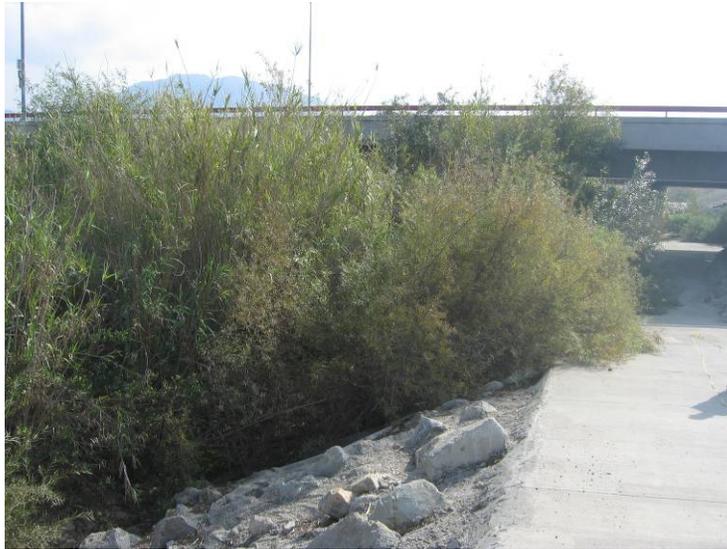
**Calleguas Creek Levee (CC-2) (Photo No. M1)** – Vegetation within 15' of toe (Riverward side)

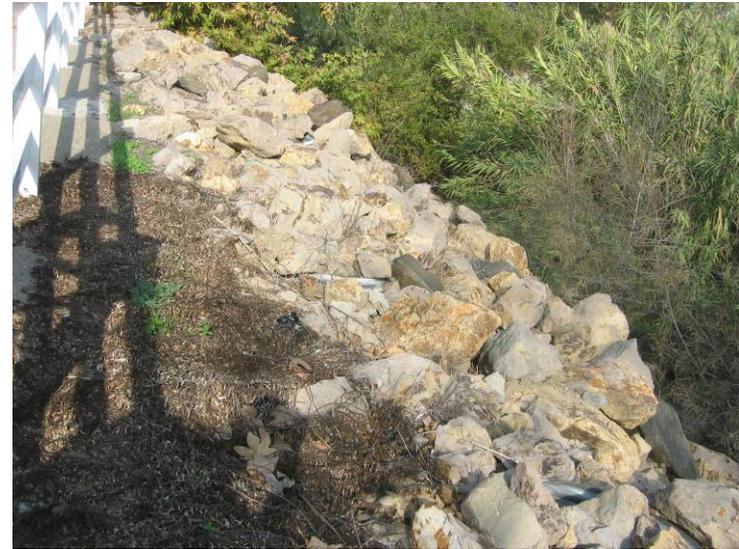
**Calleguas Creek Levee (CC-2) (Photo No. M3)** – A group of three (3) empty 36-in CMP tree pots at top of slope (Riverward side)

M3	A group of three (3) empty 36-in CMP tree pots at top of slope (Riverward side)	Remove empty CMP tree pots and root balls, if found, fill voids with impervious material and firmly compact.	C5 - Obtain direction from D&C.	E2	Same as M2		The businesses are higher than the invert. Is this a levee?	Determination of the levee situation on certain lengths of the levee system will require a hydraulic analysis. This analysis will be performed during the next phase of work.
M4	An empty 36-in CMP tree pot at top of slope (Riverward side)	Remove an empty CMP tree pot and root ball, if found, fill void with impervious material and firmly compact.	C5 - Obtain direction from D&C.	E2	Same as M2		The businesses are higher than the invert. Is this a levee?	Determination of the levee situation on certain lengths of the levee system will require a hydraulic analysis. This analysis will be performed during the next phase of work.

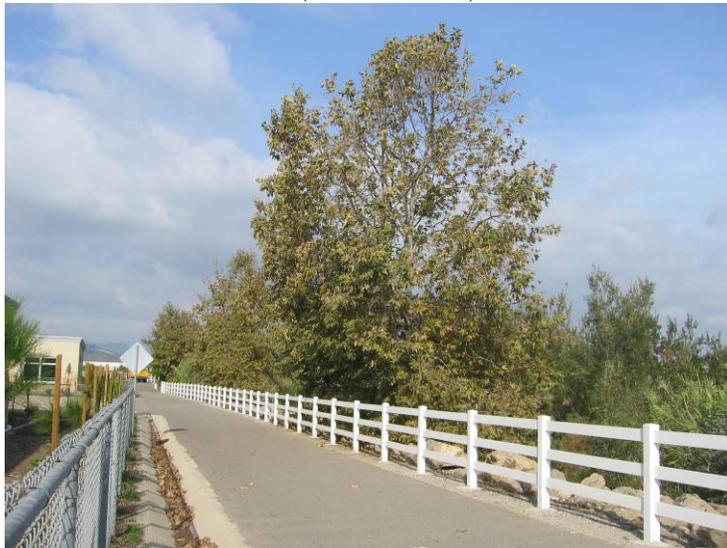
**Calleguas Creek Levee (CC-2) (Photo No. M2)** – Five groups of three trees planted at approximately 50 to 100 feet intervals (Riverward side)

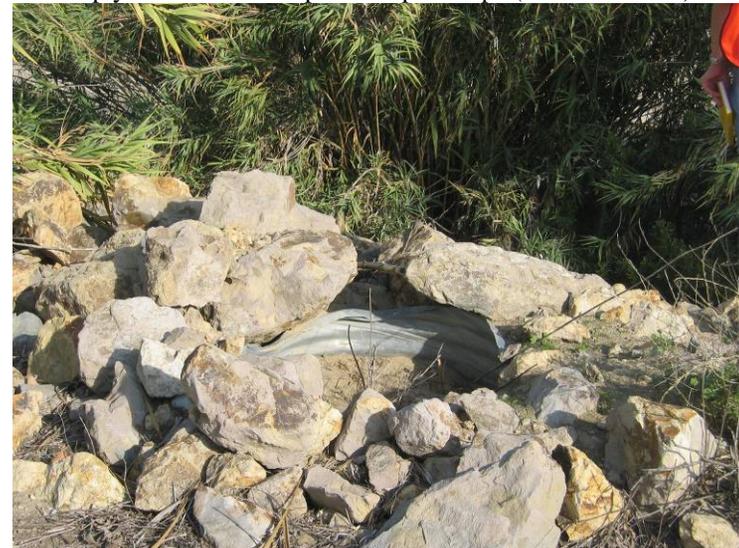
**Calleguas Creek Levee (CC-2) (Photo No. M4)** – An empty 36-in CMP tree pot at top of slope (Riverward side)

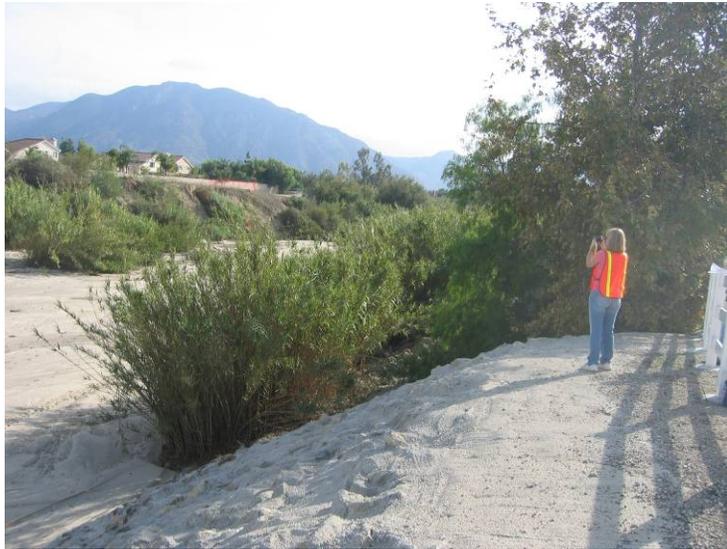
**Calleguas Creek Levee (CC-2) (Photo No. M5) – Vegetation within 15' of toe (Riverward side)**

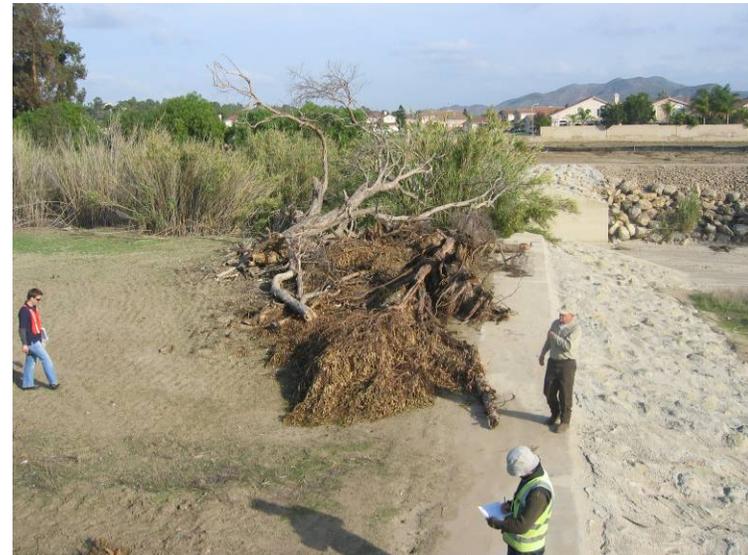
**Calleguas Creek Levee (CC-2) (Photo No. M7) – Debris (a stock pile of dead trees) on top of grade control structure (Riverward side)**

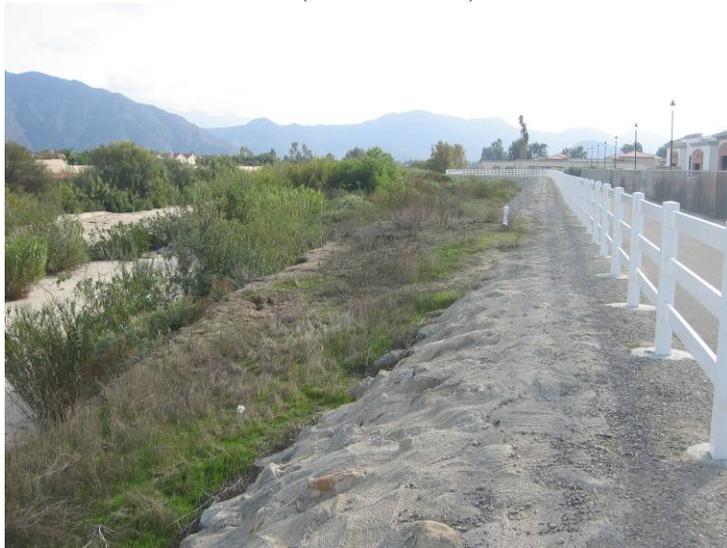
**Calleguas Creek Levee (CC-2) (Photo No. M6) – (1) Eroding earthen terrace in front of revetment; (2) Vegetation within 15' of toe**

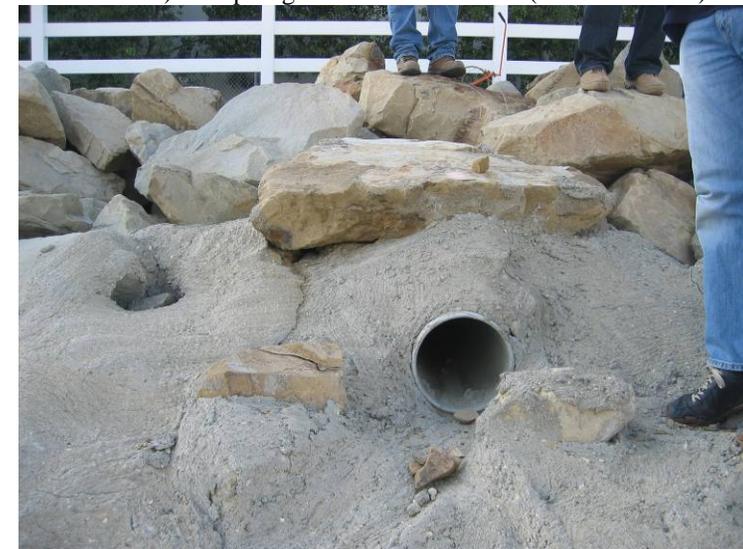
**Calleguas Creek Levee (CC-2) (Photo No. M8) – 10" steel pipe w/o a closure device (Sta.7+55)**

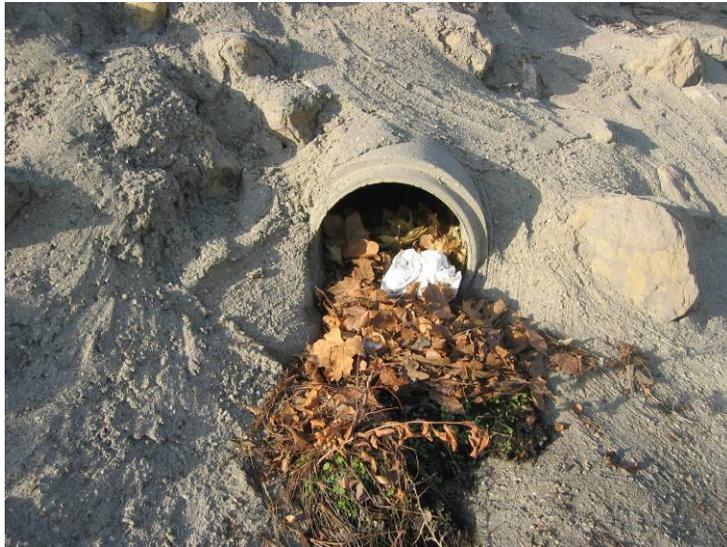
**Calleguas Creek Levee (CC-2)** (Photo No. M9) – 18” RCP w/o a closure device

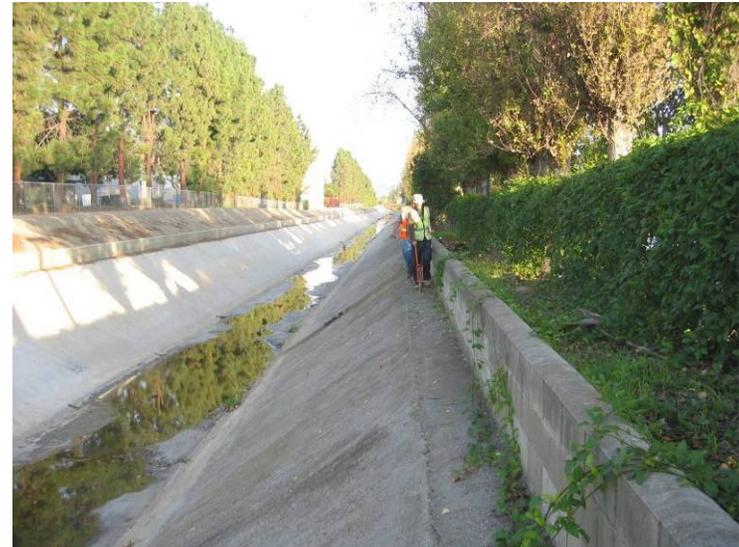
**Calleguas Creek Levee (CC-2)** (Photo No. M11) – Vegetation (Landscaping) within 15’ of floodwall for its entire length (Landward side)

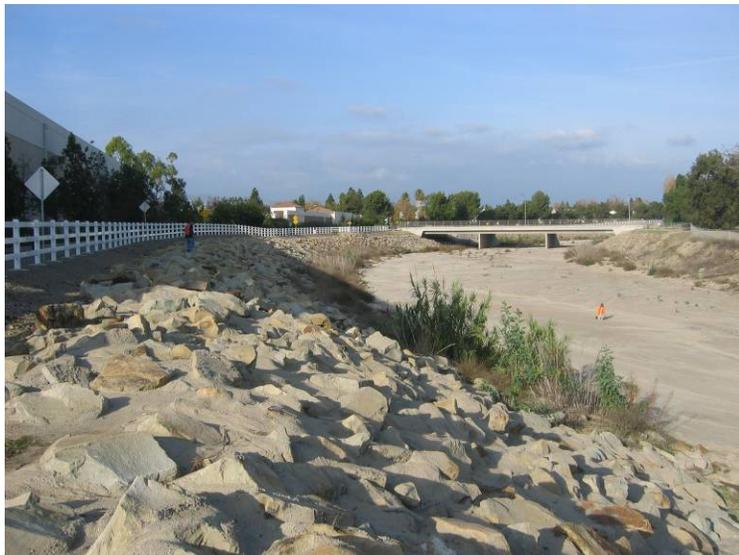
**Calleguas Creek Levee (CC-2)** (Photo No. M10) – Vegetation within 15’ of toe between Somis Drain confluence and Adolfo Road (Landward side)

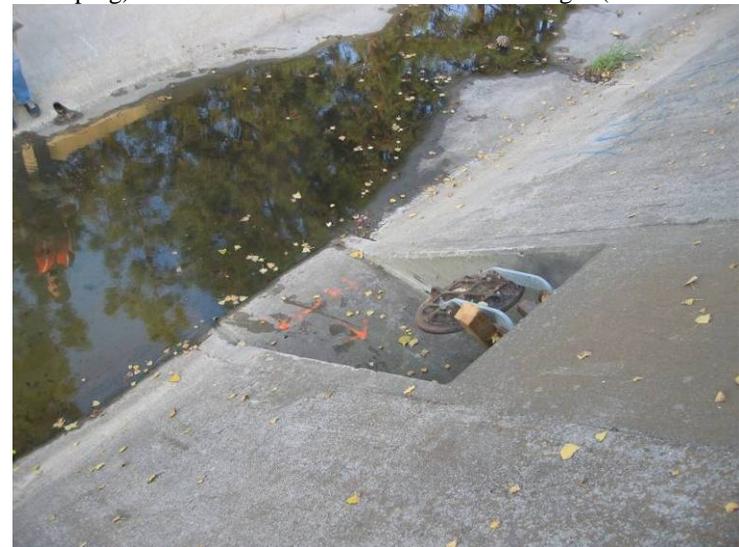
**Calleguas Creek Levee (CC-2)** (Photo No. M12) – A flap gate for 18” RCP is fixed open by debris. (Riverward side)

Maint. Defect	Description	Recommended Action by Tetra-Tech	Recommended Response by O&M Division	Environ. Permit Codes	Environmental Services Section Comments	R.O.W. Issue*	Levee Certification Project Team's Comments to Draft Evaluation Reports	Tetra Tech's Response
<b>Calleguas Creek Levee (CC-2) – Somis Drain Category 2</b>								
M11	Vegetation (Landscaping) within 15' of floodwall for its entire length (Landward side)	Vegetation may need to be removed. In which case, remove vegetation and root ball, fill voids with impervious material and firmly compact.	C1 - Up to the fence, C5 - Beyond the fence	E1	Landscaping not regulated			
M12	A flap gate for 18" RCP is fixed open by debris. (Riverward side)	Remove debris from pipe opening and ensure complete seal around the gate.	C1	E1	Debris removal OK, use BMPs
