FEMA Levee Certification

**Sespe Creek Levee (SC-1)
Old Telegraph Road to Goodenough Road**

Evaluation Report

February 13, 2009

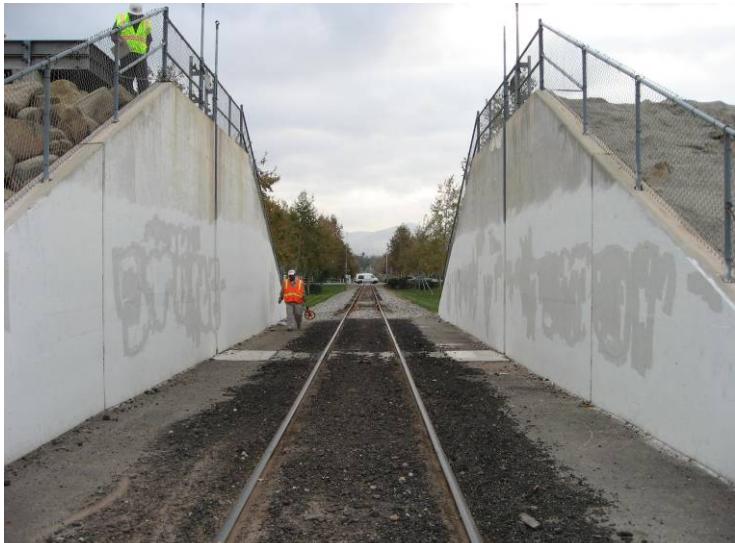
Sespe Creek Levee (Photo No. P1) – Railroad crossing immediately upstream of Old Telegraph Road

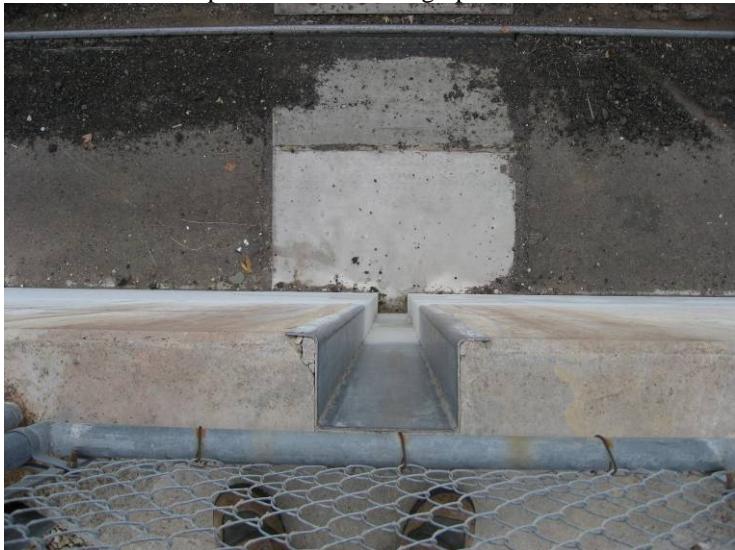
Sespe Creek Levee (Photo No. P2) – Located on top of levee looking down on stop log slot

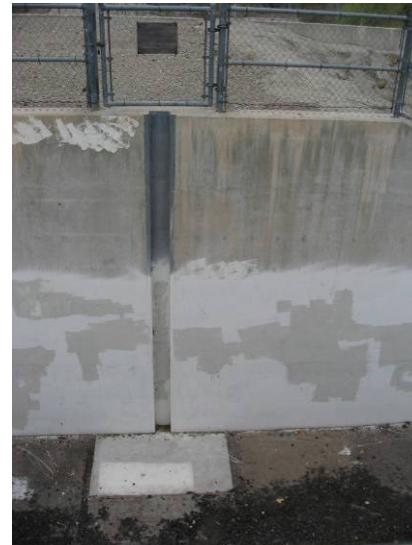
Sespe Creek Levee (Photo No. P3) – Stop log slot looking downstream of levee

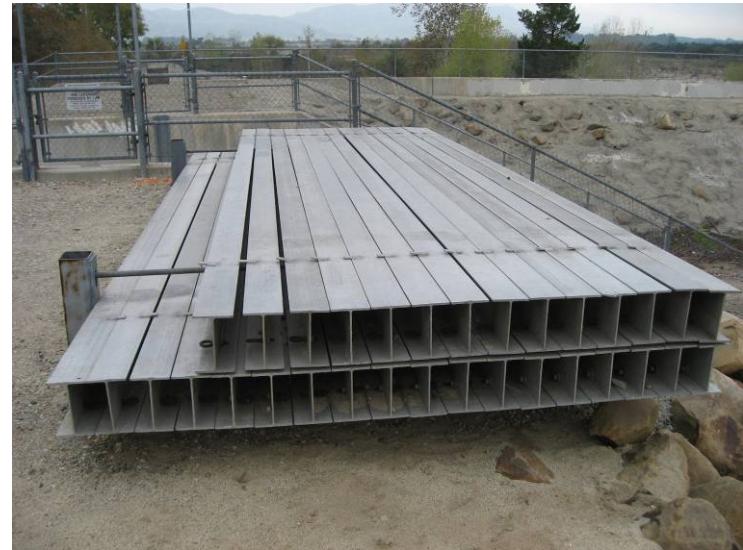
Sespe Creek Levee (Photo No. P4) – 32 aluminum beams for stop log structure, looking downstream

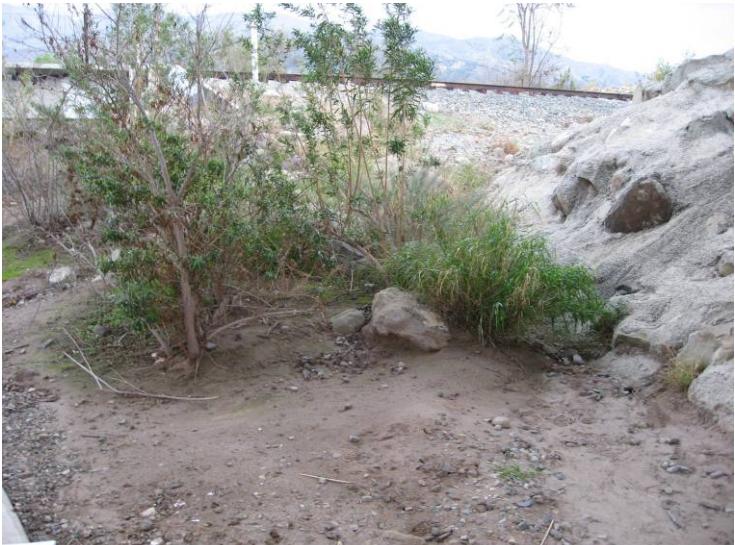
Sespe Creek Levee (Photo No. M1) – Vegetation within 15' of levee toe
(Riverward side)

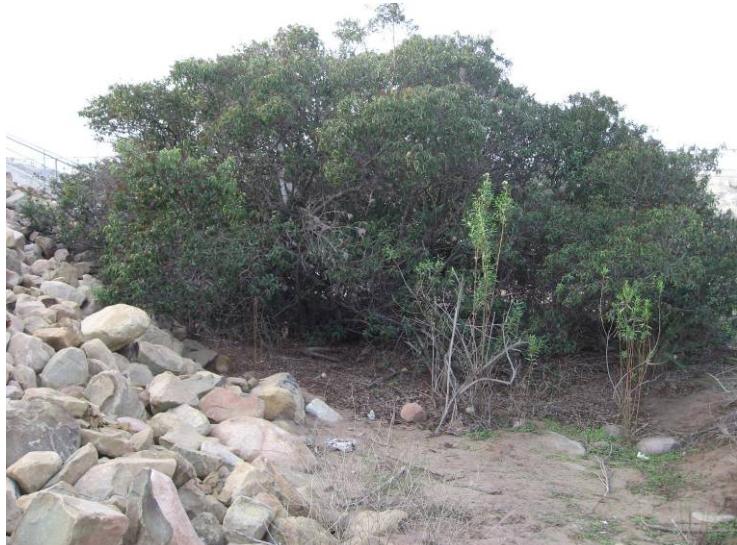
Sespe Creek Levee (Photo No. M3) – Vegetation within 15' of levee toe
(Riverward side)

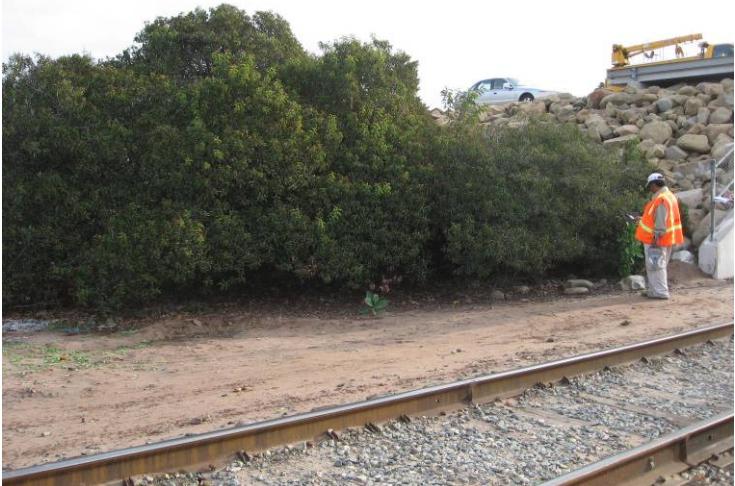
Sespe Creek Levee (Photo No. M2) – Vegetation within 15' of levee toe
(Riverward side)

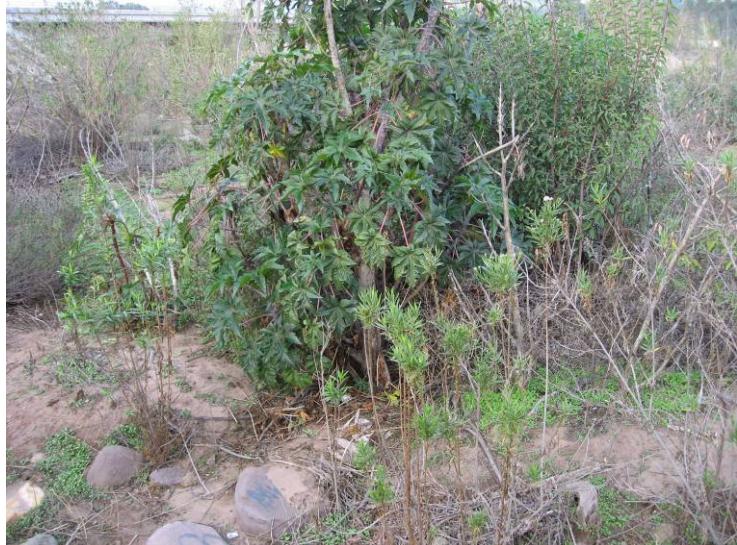
Sespe Creek Levee (Photo No. M4) – Vegetation within 15' of levee toe
(Riverward side)

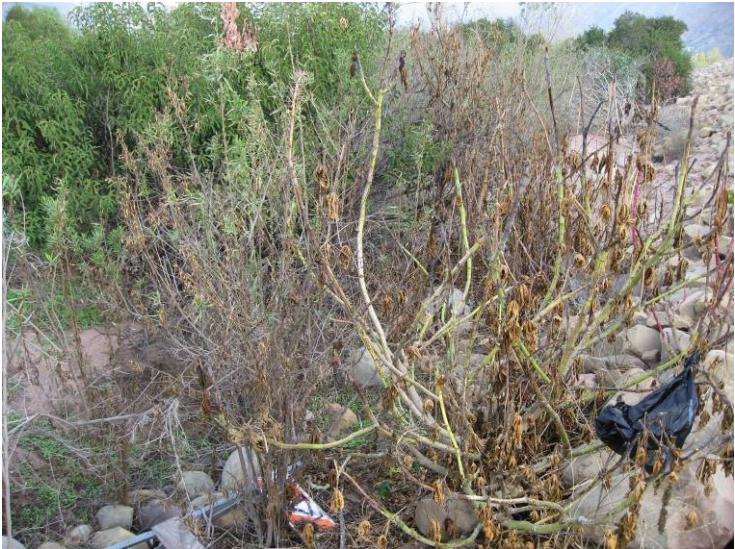
Sespe Creek Levee (Photo No. M5) – Vegetation & minor debris within 15' of levee toe (Riverward side)

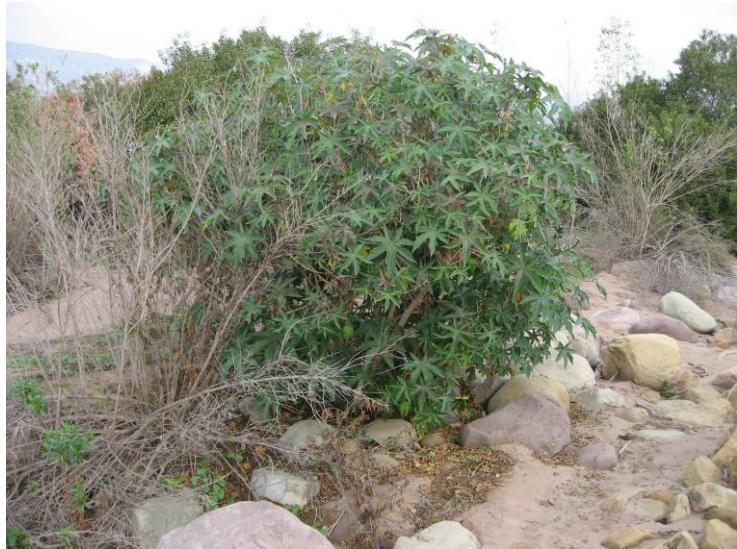
Sespe Creek Levee (Photo No. M7) – Vegetation & minor debris within 15' of levee toe (Riverward side)

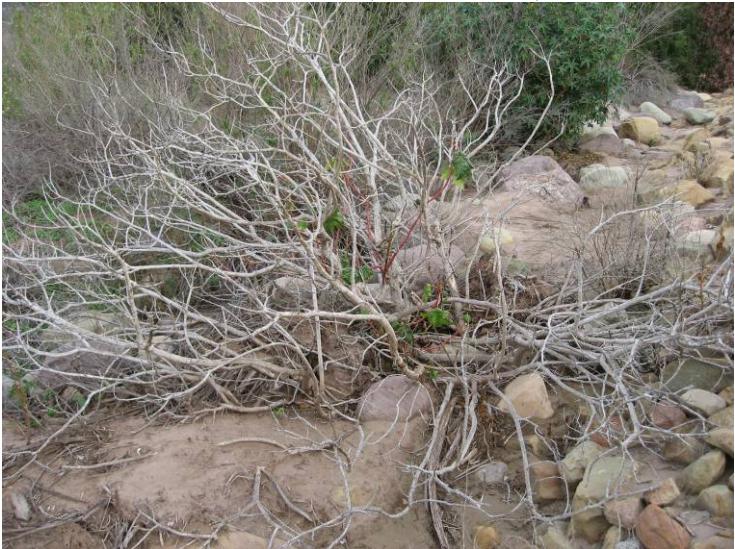
Sespe Creek Levee (Photo No. M6) – Vegetation & minor debris within 15' of levee toe (Riverward side)

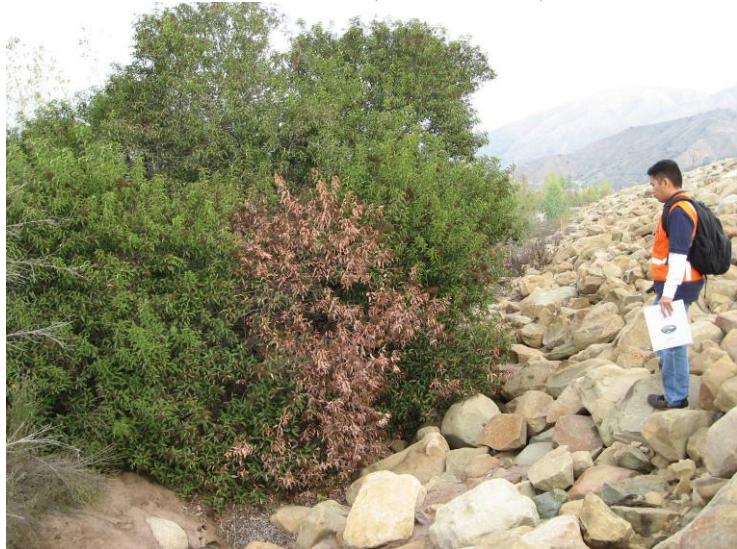
Sespe Creek Levee (Photo No. M8) – Vegetation & minor debris within 15' of levee toe (Riverward side)

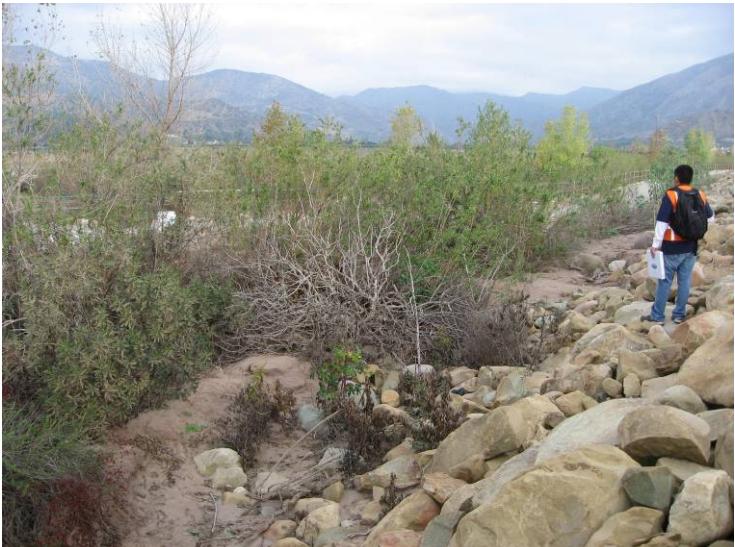
Sespe Creek Levee (Photo No. M9) – Vegetation & minor debris within 15' of levee toe (Riverward side)

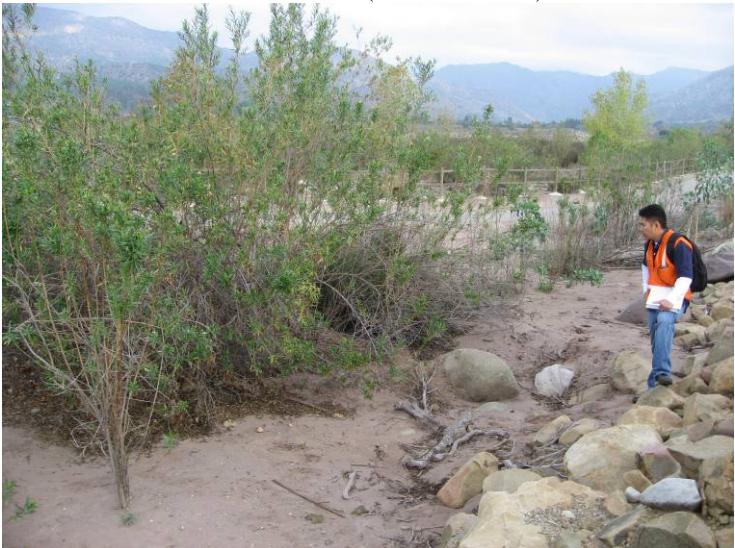
Sespe Creek Levee (Photo No. M10) – Vegetation & minor debris within 15' of levee toe (Riverward side)

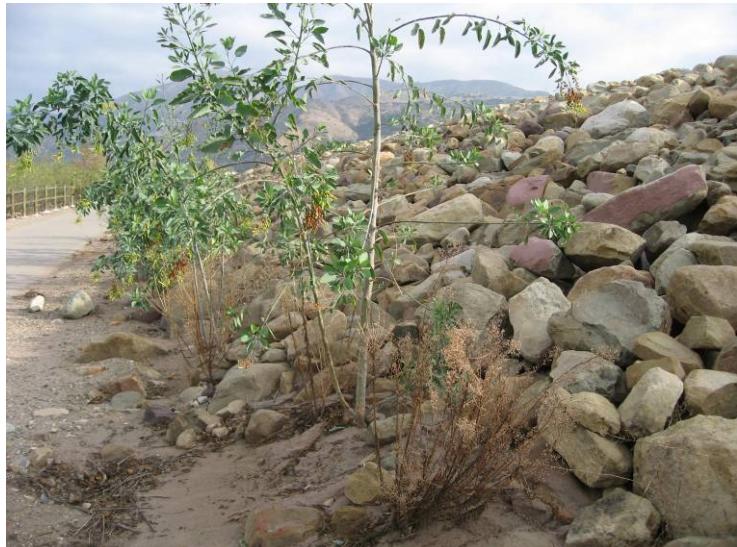
Sespe Creek Levee (Photo No. M11) – Vegetation within 15' of levee toe (Riverward side)

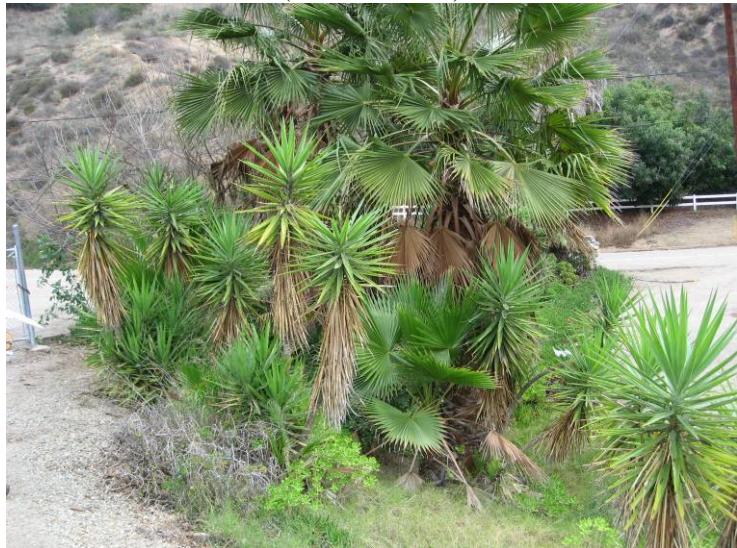
Sespe Creek Levee (Photo No. M12) – Vegetation on levee embankment (Landward side)

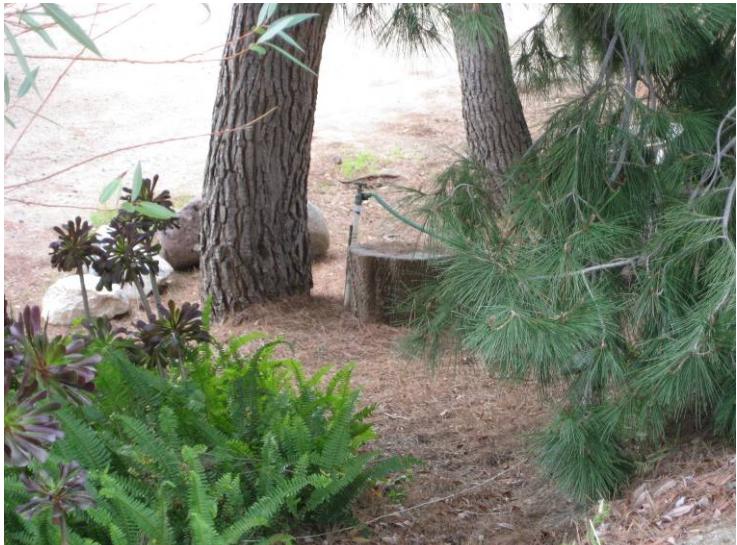
Sespe Creek Levee (Photo No. M13) – Vegetation & irrigation spigot within 15' of levee toe (Landward side)

GPS		*Photo No.	Description	Action Required
Lat	Long			
<u>Sespe Creek Levee (SC-1)</u>				
N34.41784	W118.92353	M13, M14, M15	Vegetation & Spigot on Levee embankment (Landward Side)	Remove vegetation and root ball, fill voids with impervious material and firmly compact.
N34.40667	W118.92945	M16, M17	Undercut of Levee toe (Landward side)	Re-establish 2:1 toe of levee embankment. Additional engineering analyses are recommended.
N/A	N/A	M18-M27	Broken stone revetment throughout levee embankment (Riverward side)	Additional engineering analyses are recommended.
N/A	N/A	M28	Sinkhole at edge of bike path exposing buried groin	Repair sinkholes and fill voids with impervious material and firmly compact.

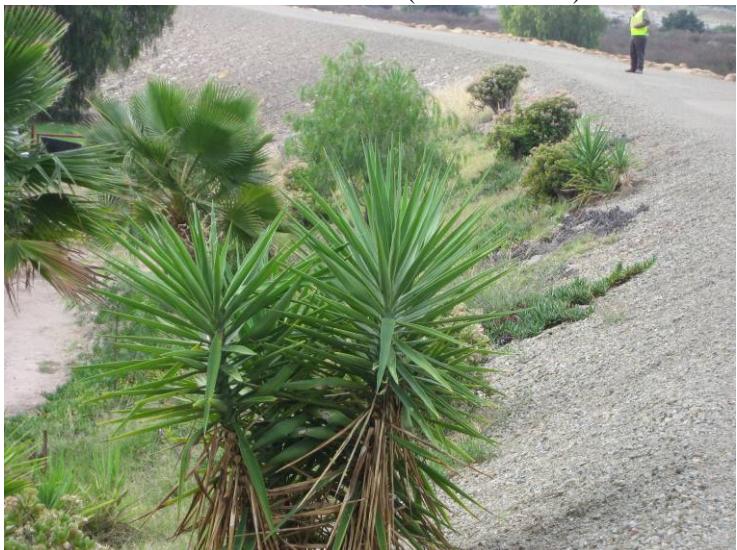
Sespe Creek Levee (Photo No. M14) – Vegetation on levee embankment & toe (Landward side)

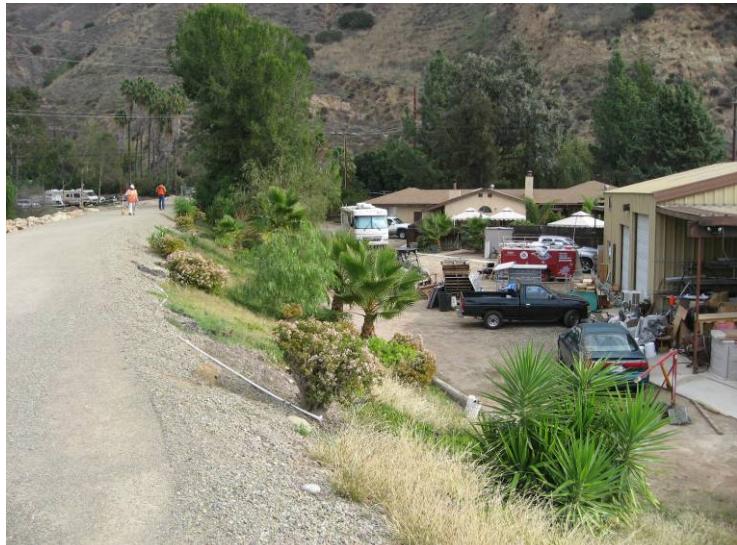
Sespe Creek Levee (Photo No. M15) – Vegetation on levee embankment (Landward side)

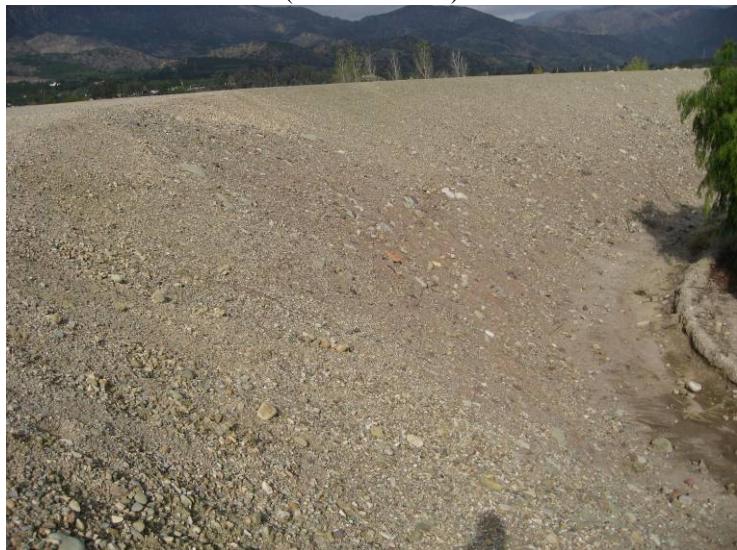
The field investigation identified several critical issues that must be resolved prior to certification. The most significant issues are undercutting of landward side levee toe near Old Telegraph Road and vegetation removal. Engineering analyses will also need to be performed to verify that this levee meets the NFIP Section 65.10 requirements. Based on the review of existing data and observations from the field investigation, it is recommended that the SC-1 levee system be classified as a Category 2 Levee.

Sespe Creek Levee (Photo No. M16) – Undercut of Levee toe (Landward side)

5. Deep Seated Slope Stability					A No slides present.	Restoration of the landward side levee toe to a 2:1 slope is required near the downstream end near the access road. Additional engineering analyses are recommended.
					M Signs of deep seated instability can not be determined from site assessment or evidence may or may not be an indicator of deep seated stability..	
			X		U Evidence of deep seated sliding that threatens FCW integrity. Repairs are required to reestablish FCW integrity.

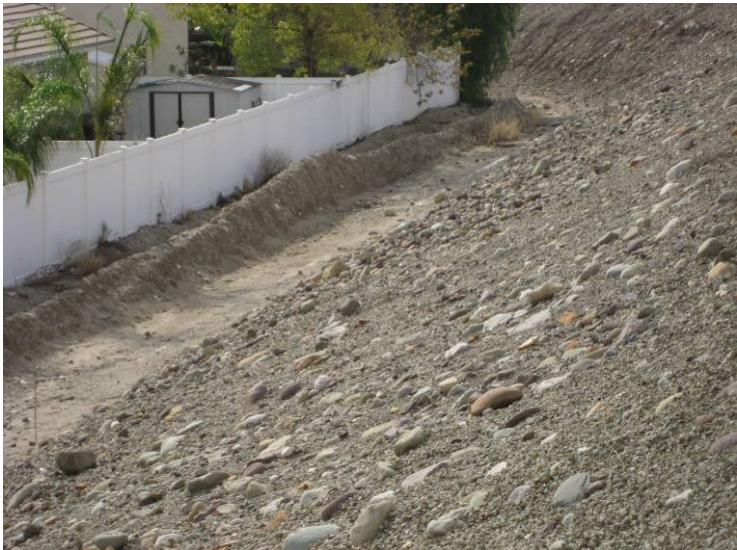
Sespe Creek Levee (Photo No. M17) – Undercut of Levee toe (Landward side)

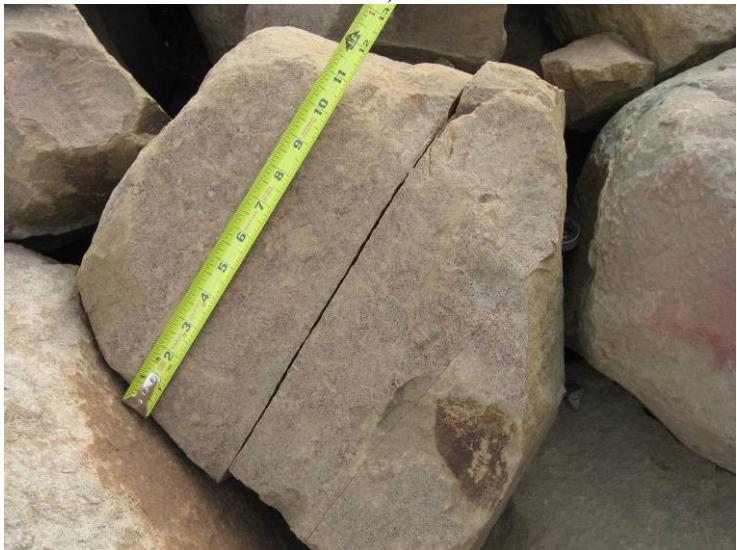
Sespe Creek Levee (Photo No. M18) – Broken stone revetment (Riverward side)

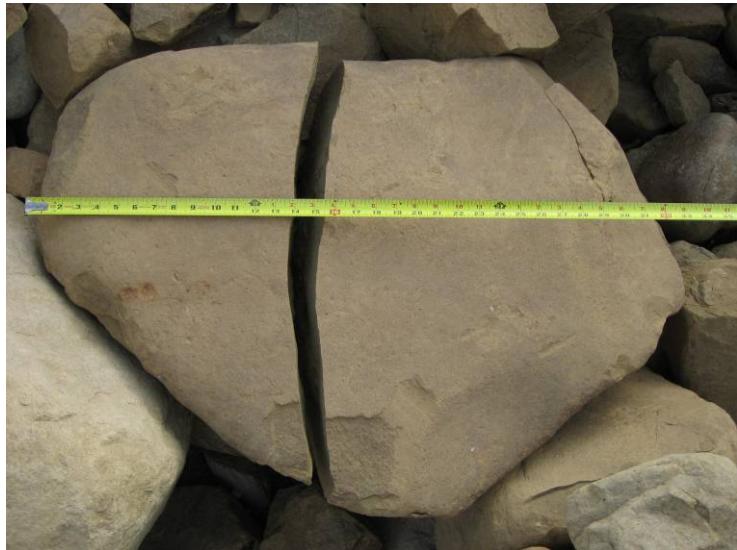
Sespe Creek Levee (Photo No. M19) – Broken stone revetment (Riverward side)

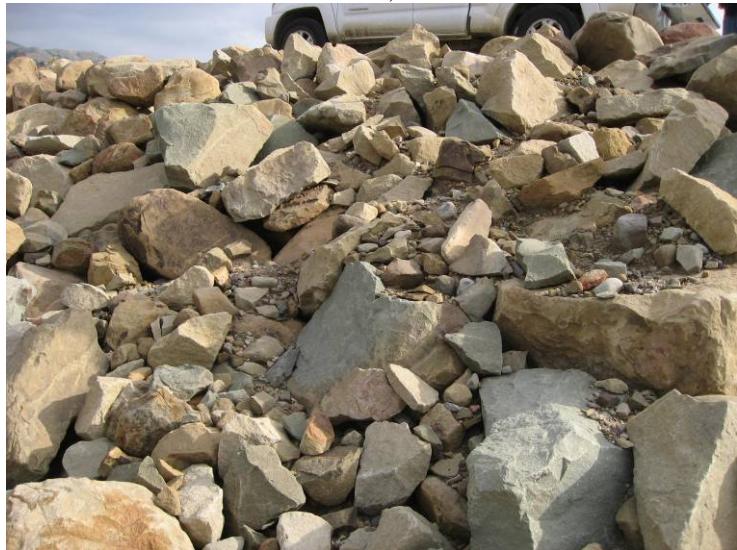
Sespe Creek Levee (Photo No. M20) – Broken stone revetment (Riverward side)

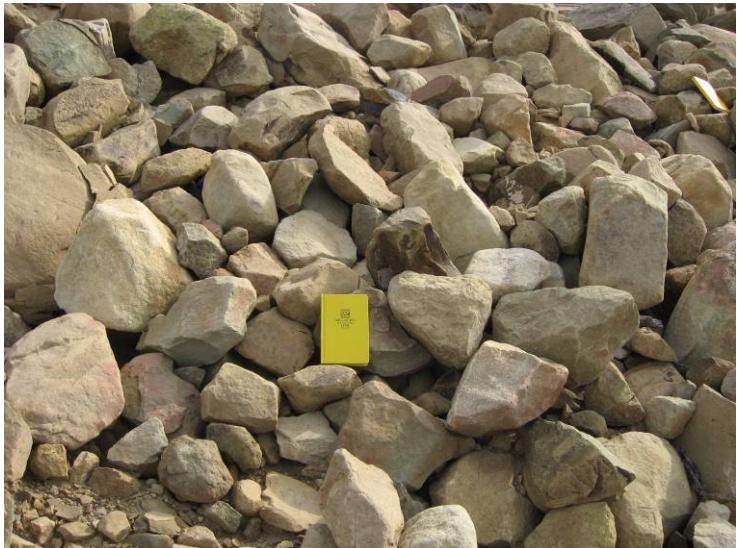
Sespe Creek Levee (Photo No. M21) – Broken stone revetment (Riverward side)

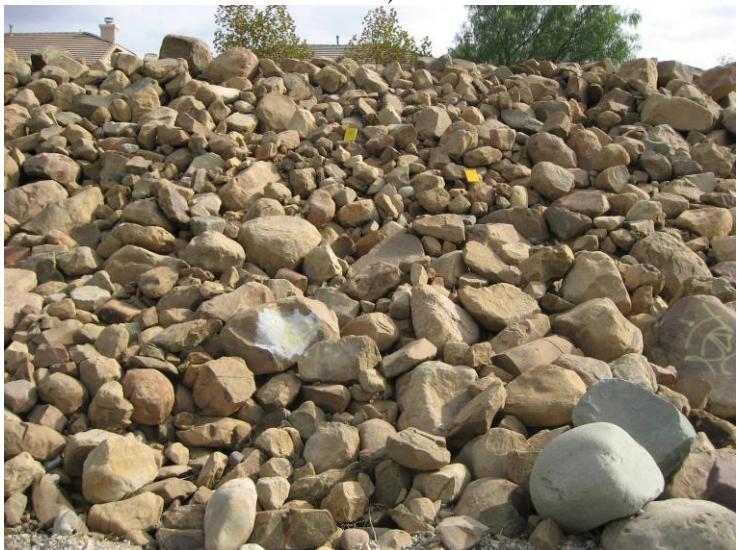
Sespe Creek Levee (Photo No. M22) – Broken stone revetment (Riverward side)

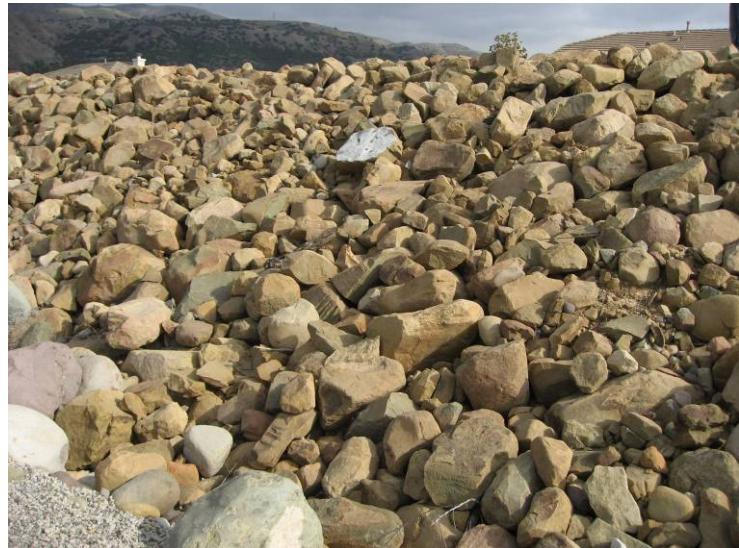
Sespe Creek Levee (Photo No. M23) – Broken stone revetment (Riverward side)

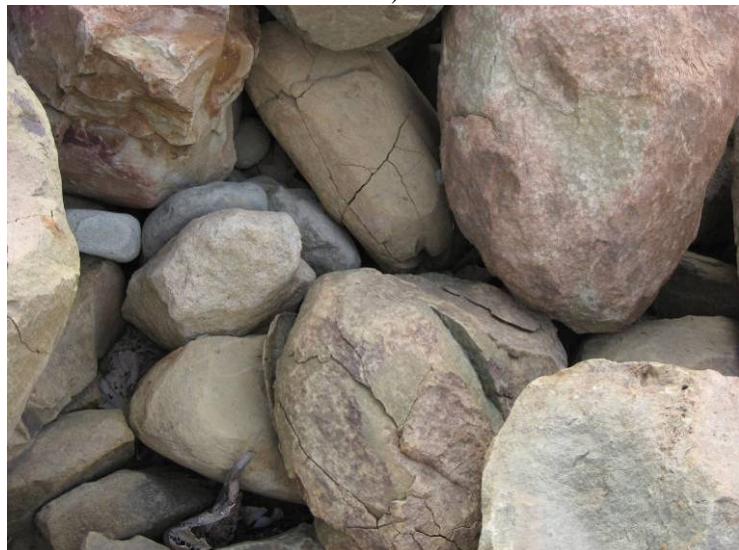
Sespe Creek Levee (Photo No. M24) – Broken stone revetment (Riverward side)

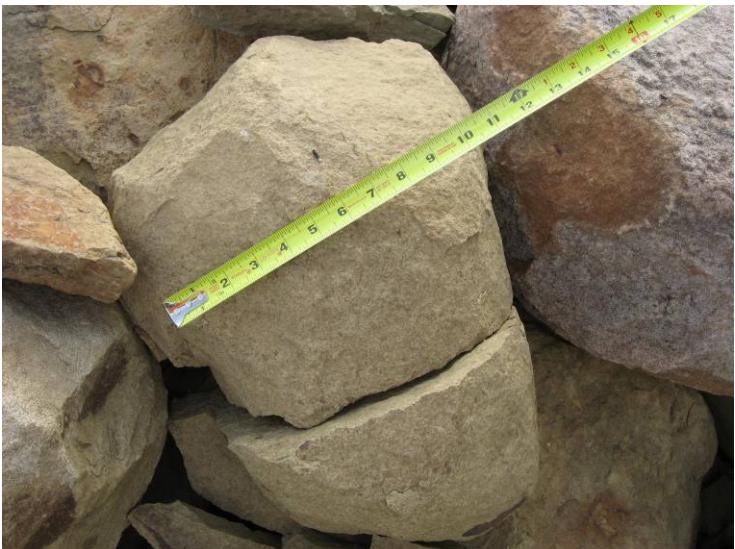
Sespe Creek Levee (Photo No. M25) – Broken stone revetment (Riverward side)

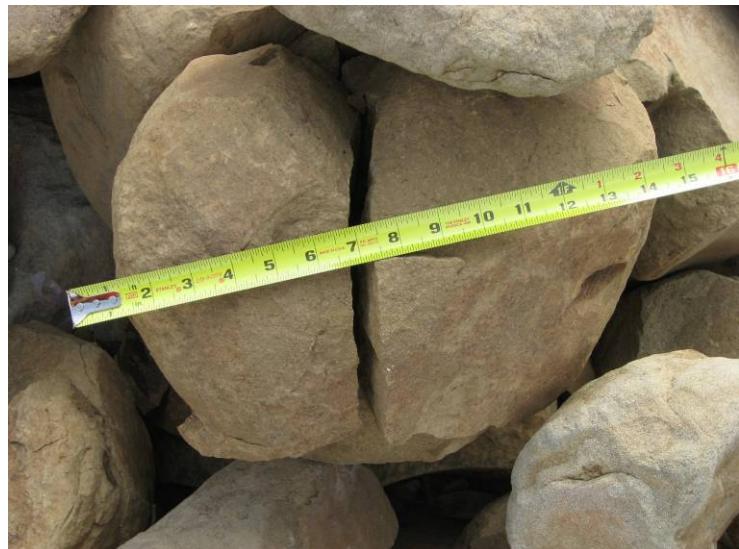
Sespe Creek Levee (Photo No. M27) – Broken stone revetment (Riverward side)

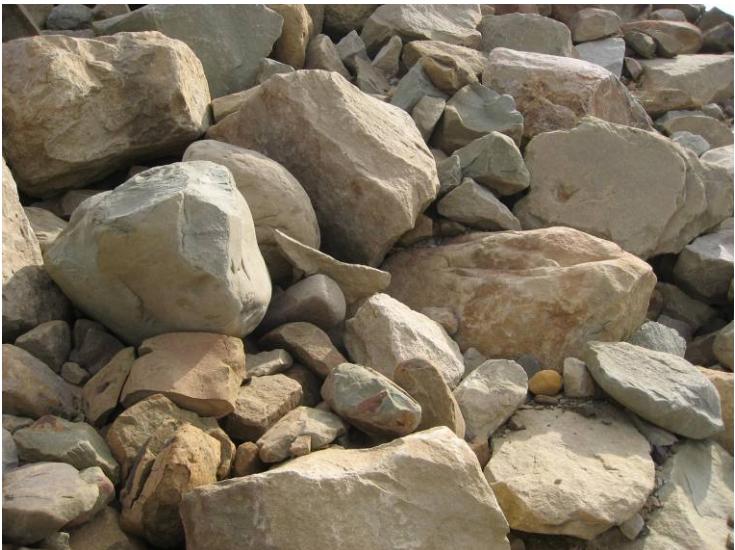
Sespe Creek Levee (Photo No. M26) – Broken stone revetment (Riverward side)

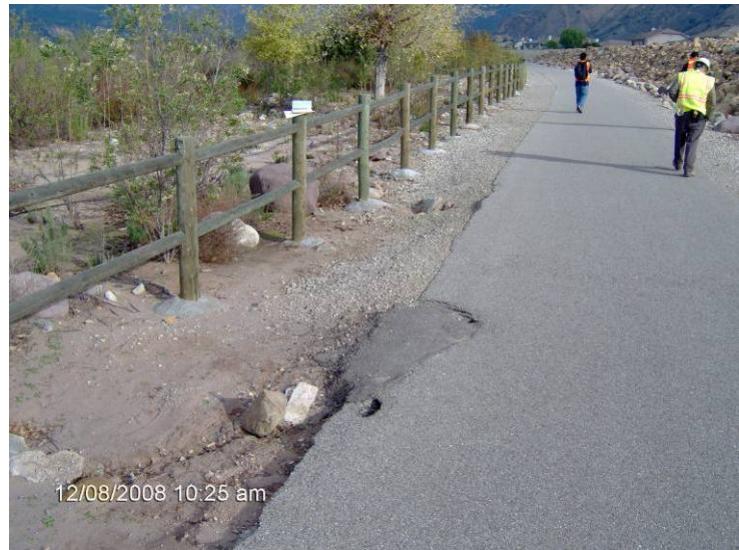
Sespe Creek Levee (Photo No. M28) – Sink hole at edge of bike path over buried groin

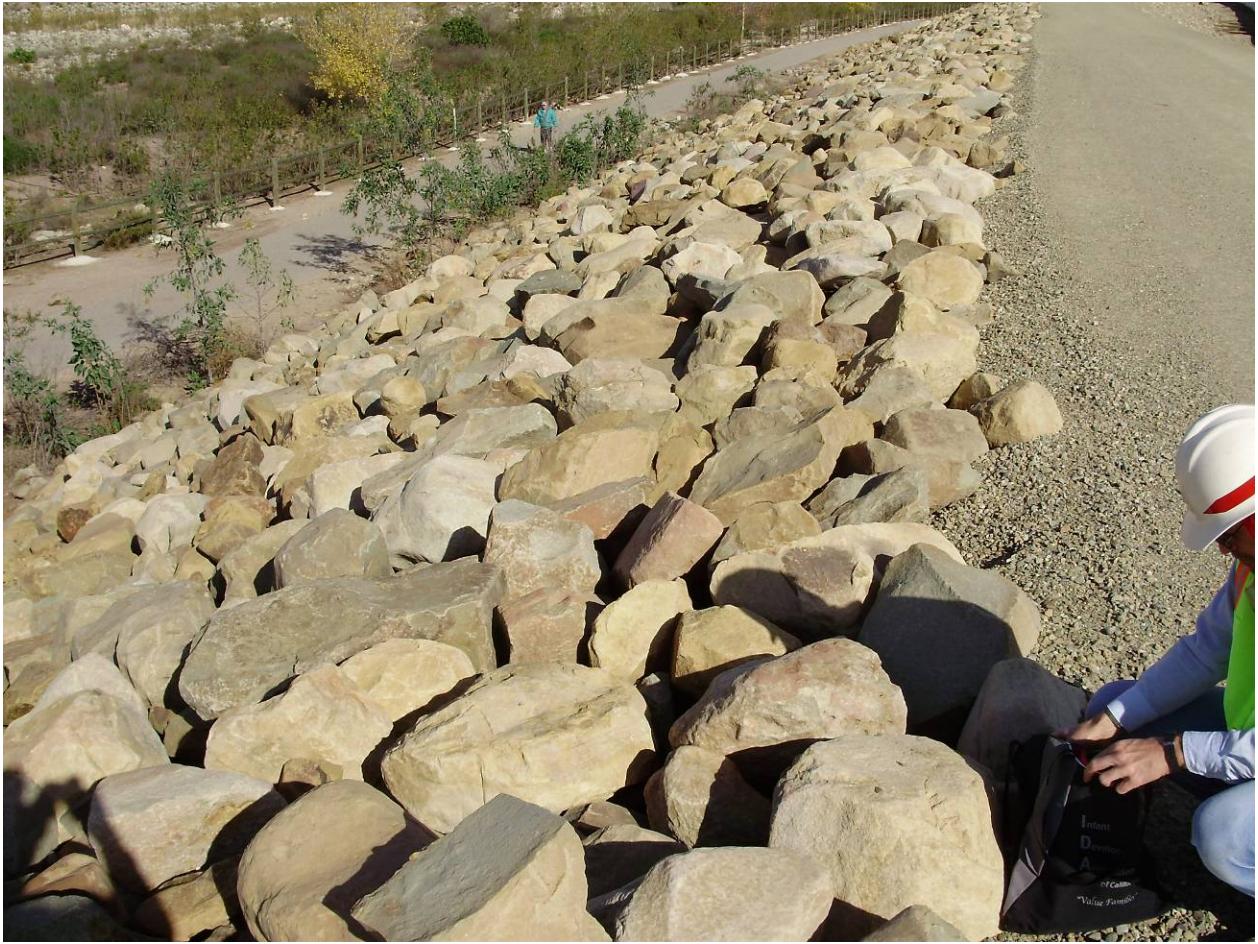
**Fig. 2.—Typical slope protection stone mix, upstream of Old Telegraph Rd. View is upstream.
Photograph by US Army Corps of Engineers, 6 Jan. 2009.**

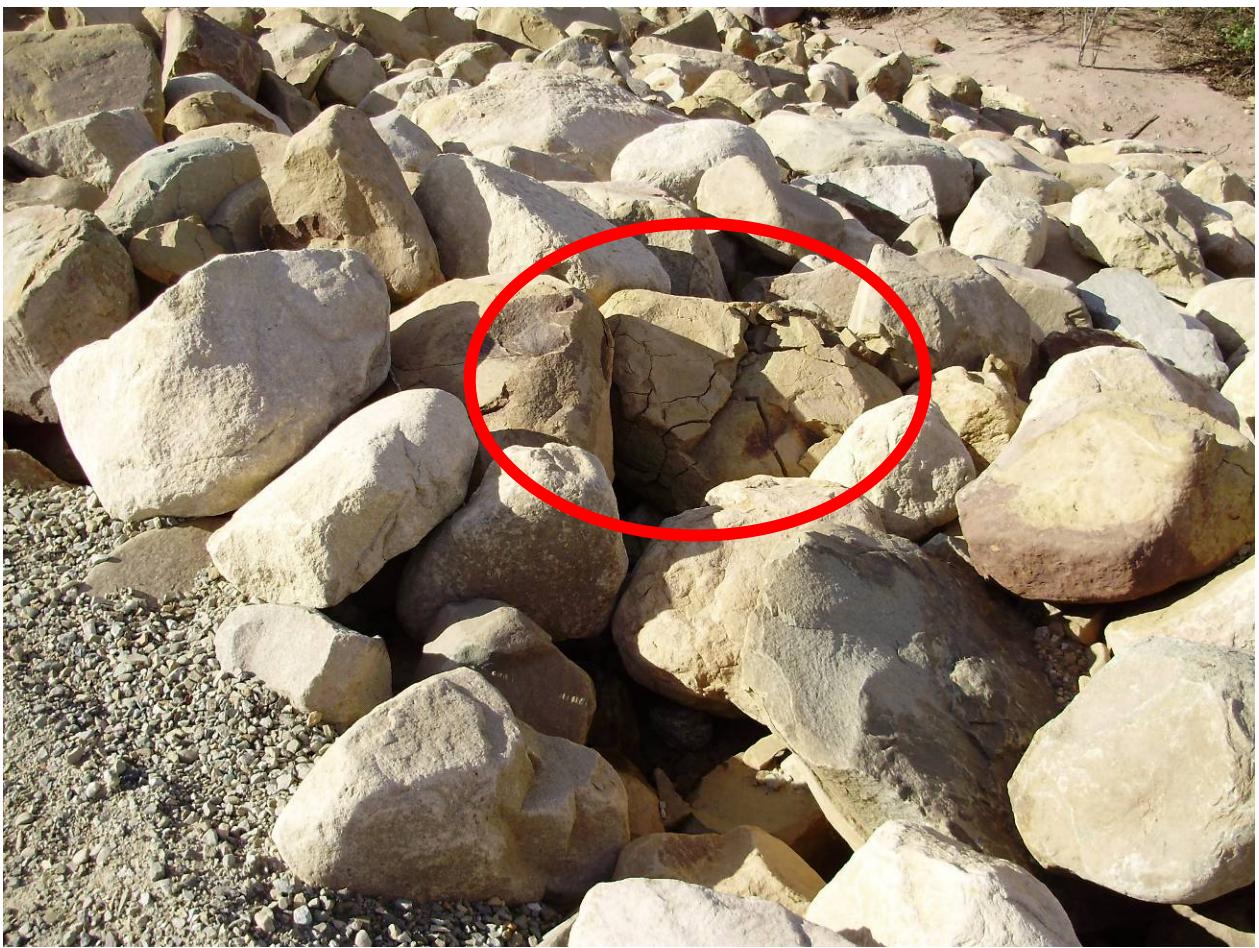
d. All deterioration is within the yellow sandstone. In general, it is the coarser-grained sandstone that appears more inclined to crack.

Fig. 26.—Typical deterioration (cracking) of yellow sandstone (inside red oval), upstream of Old Telegraph Rd. View is downstream. Photograph by US Army Corps of Engineers, 6 Jan. 2009.
