**FEMA Levee Certification
Ventura County, California**

**Calleguas Creek Levee (CC-3)
Pleasant Valley Road to Highway 101**

**Evaluation Report
February 27, 2009**

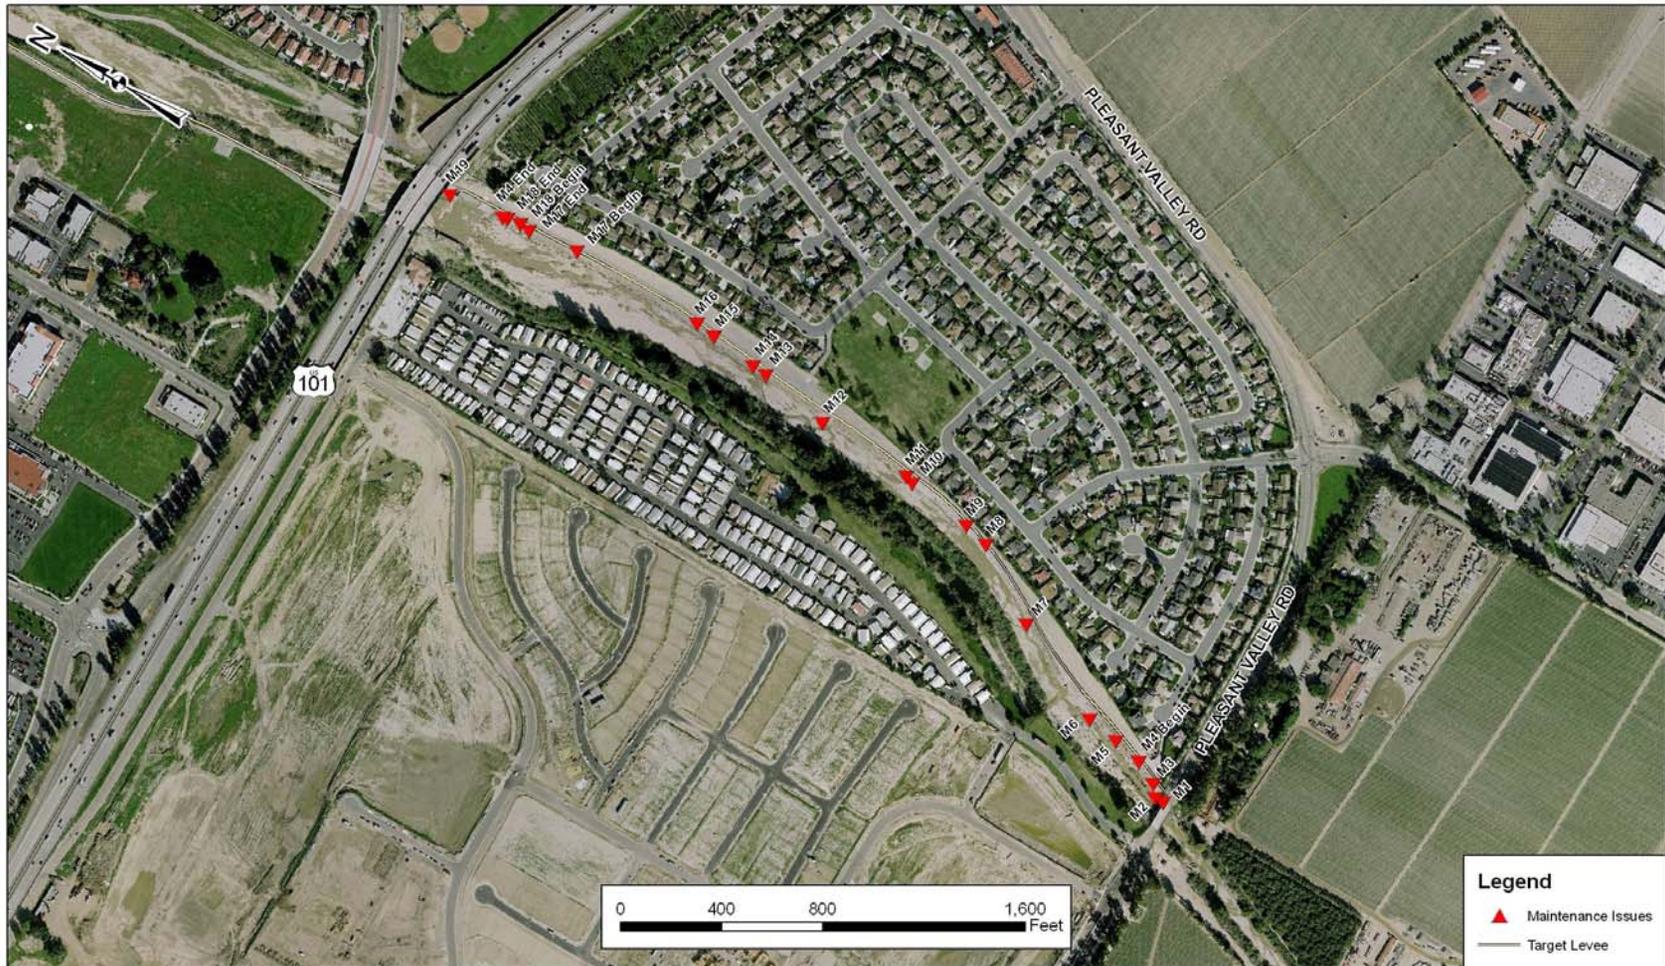
Appendix C – Photograph Locations of Maintenance Required Areas along Calleguas Creek Levee (CC-3)

The field investigation report included as Exhibit 1 documents maintenance issues that were identified during the field investigation. Those issues are summarized in Table 2 of that report. The District has been unable to implement certain maintenance improvements due to permitting and environmental constraints. However, these locations need to be repaired or remediated in order for the levee system to meet the levee certification criteria set by USACE and FEMA and to be fully operational. Table 2 also provides possible repair or remediation actions for the locations along with the GPS points. Photos taken at the maintenance required locations are included in Appendix C of the report. Major maintenance issues are related to vegetation removal, animal burrows, erosion of the riprap along certain portions of the levee's toe and penetrations missing closure devices (flap gates).
