FEMA Levee Certification

**Sespe Creek Levee (SC-1)
Old Telegraph Road to Goodenough Road**

Evaluation Report

February 13, 2009

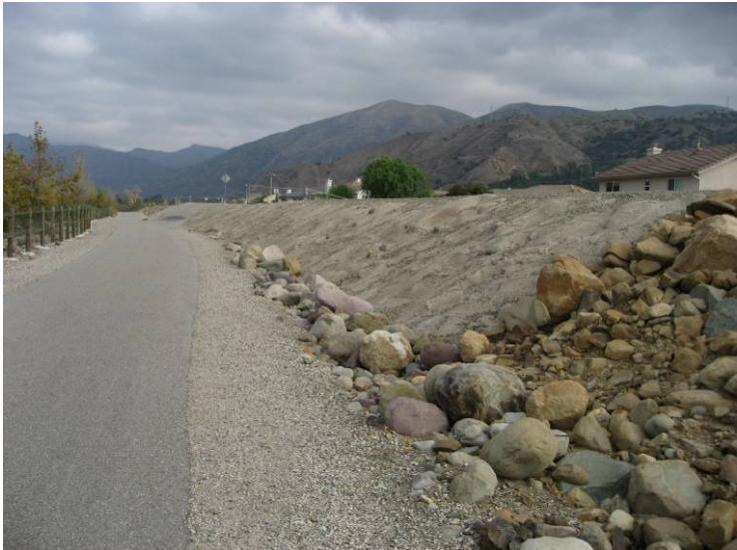
Sespe Creek Levee (Photo No. F1) – Paved pedestrian trail at the toe of the levee (Riverward side)

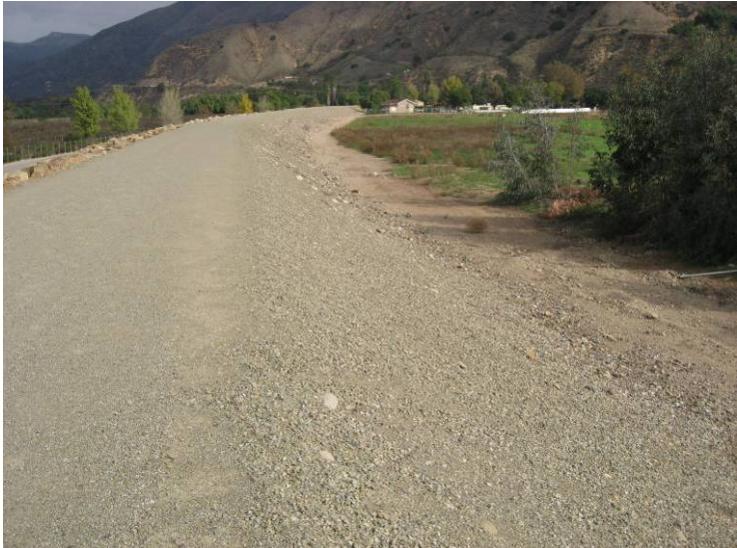
Sespe Creek Levee (Photo No. F2) – Unpaved maintenance road on the top of the levee (Photo taken looking toward the landward side)

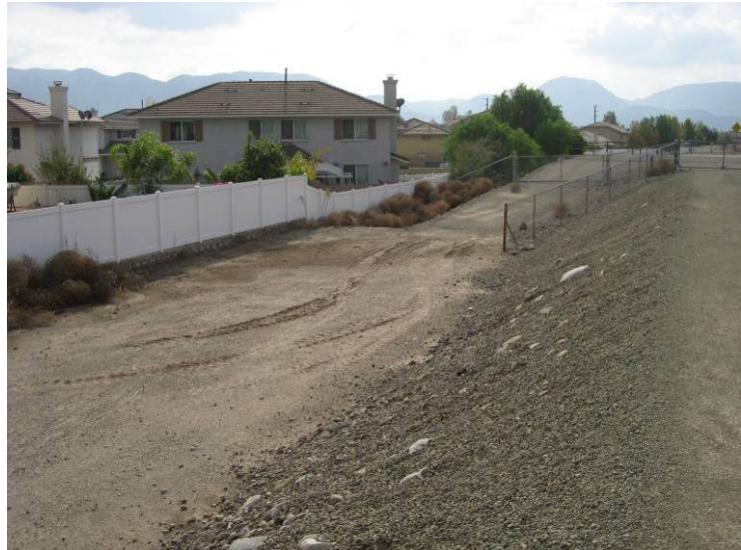
Sespe Creek Levee (Photo No. F3) – Maintenance road access ramp at the toe of the levee (Landward side)

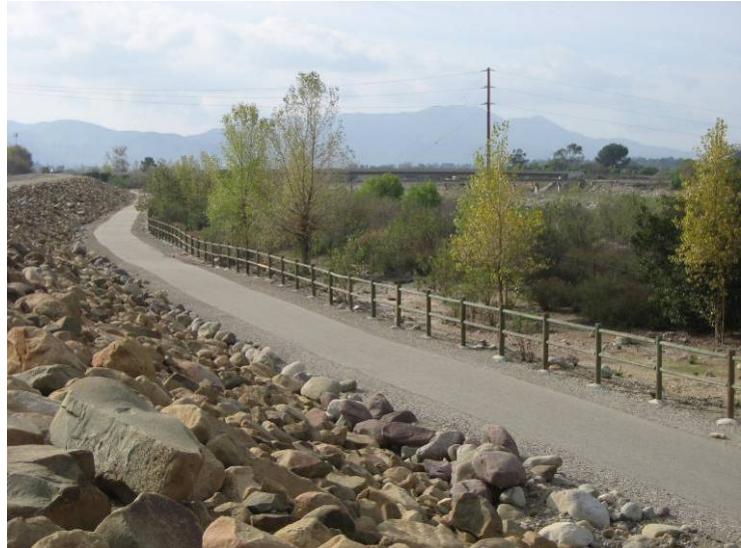
Sespe Creek Levee (Photo No. F4) – Typical Levee embankment and paved pedestrian trail at the toe of the levee (Riverward Side)

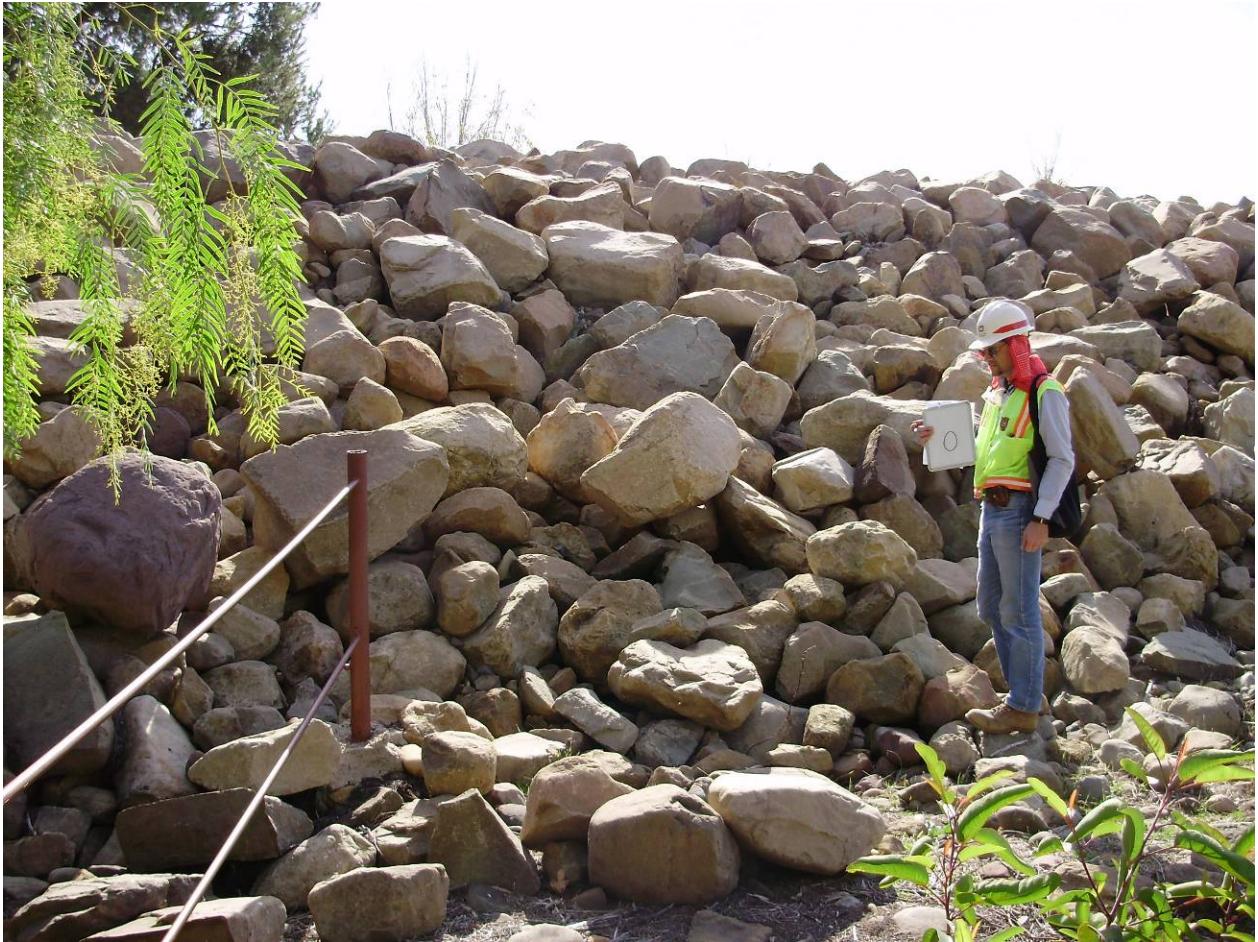
Fig. 3.—Slope protection stone, showing gradation and stone quality, levee sta. 112+75; this is upstream of Old Telegraph Rd. View is to the east. This is the upstreammost photograph taken. Photograph by US Army Corps of Engineers, 6 Jan. 2009.

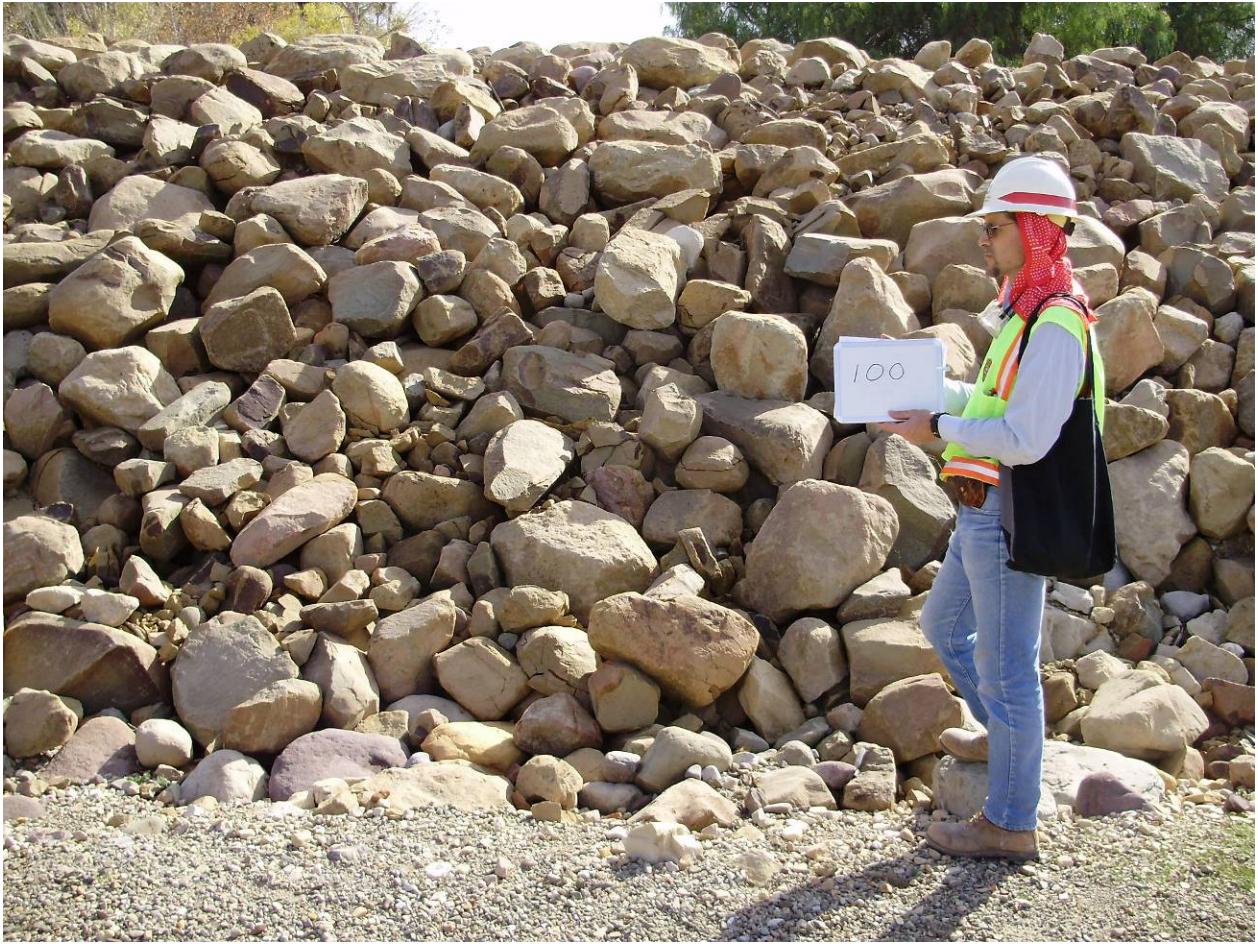
Fig. 4.—Slope protection stone, showing gradation and stone quality, levee sta. 110+30; this is upstream of Old Telegraph Rd. View is to the east. Photograph by US Army Corps of Engineers, 6 Jan. 2009.

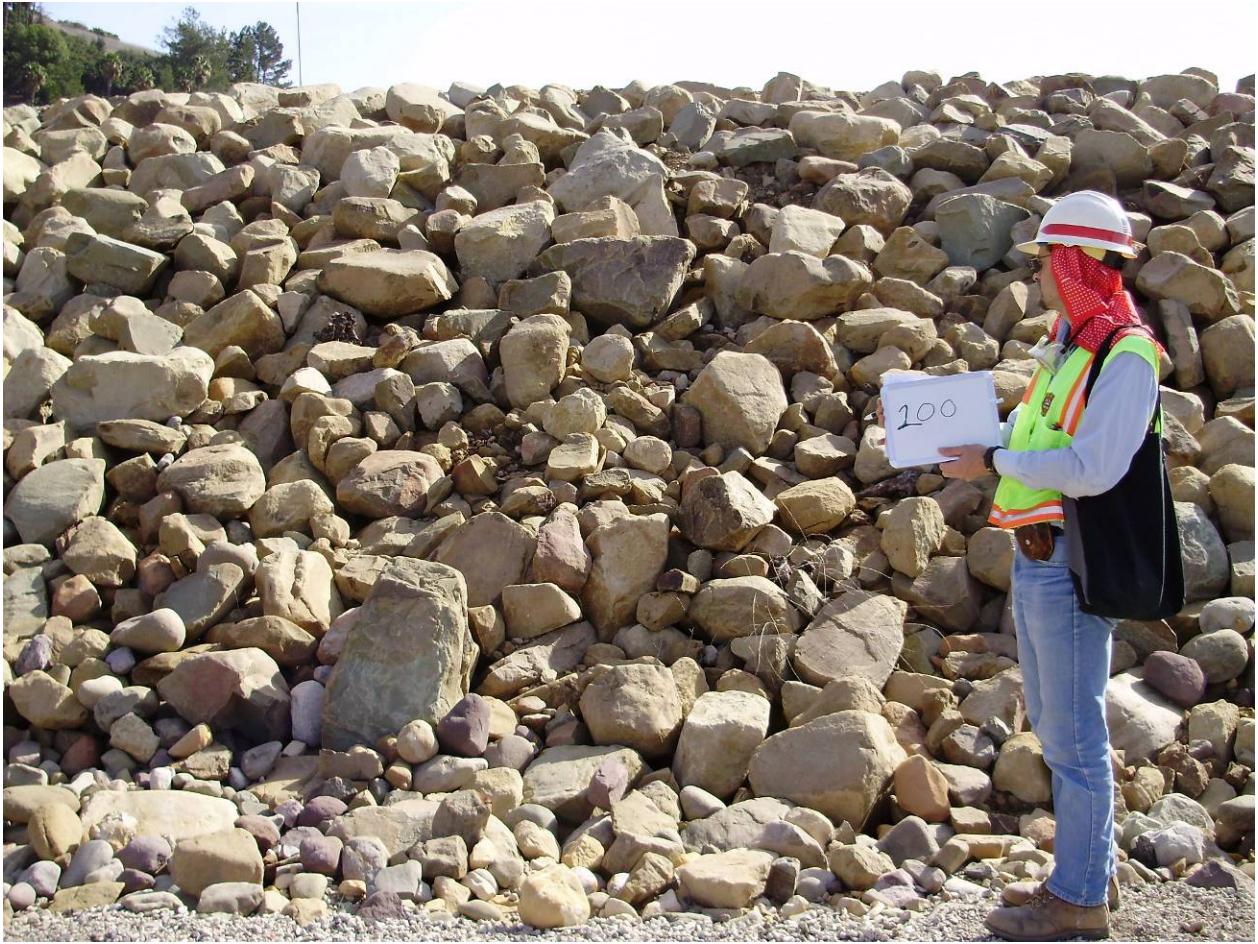
Fig. 5.—Slope protection stone, showing gradation and stone quality, levee sta. 107+30; this is upstream of Old Telegraph Rd. View is to the east. Photograph by US Army Corps of Engineers, 6 Jan. 2009.

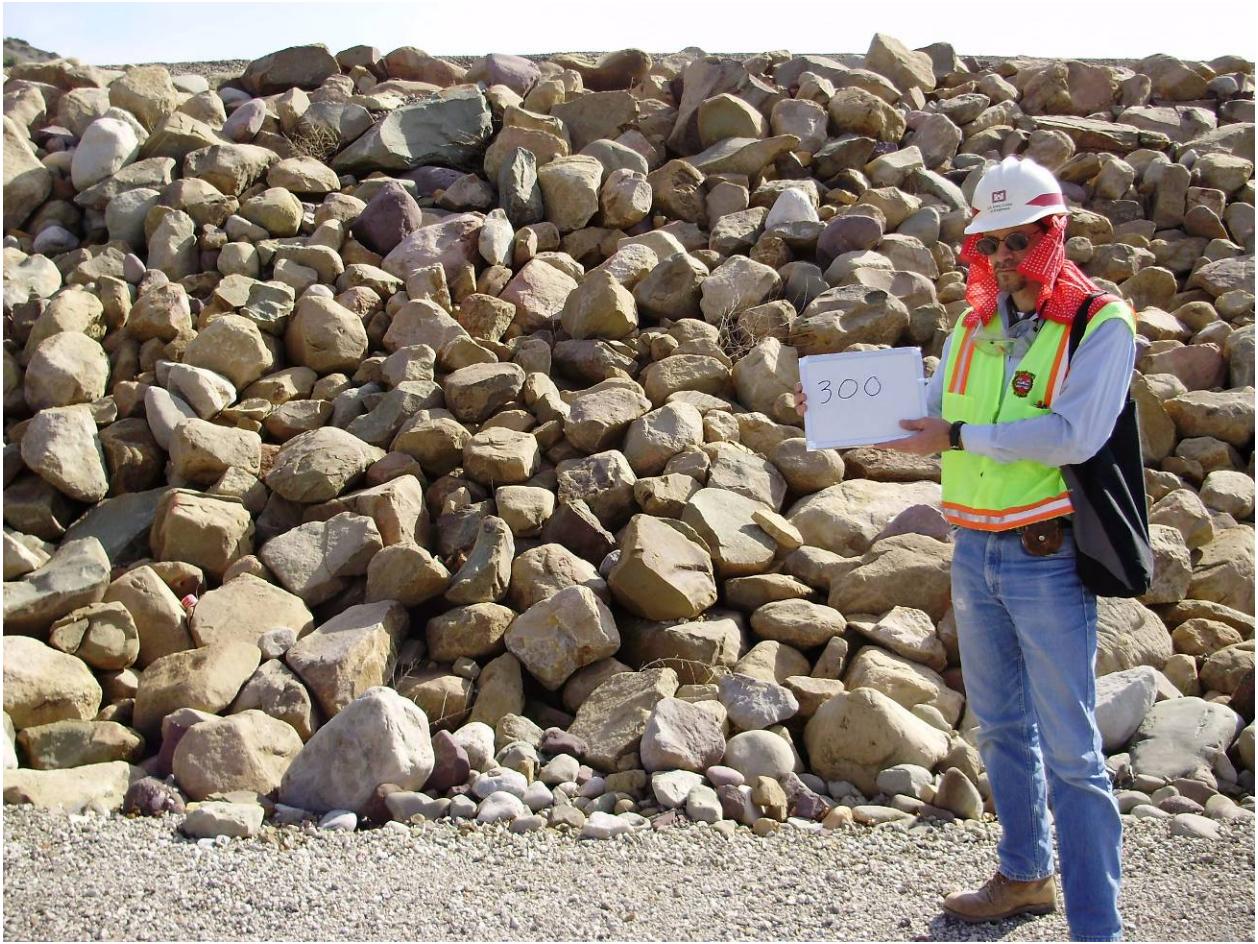
Fig. 6.—Slope protection stone, showing gradation and stone quality, levee sta. 105+40; this is upstream of Old Telegraph Rd. View is to the east. Photograph by US Army Corps of Engineers, 6 Jan. 2009.

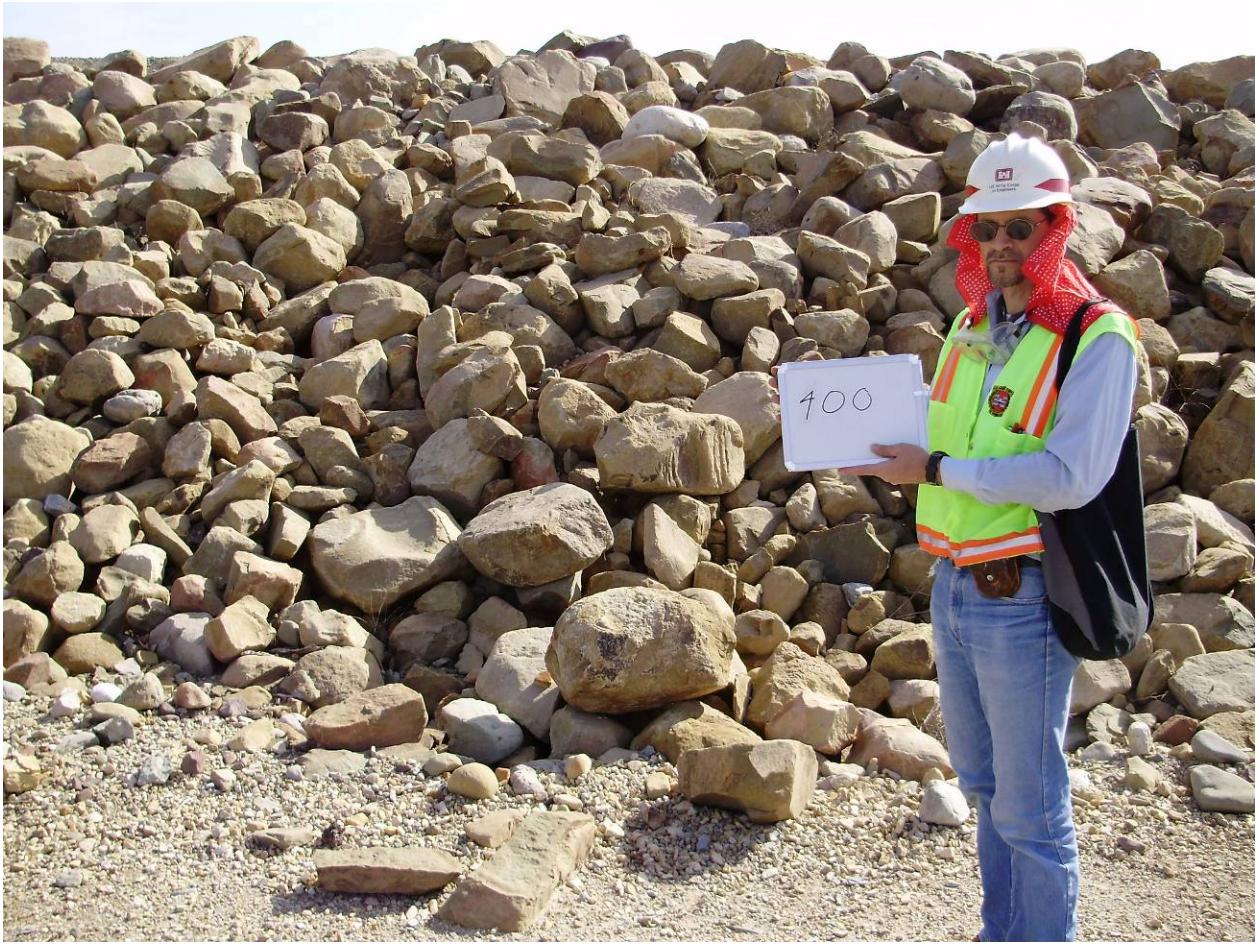
Fig. 7.—Slope protection stone, showing gradation and stone quality, levee sta. 102+90; this is upstream of Old Telegraph Rd. View is to the east. Photograph by US Army Corps of Engineers, 6 Jan. 2009.

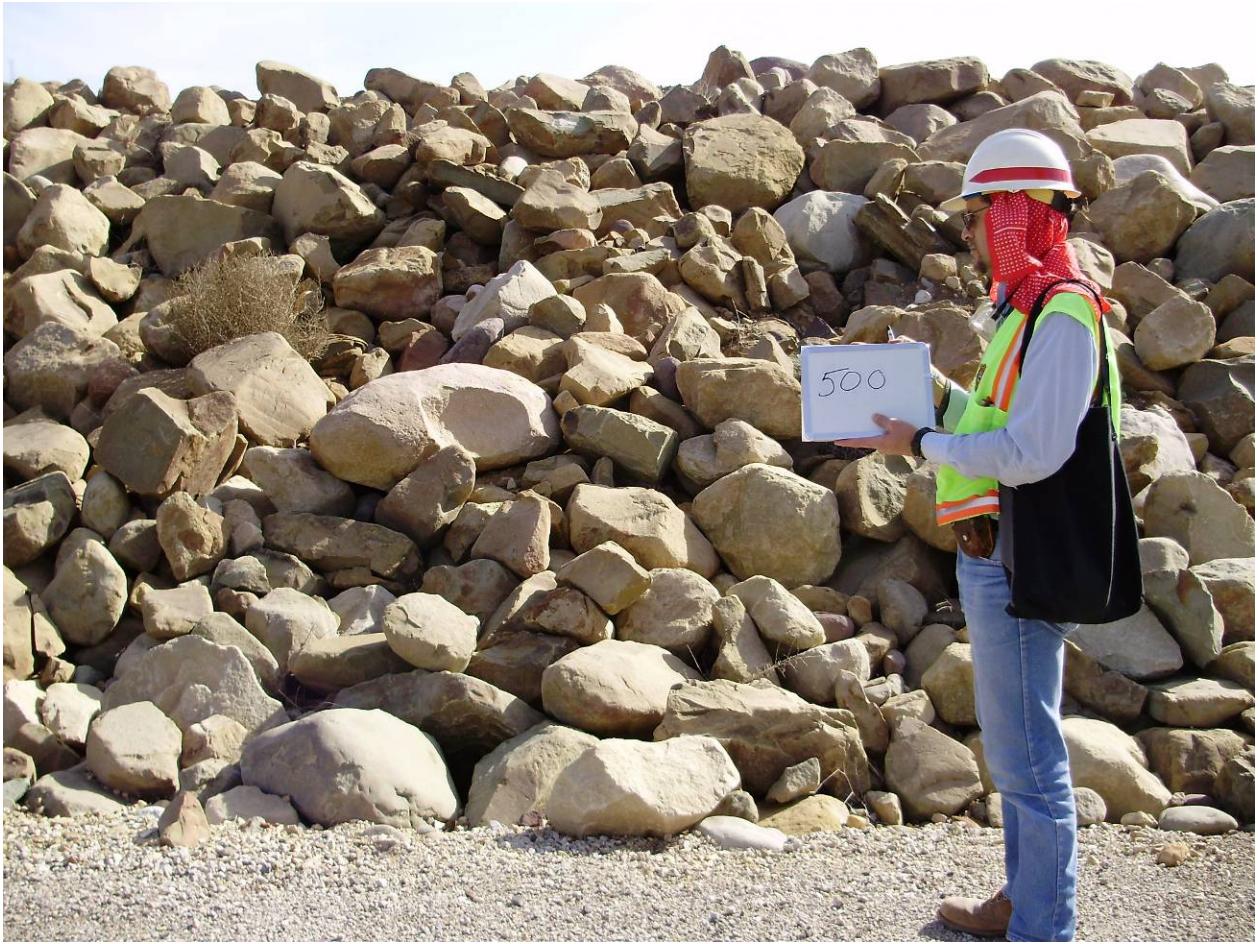
Fig. 8.—Slope protection stone, showing gradation and stone quality, levee sta. 100+40; this is upstream of Old Telegraph Rd. View is to the east. Photograph by US Army Corps of Engineers, 6 Jan. 2009.

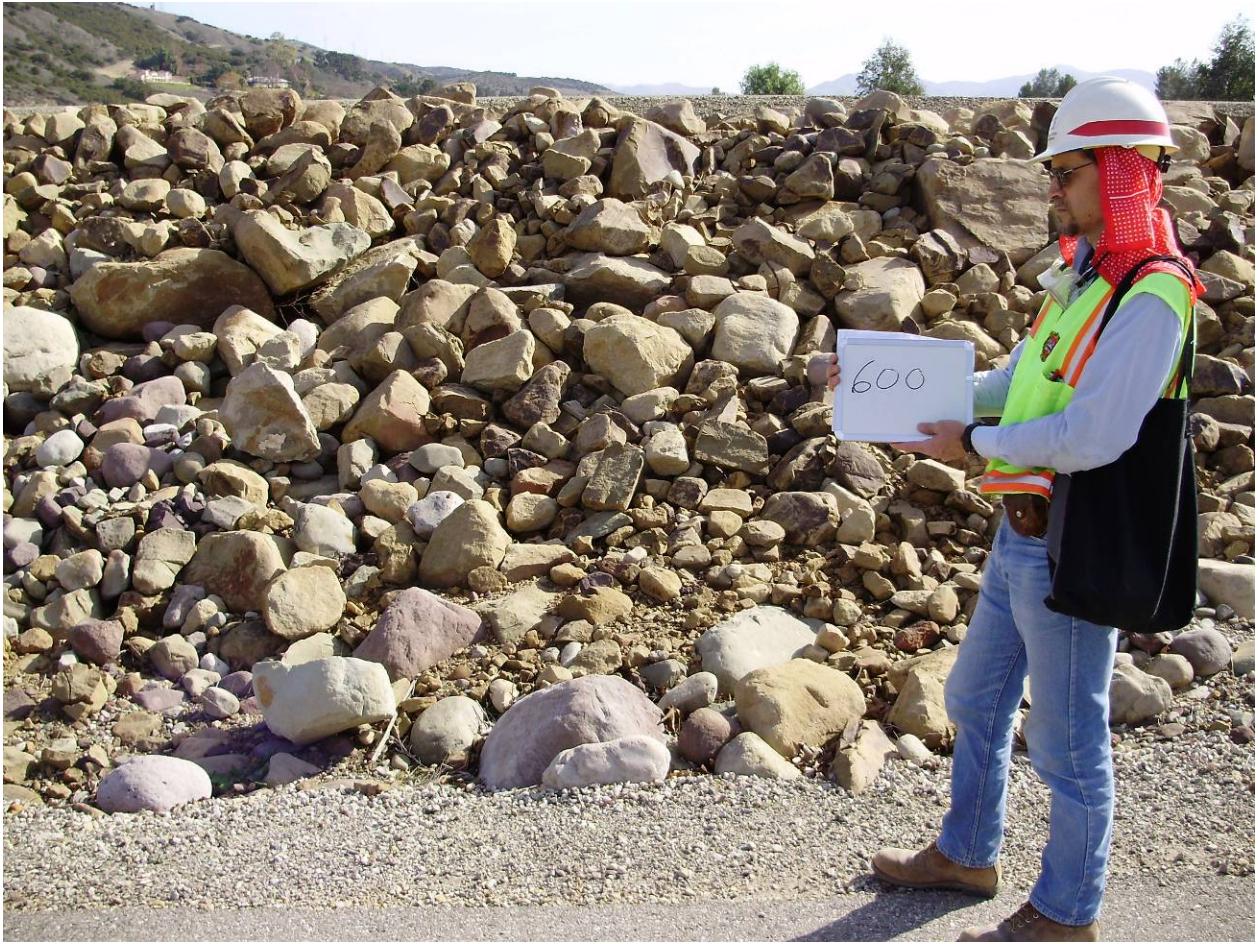
Fig. 9.—Slope protection stone, showing gradation and stone quality, levee sta. 98+00; this is upstream of Old Telegraph Rd. View is to the east. Photograph by US Army Corps of Engineers, 6 Jan. 2009.

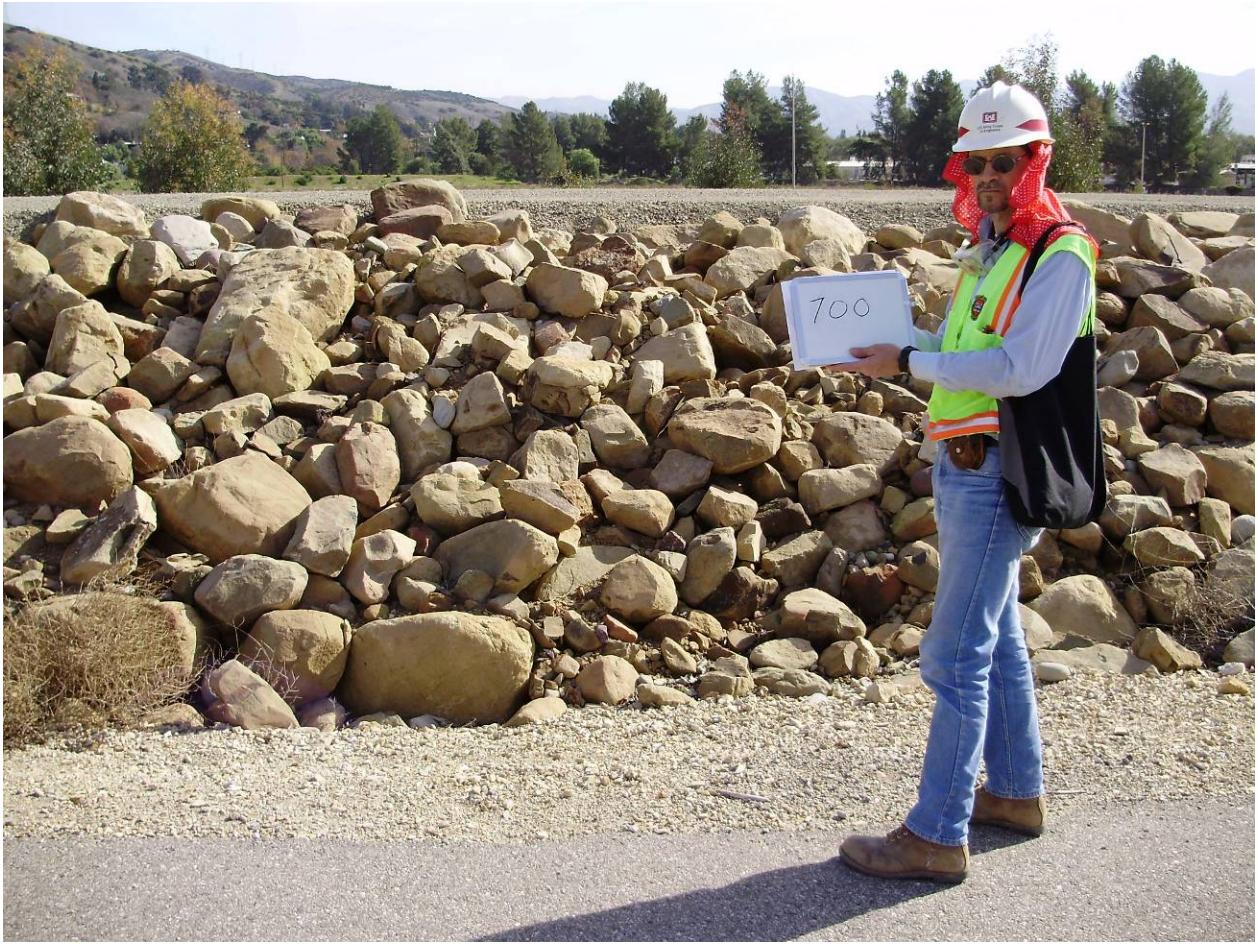
g. Verification testing of protection stone gradation in certain areas upstream of Old Telegraph Rd. possibly could demonstrate that there are segments with smaller than the specified gradation, but this is not due to stone breakdown. The project record documents that during construction, under-gradation-sized slope protection stone was encountered during inspections at sta. 94+00 (see **figs. 10, 11**). No fix was prescribed and the material was left in place on the grounds that the stone

Fig. 10.—Slope protection stone, showing gradation and stone quality, levee sta. 95+50; this is upstream of Old Telegraph Rd. View is to the east. Photograph by US Army Corps of Engineers, 6 Jan. 2009.

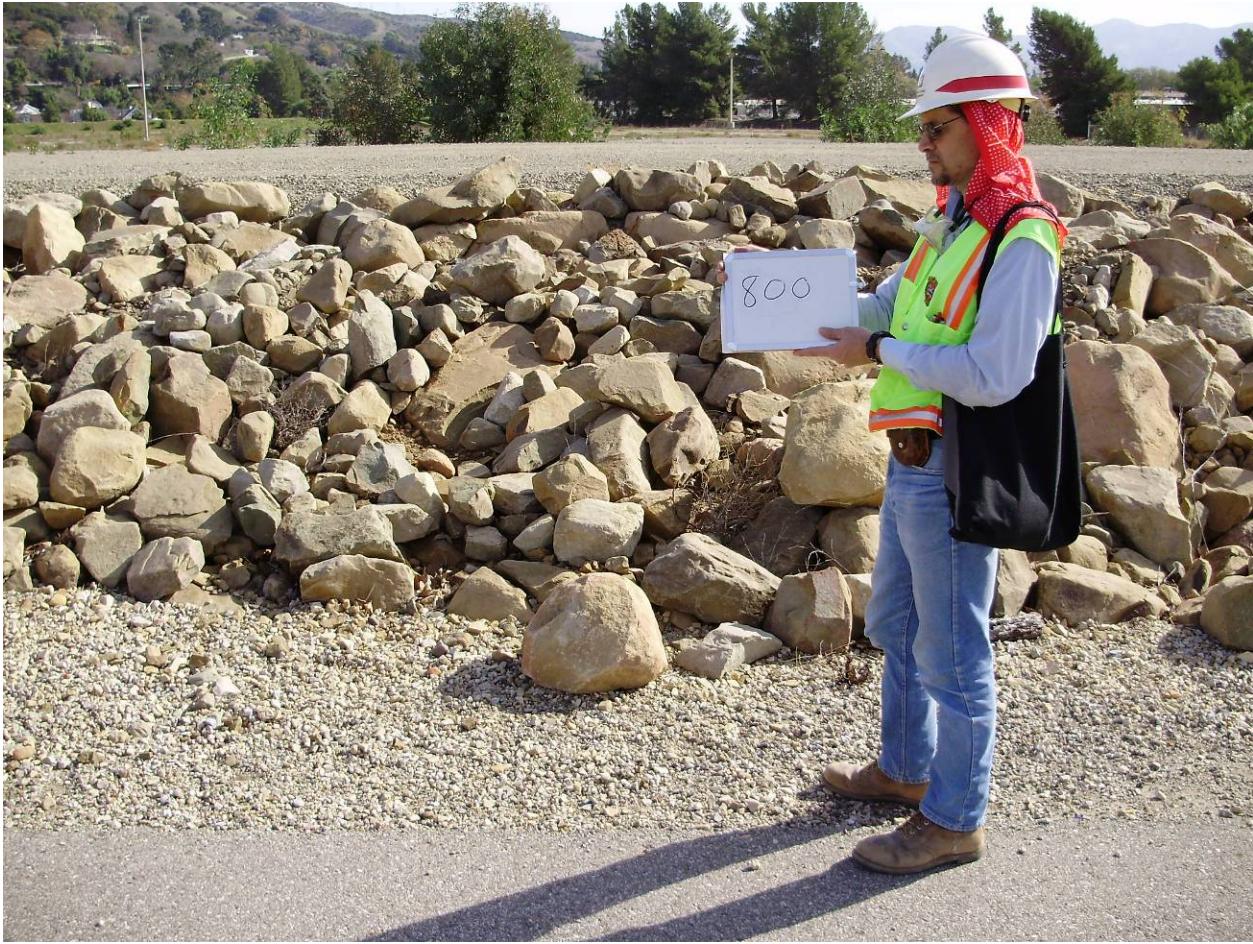
Fig. 11.—Slope protection stone, showing gradation and stone quality, levee sta. 93+10; this is upstream of Old Telegraph Rd. View is to the east. Photograph by US Army Corps of Engineers, 6 Jan. 2009.

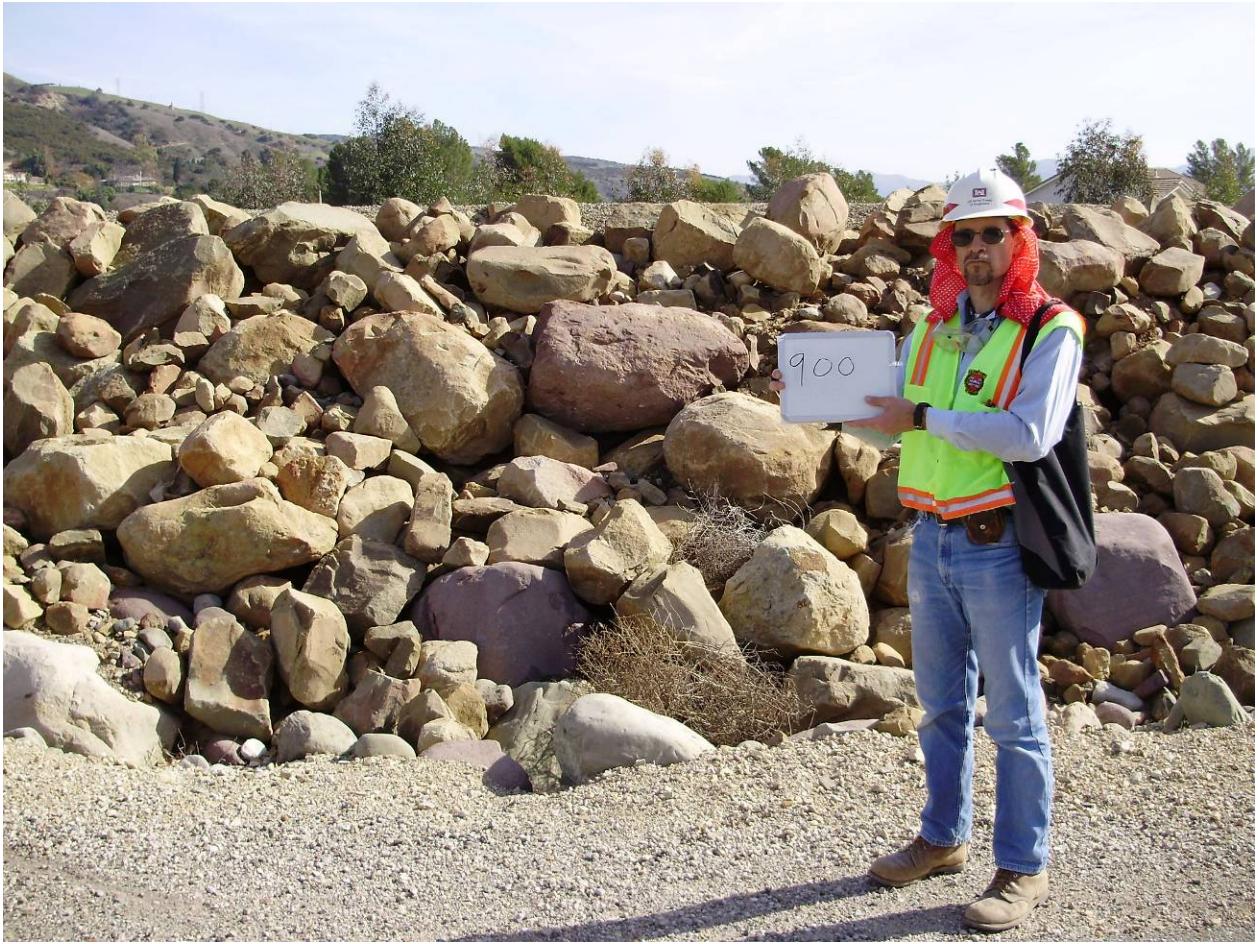
Fig. 12.—Slope protection stone, showing gradation and stone quality, levee sta. 90+60; this is upstream of Old Telegraph Rd. View is to the east. Photograph by US Army Corps of Engineers, 6 Jan. 2009.

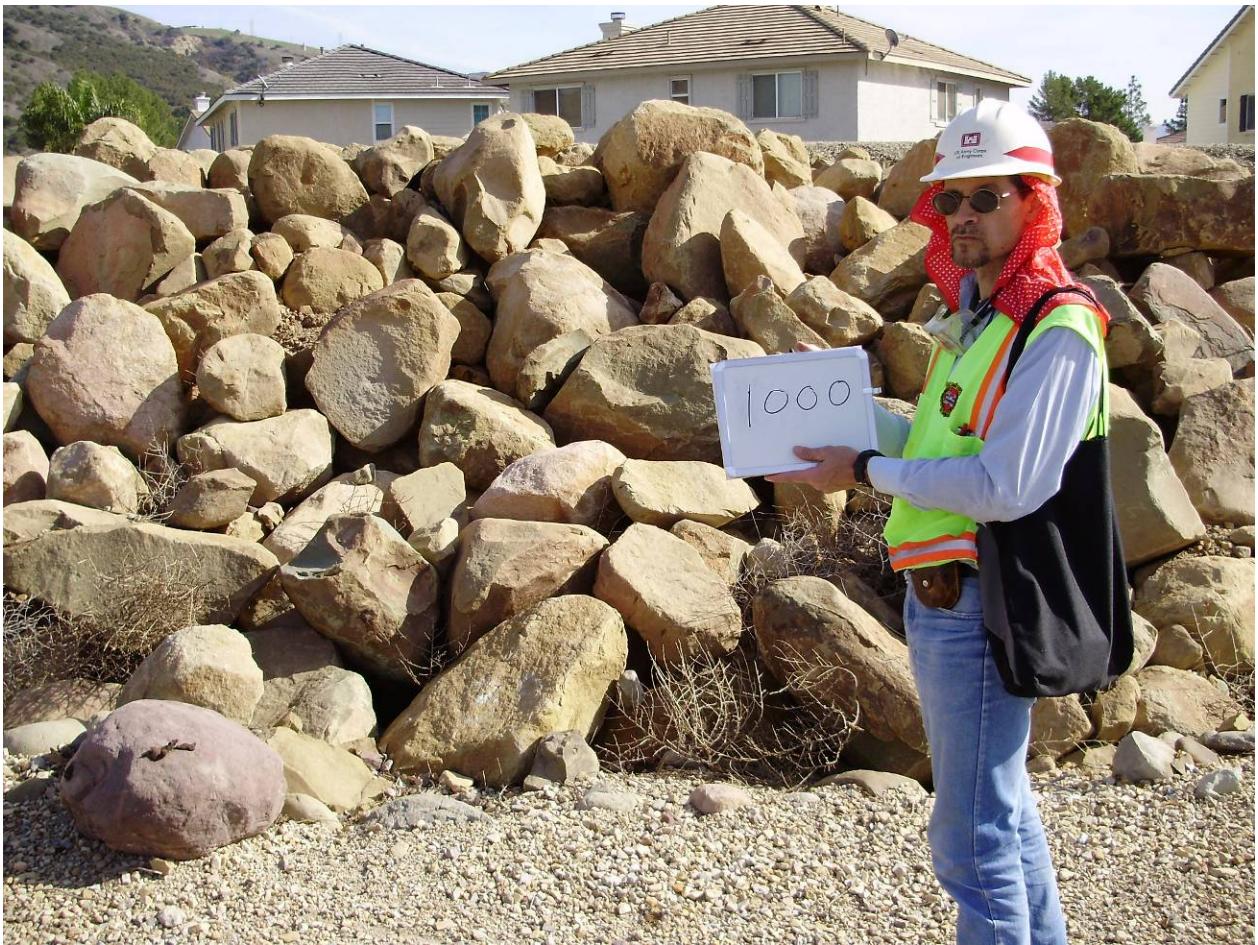
Fig. 13.—Slope protection stone, showing gradation and stone quality, levee sta. 88+10; this is upstream of Old Telegraph Rd. View is to the east. Photograph by US Army Corps of Engineers, 6 Jan. 2009.

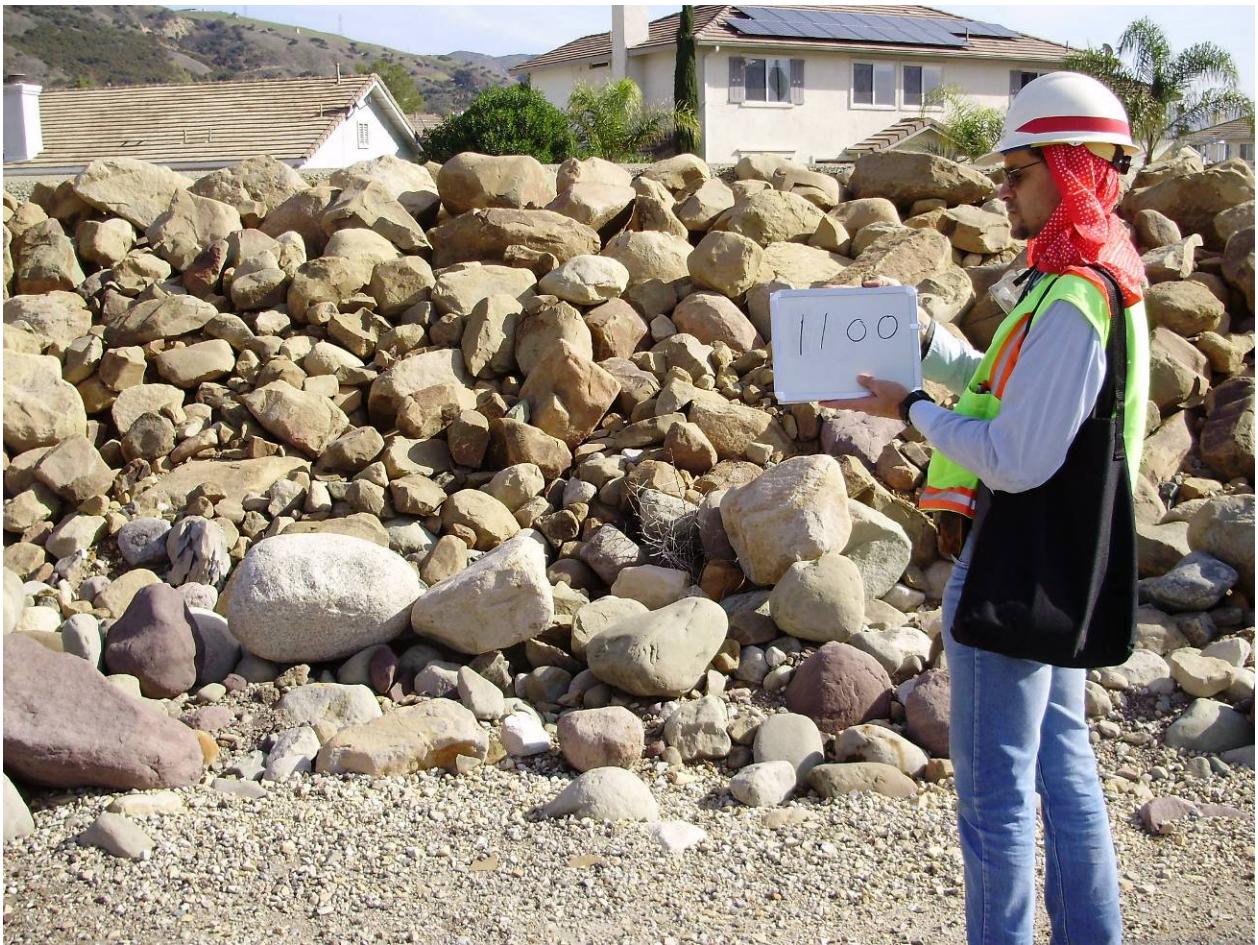
Fig. 14.—Slope protection stone, showing gradation and stone quality, levee sta. 85+70; this is upstream of Old Telegraph Rd. View is to the east. Photograph by US Army Corps of Engineers, 6 Jan. 2009.

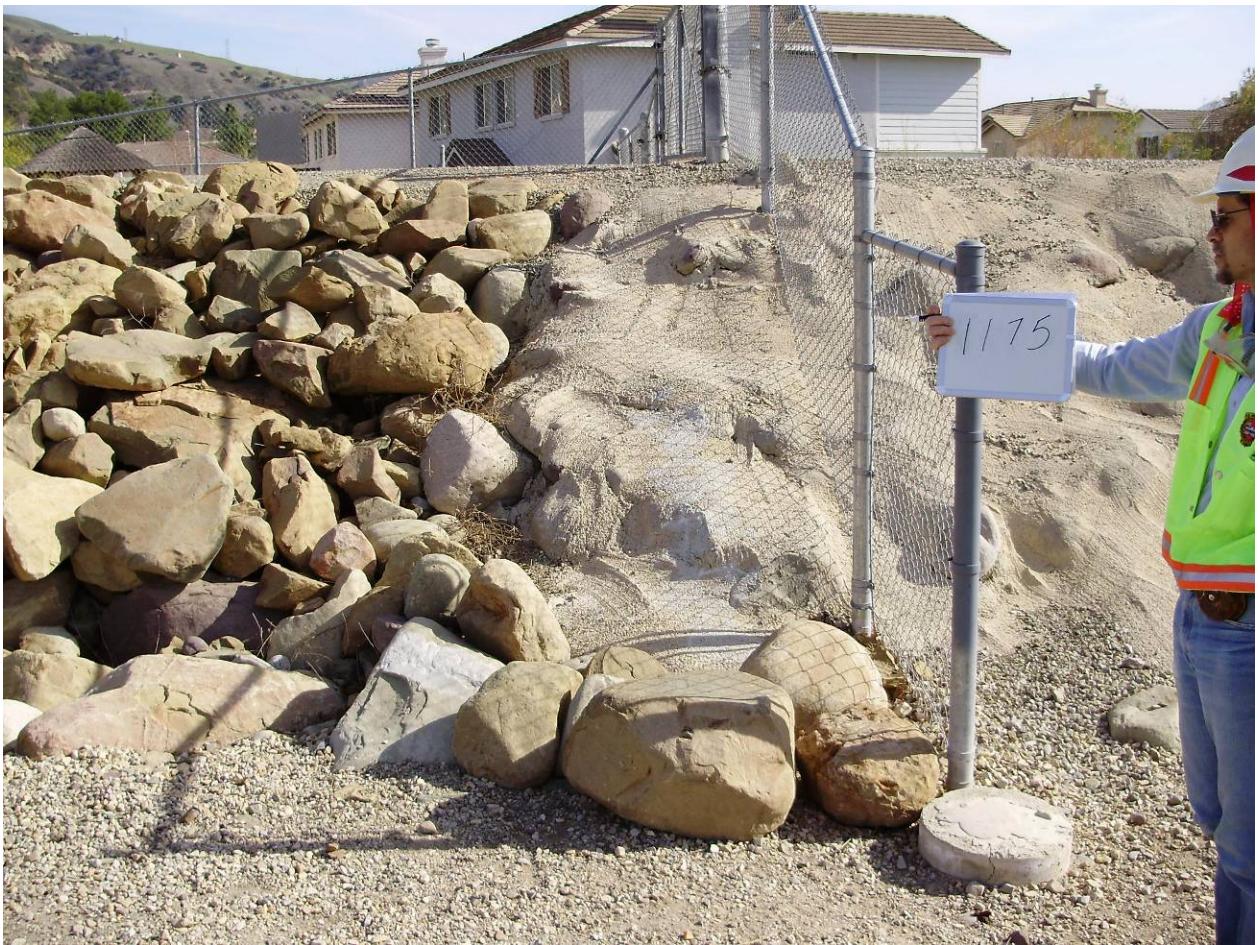
Fig. 15.—Slope protection stone, showing gradation and stone quality, levee sta. 84+35; this is upstream of Old Telegraph Rd. It also shows the upstream end of a grouted stone segment, which is grouted because an access ramp has been built near here down to the creek-side levee toe, from the levee crest. View is to the east. Photograph by US Army Corps of Engineers, 6 Jan. 2009.

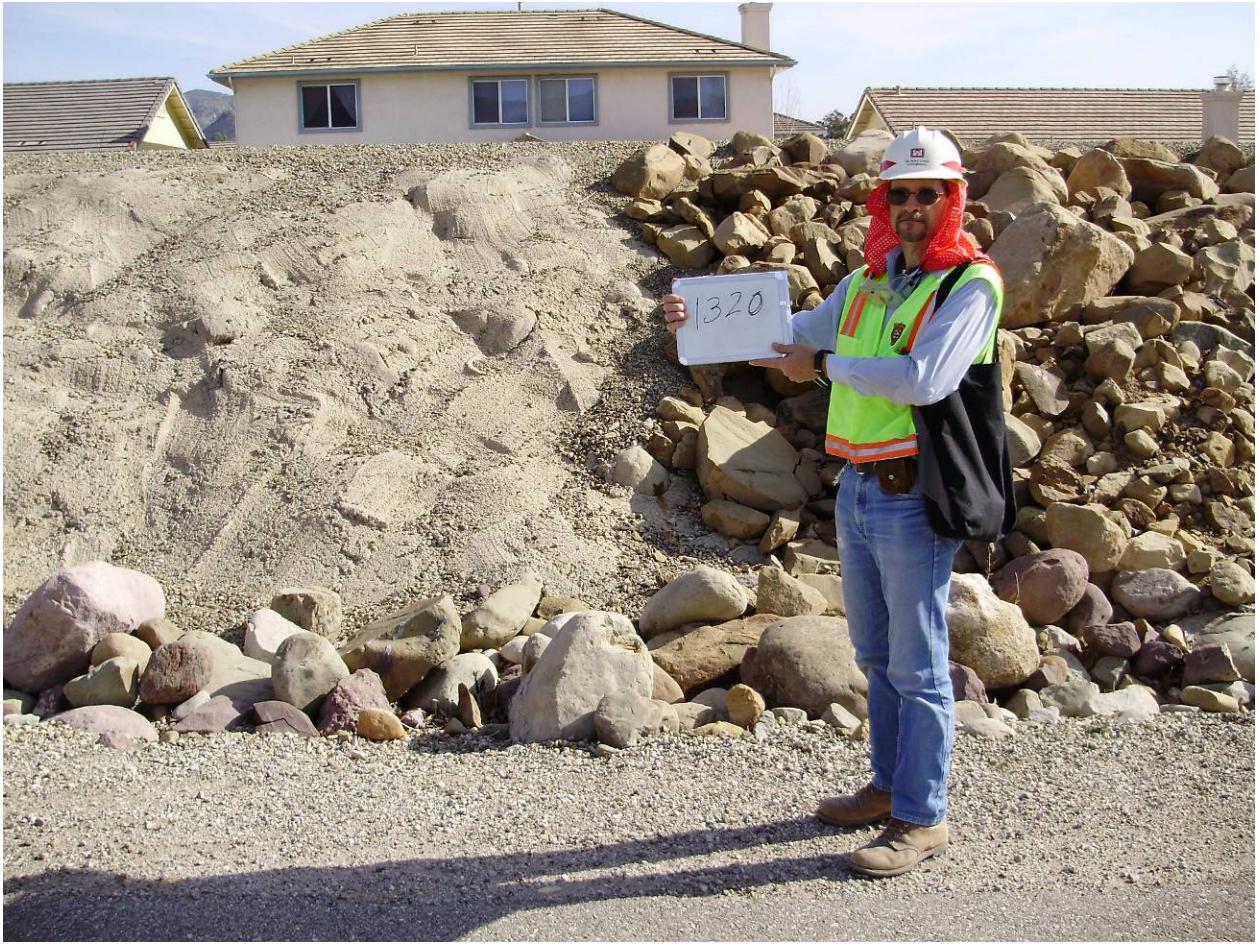
Fig. 16.—Slope protection stone, showing gradation and stone quality, levee sta. 80+80; this is upstream of Old Telegraph Rd. It also shows the downstream end of a grouted stone segment, which is grouted because an access ramp has been built near here down to the creek-side levee toe, from the levee crest. View is to the east. Photograph by US Army Corps of Engineers, 6 Jan. 2009.

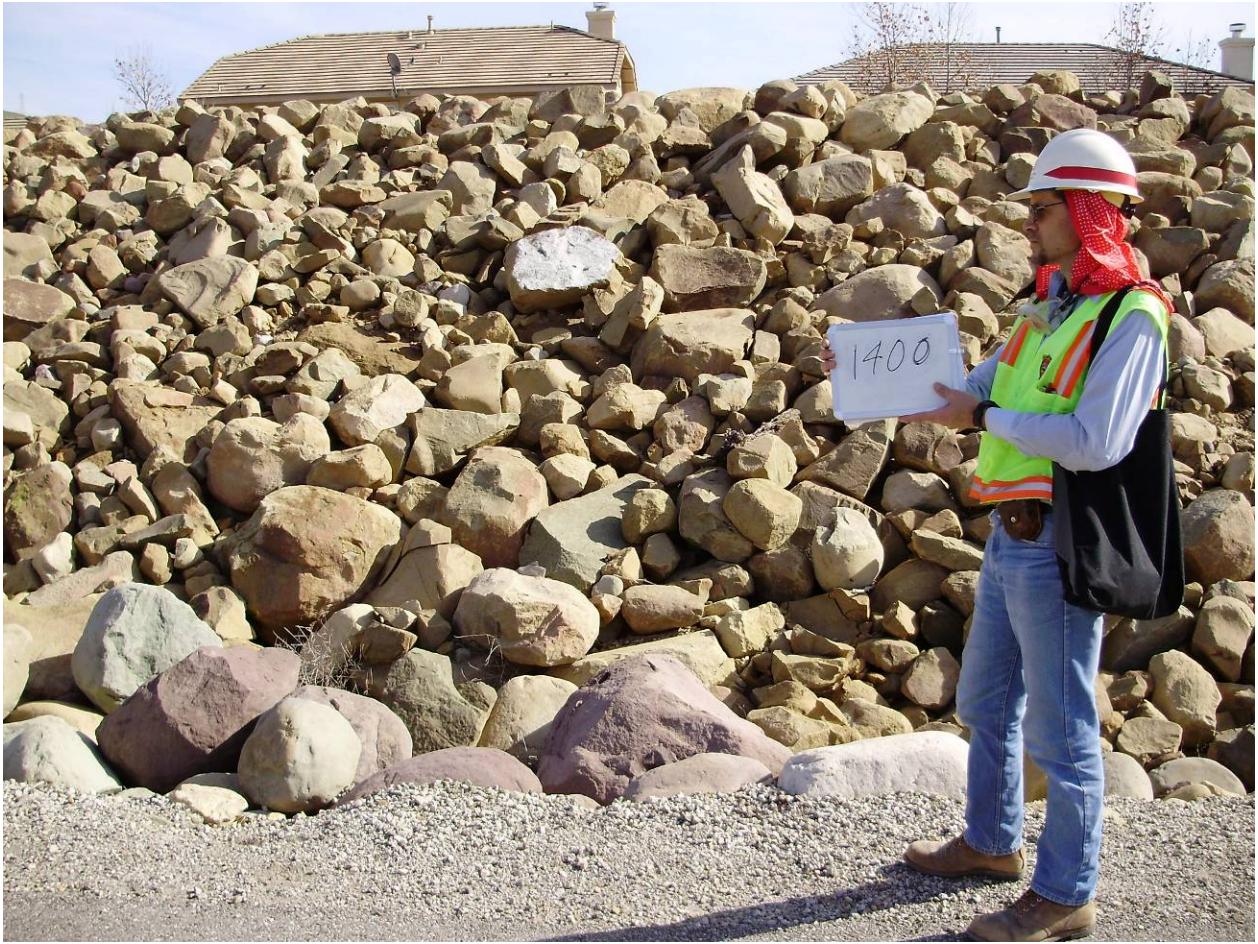
Fig. 17.—Slope protection stone, showing gradation and stone quality, levee sta. 78+30; this is upstream of Old Telegraph Rd. View is to the east. Photograph by US Army Corps of Engineers, 6 Jan. 2009.

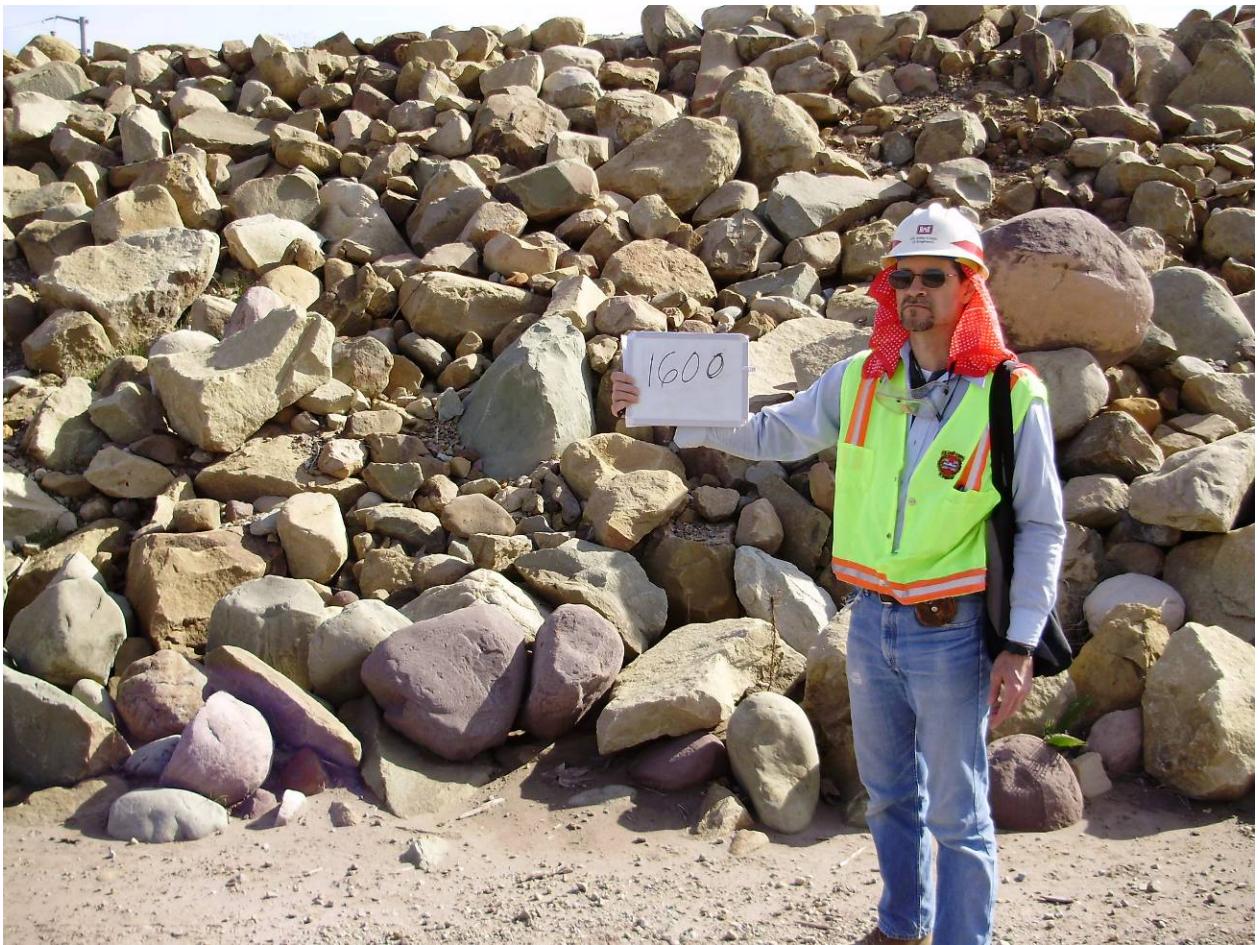
Fig. 19.—Slope protection stone, showing gradation and stone quality, levee sta. 73+40; this is upstream of Old Telegraph Rd. View is to the east. Photograph by US Army Corps of Engineers, 6 Jan. 2009.

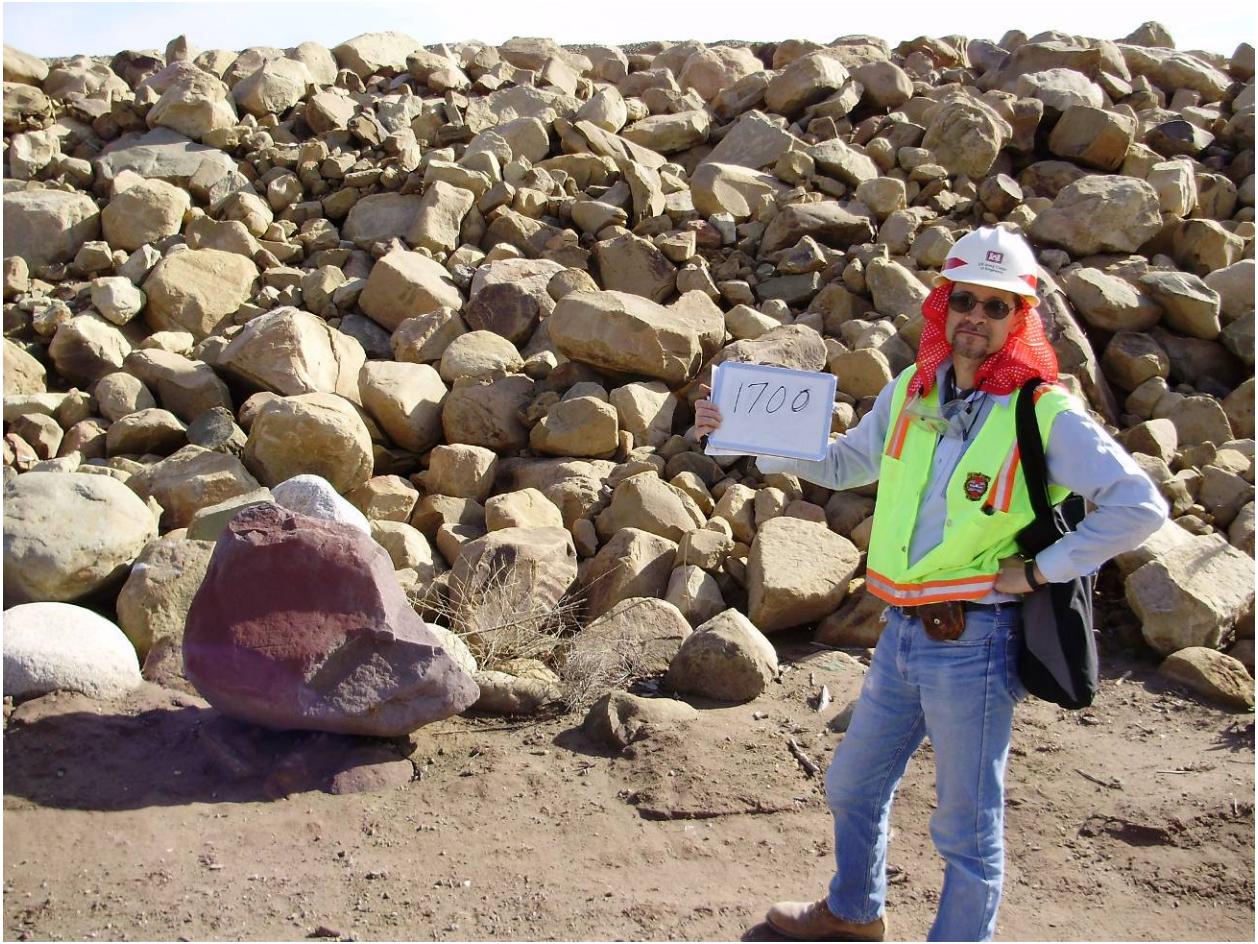
Fig. 20.—Slope protection stone, showing gradation and stone quality, levee sta. 70+90; this is upstream of Old Telegraph Rd. View is to the east. Photograph by US Army Corps of Engineers, 6 Jan. 2009.
