FEMA Levee Certification

**Sespe Creek Levee (SC-1)
Old Telegraph Road to Goodenough Road**

Evaluation Report

February 13, 2009

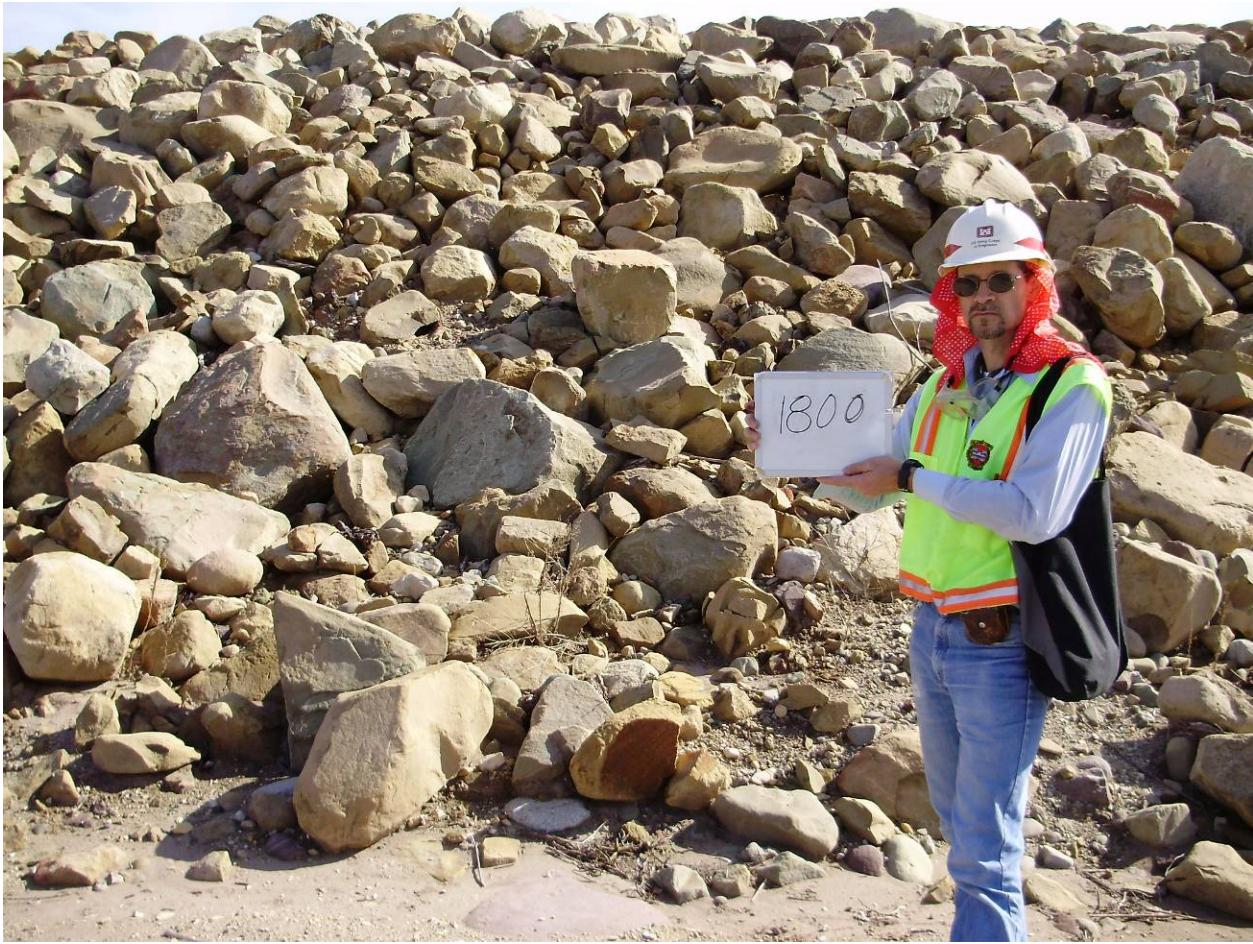
Fig. 21.—Slope protection stone, showing gradation and stone quality, levee sta. 68+50; this is upstream of Old Telegraph Rd. View is to the east. Photograph by US Army Corps of Engineers, 6 Jan. 2009.

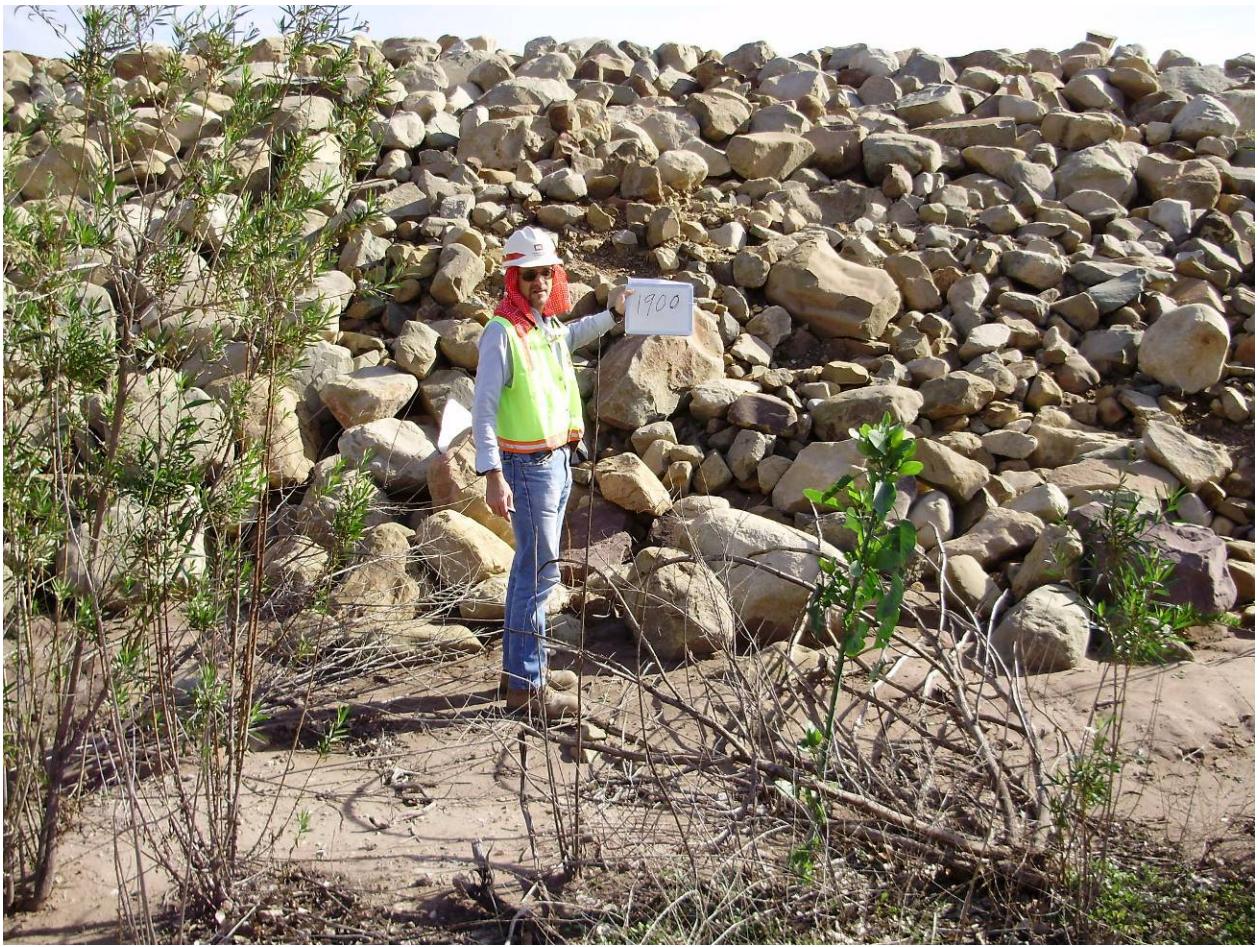
Fig. 22.—Slope protection stone, showing gradation and stone quality, levee sta. 66+00; this is upstream of Old Telegraph Rd. This is the downstreammost point photographed that is still UPSTREAM of Old Telegraph Rd. View is to the east. Photograph by US Army Corps of Engineers, 6 Jan. 2009.

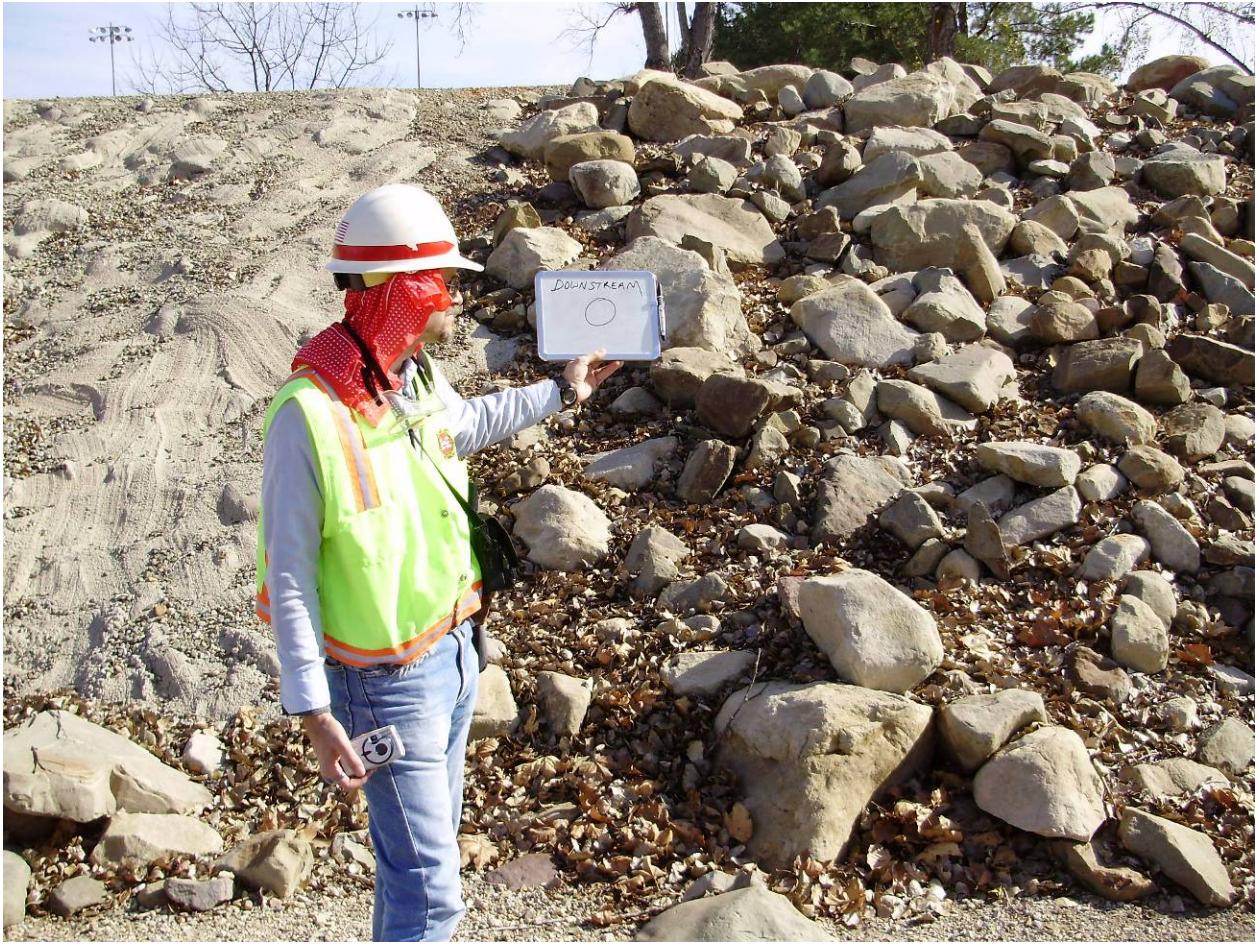
Fig. 23.—Slope protection stone, showing gradation and stone quality, levee sta. 56+33; this is downstream of Old Telegraph Rd. The area immediately adjacent the Old Telegraph Rd. abutment has been grouted. This is the upstream end of the ungrouted stone that also is downstream of Old Telegraph Rd. View is to the east. Photograph by US Army Corps of Engineers, 6 Jan. 2009.

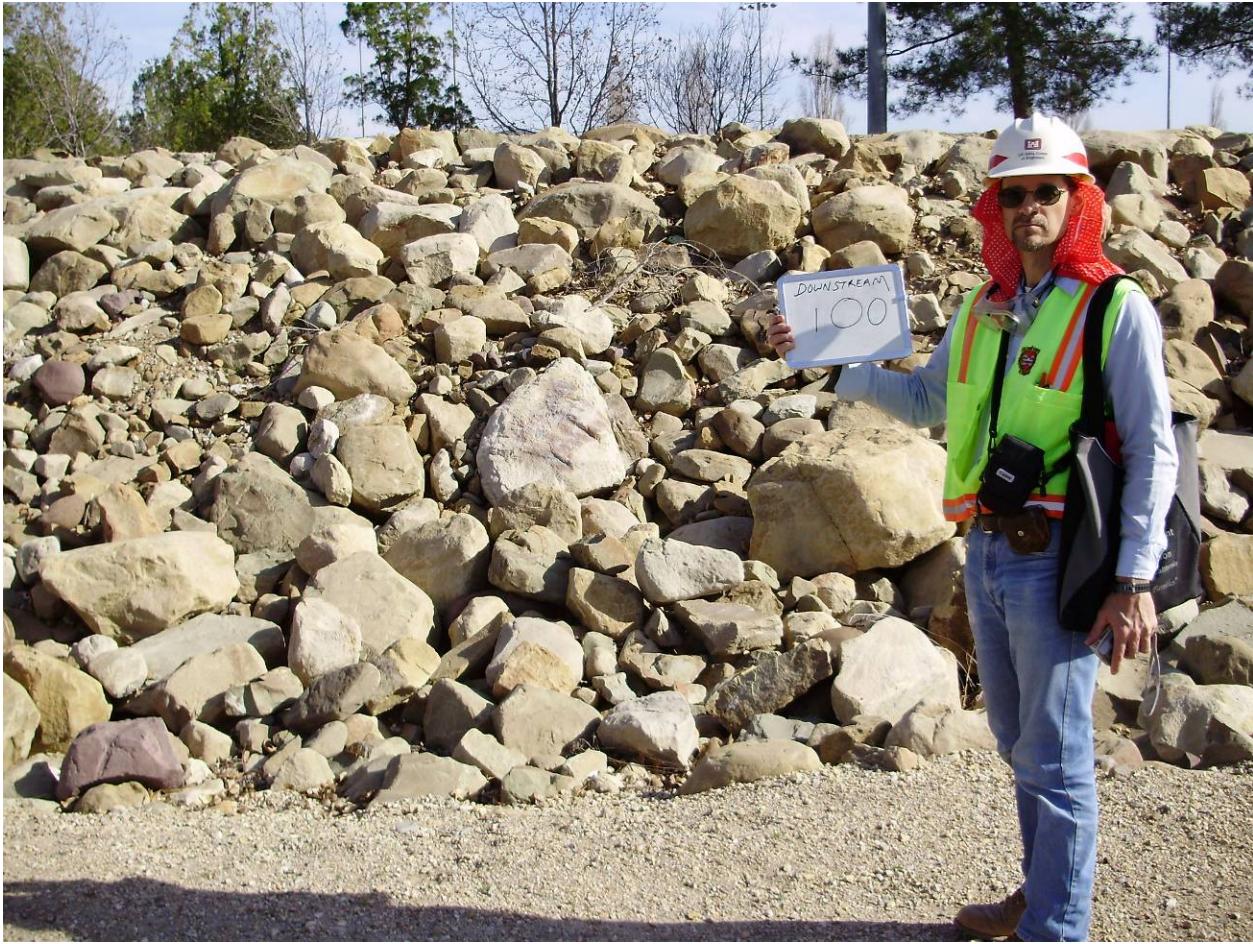
Fig. 24.—Slope protection stone, showing gradation and stone quality, levee sta. 53+90; this is downstream of Old Telegraph Rd. View is to the east. Photograph by US Army Corps of Engineers, 6 Jan. 2009.

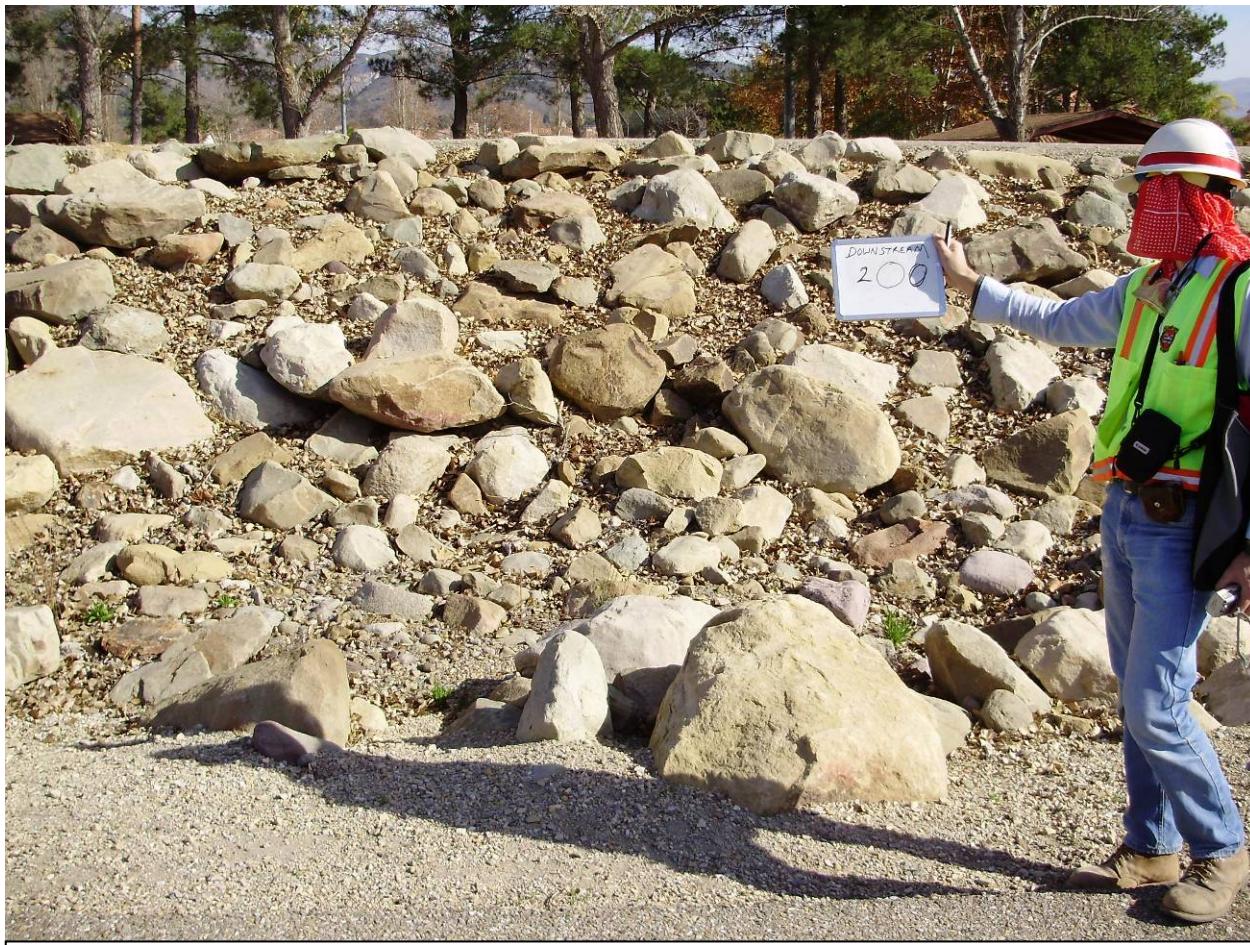
Fig. 25.—Slope protection stone, showing gradation and stone quality, levee sta. 51+40; this is downstream of Old Telegraph Rd. View is to the east. This is the downstreammost point that was photographed. UngROUTed slope protection stone continues downstream to sta. 25+00. Photograph by US Army Corps of Engineers, 6 Jan. 2009.
